## Profile/Photo Observation Report

Date:	<b>04/20/2018</b>	Weather:		Coding:	<b>PACP 6.0</b>
Pipe Length (ft):	<b>335.8</b>	Owner:	<b>NA</b>	Pre Clean:	<b>Not Known</b>
P.O.#:		Surveyor:	<b>Byrd Fitzgerald</b>	PSR:	<b>P-706-013.2-013.1</b>
Customer:		Clean Date:	<b>01/01/1900</b>	Shape:	<b>C</b>

Street:	<b>Capitol</b>	Flow Control:	<b>Not Controlled</b>
City:	<b>Hobart, IN</b>	Year Renewed:	
Location:	<b>Light Highway</b>	Tape/Media #:	
Purpose:	<b>Maintenance Related</b>	Dia/Height:	<b>12"</b>
Use:	<b>Sanitary</b>	Material:	<b>PVC</b>
Drain Area:	<b>NA</b>	Lining:	
Category:	<b>NA</b>		
Comment:	<b>Reverse setup. shorter than expected.</b>		
Location Details:		Direction of Survey:	<b>Upstream</b>
US MH:	<b>M-706-013.1</b>	DS MH:	<b>M-706-013.2</b>
		Total Length Surveyed (ft):	<b>218.6</b>

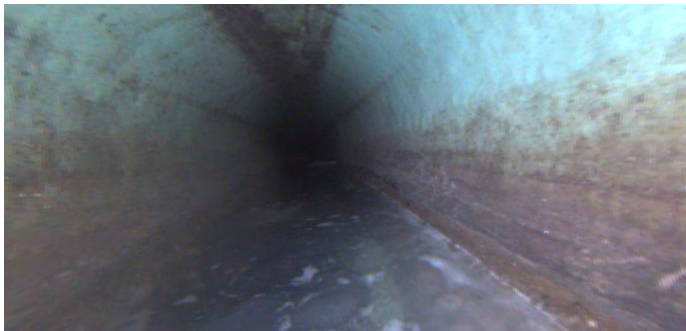
Code: **AMH**  
Description: **Manhole**

Distance (ft): **.0**  
Structural Grade: **0**  
O&M Grade: **0**  
Clock Start/From:  
Clock To:  
1st Value:  
2nd Value:  
Value Percent:  
Continuous Index:  
Within 8" of Joint: **NO**  
Remarks: **M-706-013.2**

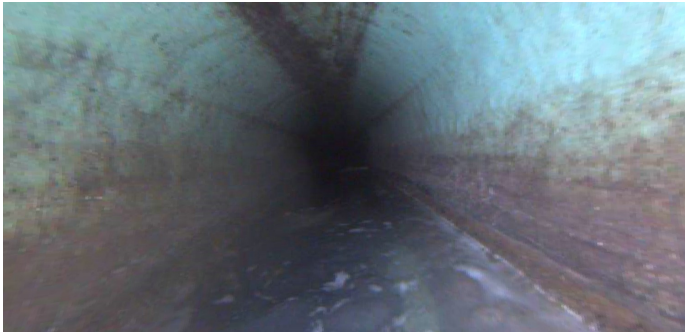
Code:	<b>MWL</b>
Description:	<b>Water Level</b>

Distance (ft):	<b>.0</b>
Structural Grade:	<b>0</b>
O&M Grade:	<b>0</b>
Clock Start/From:	
Clock To:	
1st Value:	
2nd Value:	
Value Percent:	<b>5.000</b>
Continuous Index:	
Within 8" of Joint:	<b>NO</b>
Remarks:

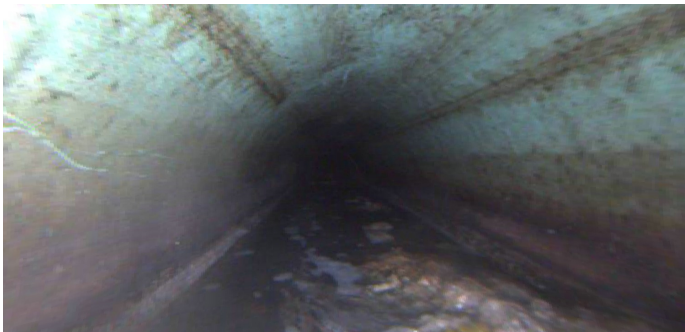
Code:	<b>DSZ</b>
Description:	<b>Deposits Settled Other</b>

Distance (ft):	<b>5.0</b>
Structural Grade:	<b>0</b>
O&M Grade:	<b>2</b>
Clock Start/From:	<b>6</b>
Clock To:	
1st Value:	
2nd Value:	
Value Percent:	<b>5.000</b>
Continuous Index:	<b>S01</b>
Within 8" of Joint:	<b>NO</b>
Remarks:	<b>debris</b>

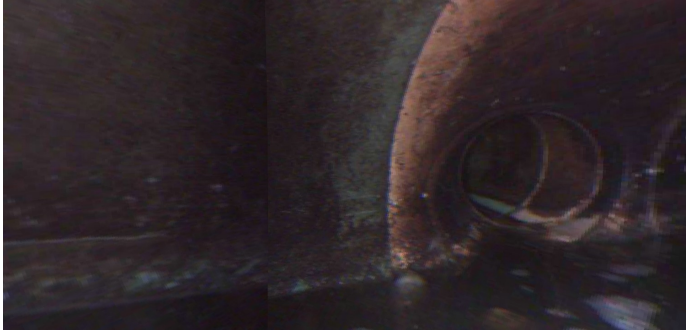
Code: **TF**  
Description: **Tap Factory**

Distance (ft): **35.2**  
Structural Grade: **0**  
O&M Grade: **0**  
Clock Start/From: **3**  
Clock To:  
1st Value: **4.000**  
2nd Value:  
Value Percent:  
Continuous Index:  
Within 8" of Joint: **YES**  
Remarks:

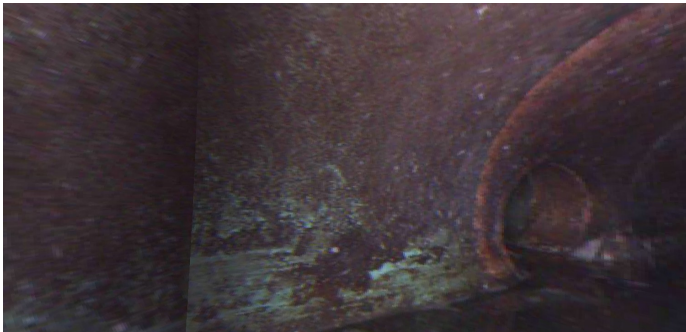
Code: **TF**  
Description: **Tap Factory**

Distance (ft): **68.3**  
Structural Grade: **0**  
O&M Grade: **0**  
Clock Start/From: **3**  
Clock To:  
1st Value: **4.000**  
2nd Value:  
Value Percent:  
Continuous Index:  
Within 8" of Joint: **YES**  
Remarks:

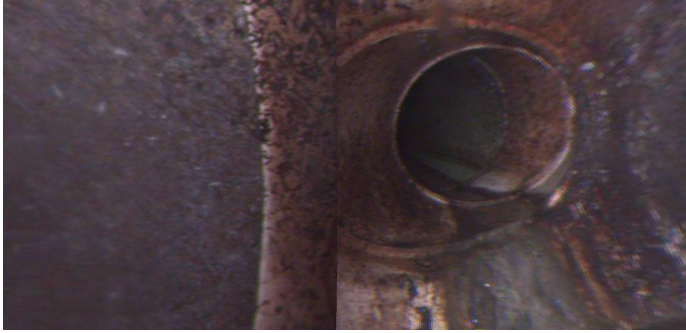
Code: **TF**  
Description: **Tap Factory**

Distance (ft): **111.5**  
Structural Grade: **0**  
O&M Grade: **0**  
Clock Start/From: **2**  
Clock To:  
1st Value: **4.000**  
2nd Value:  
Value Percent:  
Continuous Index:  
Within 8" of Joint: **YES**  
Remarks:

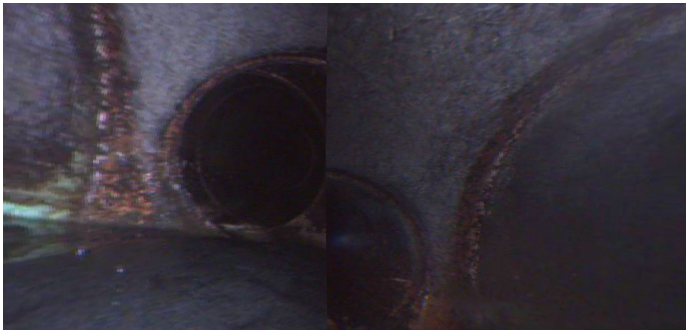
Code: **TF**  
Description: **Tap Factory**

Distance (ft): **128.7**  
Structural Grade: **0**  
O&M Grade: **0**  
Clock Start/From: **9**  
Clock To:  
1st Value: **4.000**  
2nd Value:  
Value Percent:  
Continuous Index:  
Within 8" of Joint: **YES**  
Remarks:

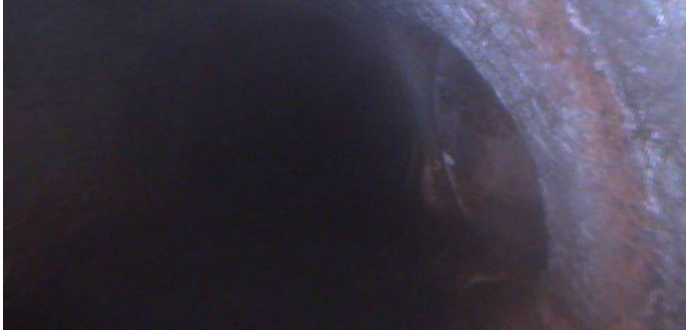
Code: **TF**  
Description: **Tap Factory**

Distance (ft): **130.3**  
Structural Grade: **0**  
O&M Grade: **0**  
Clock Start/From: **3**  
Clock To:  
1st Value: **4.000**  
2nd Value:  
Value Percent:  
Continuous Index:  
Within 8" of Joint: **YES**  
Remarks:

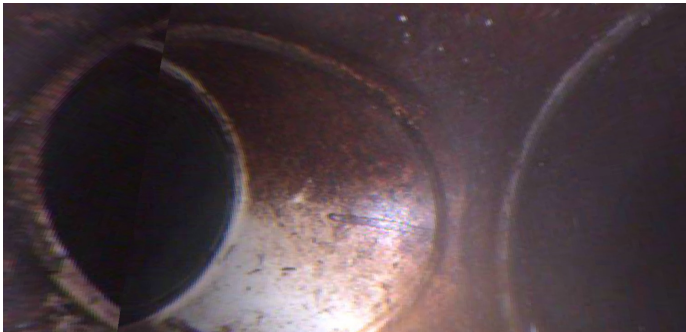
Code: **TF**  
Description: **Tap Factory**

Distance (ft): **174.7**  
Structural Grade: **0**  
O&M Grade: **0**  
Clock Start/From: **10**  
Clock To:  
1st Value: **4.000**  
2nd Value:  
Value Percent:  
Continuous Index:  
Within 8" of Joint: **YES**  
Remarks:

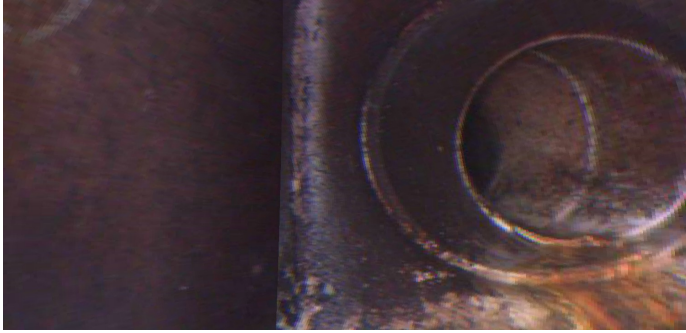
Code: **TF**  
Description: **Tap Factory**

Distance (ft): **178.7**  
Structural Grade: **0**  
O&M Grade: **0**  
Clock Start/From: **2**  
Clock To:  
1st Value: **4.000**  
2nd Value:  
Value Percent:  
Continuous Index:  
Within 8" of Joint: **YES**  
Remarks:

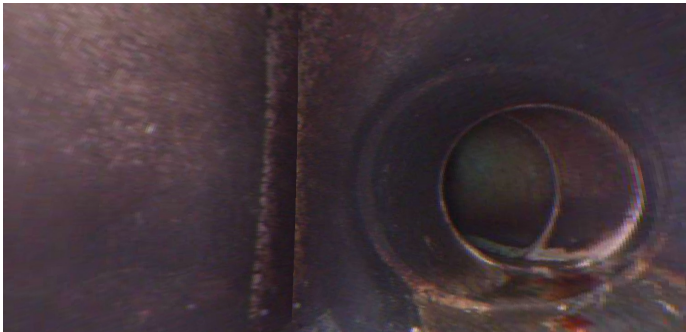
Code: **TF**  
Description: **Tap Factory**

Distance (ft): **195.9**  
Structural Grade: **0**  
O&M Grade: **0**  
Clock Start/From: **3**  
Clock To:  
1st Value: **4.000**  
2nd Value:  
Value Percent:  
Continuous Index:  
Within 8" of Joint: **YES**  
Remarks:

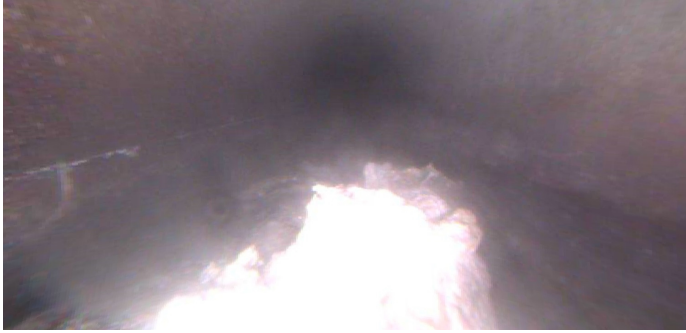
Code: **DSZ**  
Description: **Deposits Settled Other**

Distance (ft): **197.5**  
Structural Grade: **0**  
O&M Grade: **3**  
Clock Start/From: **6**  
Clock To:  
1st Value:  
2nd Value:  
Value Percent: **20.000**  
Continuous Index:  
Within 8" of Joint: **NO**  
Remarks: **wad of tissue?**

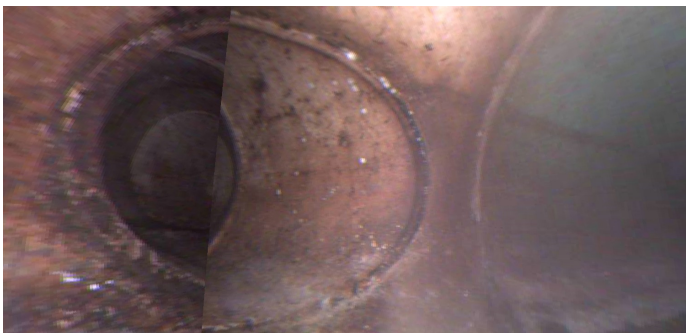
Code: **TF**  
Description: **Tap Factory**

Distance (ft): **214.4**  
Structural Grade: **0**  
O&M Grade: **0**  
Clock Start/From: **9**  
Clock To:  
1st Value: **4.000**  
2nd Value:  
Value Percent:  
Continuous Index:  
Within 8" of Joint: **YES**  
Remarks:

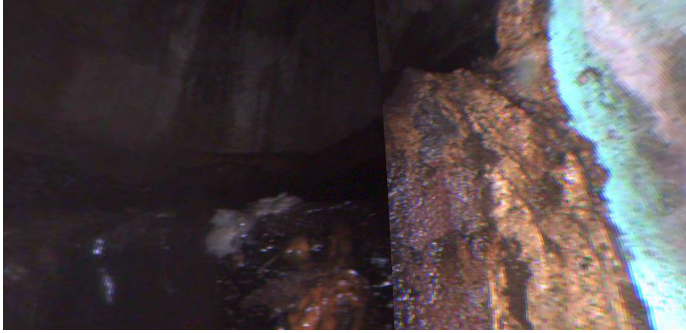
Code: **DSZ**  
Description: **Deposits Settled Other**

Distance (ft): **217.0**  
Structural Grade: **0**  
O&M Grade: **2**  
Clock Start/From: **6**  
Clock To:  
1st Value:  
2nd Value:  
Value Percent: **5.000**  
Continuous Index: **F01**  
Within 8" of Joint: **NO**  
Remarks: **debris**

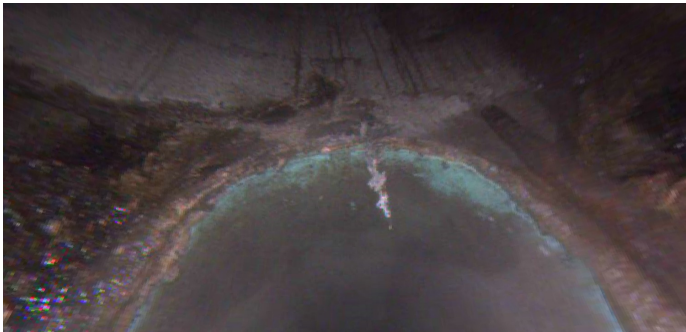
Code: **AMH**  
Description: **Manhole**

Distance (ft): **218.6**  
Structural Grade: **0**  
O&M Grade: **0**  
Clock Start/From:  
Clock To:  
1st Value:  
2nd Value:  
Value Percent:  
Continuous Index:  
Within 8" of Joint: **NO**  
Remarks: **M-706-013.1**
