Profile/Photo Observation Report

Date:	04/20/2018	Weather:		Coding:	PACP 6.0
Pipe Length (ft):	335.8	Owner:	NA	Pre Clean:	Not Known
P.O.#:		Surveyor:	Byrd Fitzgerald	PSR:	P-706-013.2-013.1
Customer:		Clean Date:	01/01/1900	Shape:	C

Street:	WATER ST	Flow Control:	Not Controlled
City:	Hobart, IN	Year Renewed:	
Location:	Light Highway	Tape/Media #:	
Purpose:	Maintenance Related	Dia/Height:	12"
Use:	Sanitary	Material:	PVC
Drain Area:	NA	Lining:	
Category:	NA		
Comment:	Reverse setup. shorter than expected.		
Location Details:		Direction of Survey:	Upstream
US MH:	M-706-013.1	DS MH:	M-706-013.2
		Total Length Surveyed (ft):	218.6

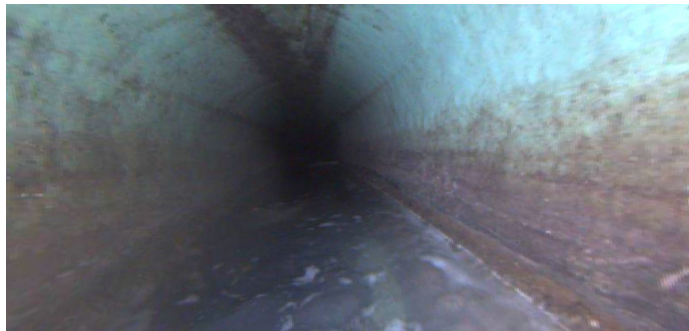
Code: **AMH**
Description: **Manhole**

Distance (ft): **.0**
Structural Grade: **0**
O&M Grade: **0**
Clock Start/From:
Clock To:
1st Value:
2nd Value:
Value Percent:
Continuous Index:
Within 8" of Joint: **NO**
Remarks: **M-706-013.2**

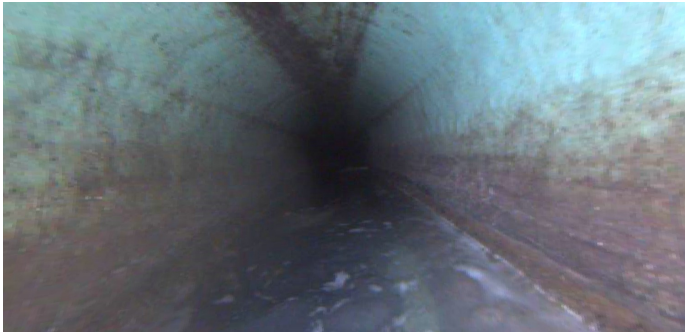
Code:	MWL
Description:	Water Level

Distance (ft):	.0
Structural Grade:	0
O&M Grade:	0
Clock Start/From:	
Clock To:	
1st Value:	
2nd Value:	
Value Percent:	5.000
Continuous Index:	
Within 8" of Joint:	NO
Remarks:

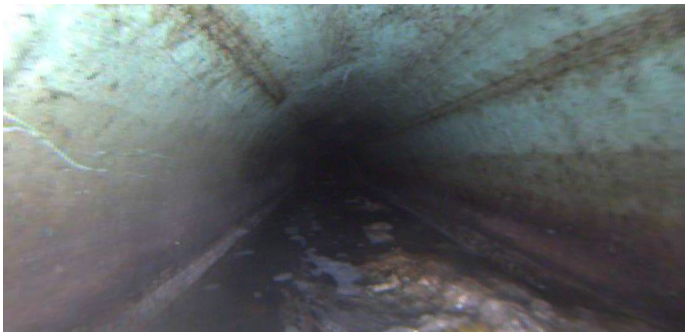
Code:	DSZ
Description:	Deposits Settled Other

Distance (ft):	5.0
Structural Grade:	0
O&M Grade:	2
Clock Start/From:	6
Clock To:	
1st Value:	
2nd Value:	
Value Percent:	5.000
Continuous Index:	S01
Within 8" of Joint:	NO
Remarks:	debris

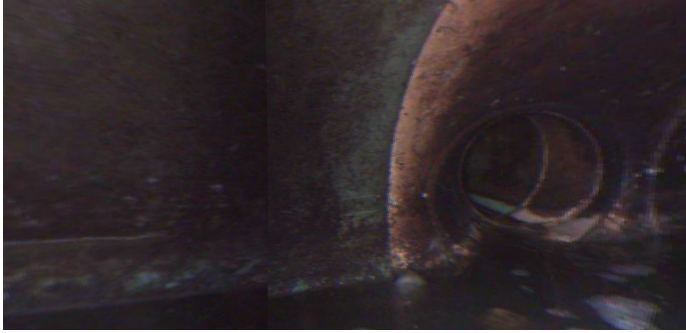
Code: **TF**
Description: **Tap Factory**

Distance (ft): **35.2**
Structural Grade: **0**
O&M Grade: **0**
Clock Start/From: **3**
Clock To:
1st Value: **4.000**
2nd Value:
Value Percent:
Continuous Index:
Within 8" of Joint: **YES**
Remarks:

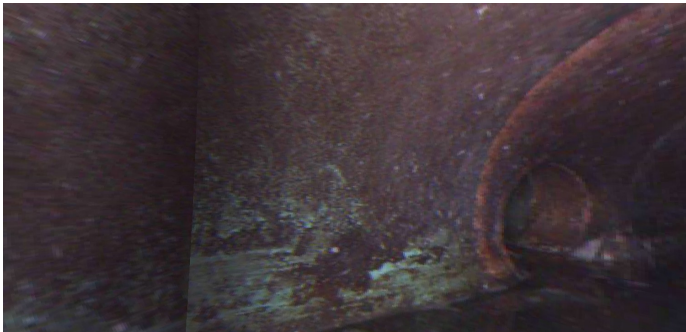
Code: **TF**
Description: **Tap Factory**

Distance (ft): **68.3**
Structural Grade: **0**
O&M Grade: **0**
Clock Start/From: **3**
Clock To:
1st Value: **4.000**
2nd Value:
Value Percent:
Continuous Index:
Within 8" of Joint: **YES**
Remarks:

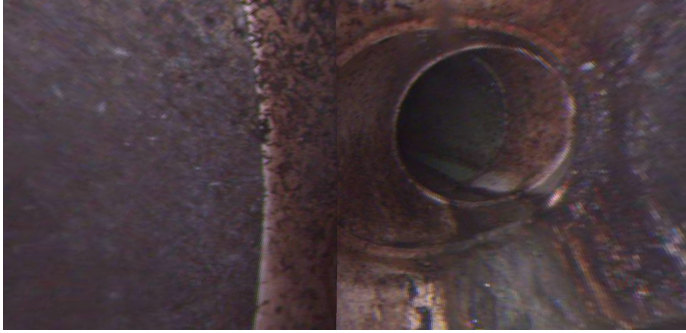
Code: **TF**
Description: **Tap Factory**

Distance (ft): **111.5**
Structural Grade: **0**
O&M Grade: **0**
Clock Start/From: **2**
Clock To:
1st Value: **4.000**
2nd Value:
Value Percent:
Continuous Index:
Within 8" of Joint: **YES**
Remarks:

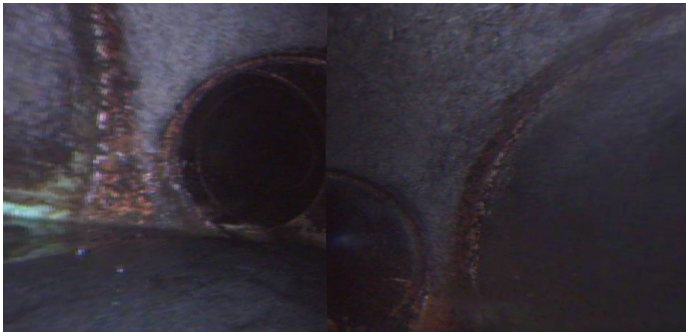
Code: **TF**
Description: **Tap Factory**

Distance (ft): **128.7**
Structural Grade: **0**
O&M Grade: **0**
Clock Start/From: **9**
Clock To:
1st Value: **4.000**
2nd Value:
Value Percent:
Continuous Index:
Within 8" of Joint: **YES**
Remarks:

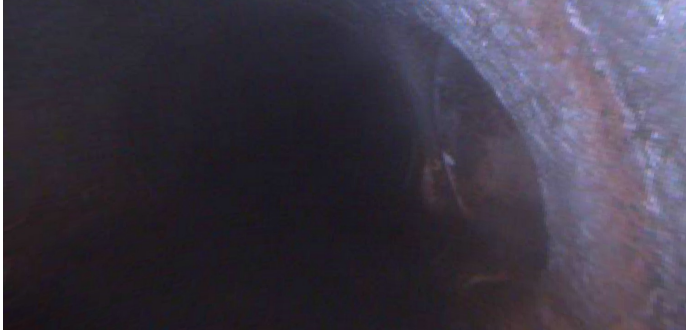
Code: **TF**
Description: **Tap Factory**

Distance (ft): **130.3**
Structural Grade: **0**
O&M Grade: **0**
Clock Start/From: **3**
Clock To:
1st Value: **4.000**
2nd Value:
Value Percent:
Continuous Index:
Within 8" of Joint: **YES**
Remarks:

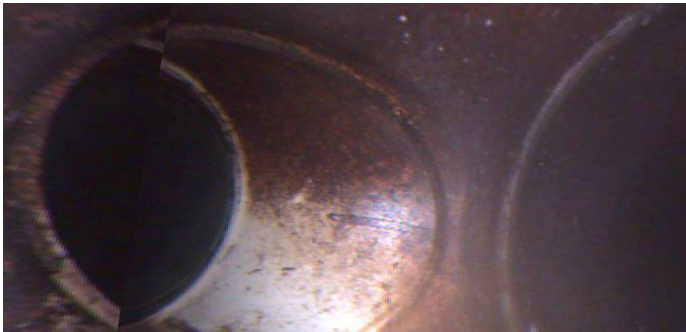
Code: **TF**
Description: **Tap Factory**

Distance (ft): **174.7**
Structural Grade: **0**
O&M Grade: **0**
Clock Start/From: **10**
Clock To:
1st Value: **4.000**
2nd Value:
Value Percent:
Continuous Index:
Within 8" of Joint: **YES**
Remarks:

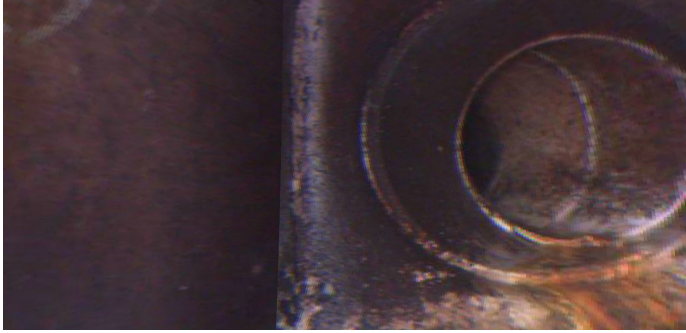
Code: **TF**
Description: **Tap Factory**

Distance (ft): **178.7**
Structural Grade: **0**
O&M Grade: **0**
Clock Start/From: **2**
Clock To:
1st Value: **4.000**
2nd Value:
Value Percent:
Continuous Index:
Within 8" of Joint: **YES**
Remarks:

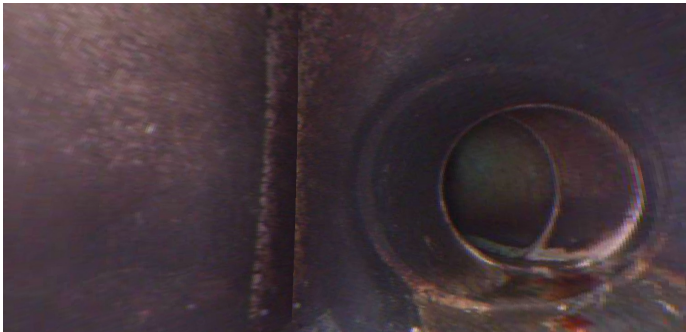
Code: **TF**
Description: **Tap Factory**

Distance (ft): **195.9**
Structural Grade: **0**
O&M Grade: **0**
Clock Start/From: **3**
Clock To:
1st Value: **4.000**
2nd Value:
Value Percent:
Continuous Index:
Within 8" of Joint: **YES**
Remarks:

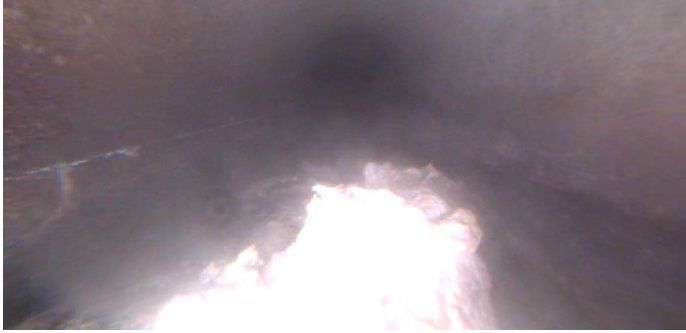
Code: **DSZ**
Description: **Deposits Settled Other**

Distance (ft): **197.5**
Structural Grade: **0**
O&M Grade: **3**
Clock Start/From: **6**
Clock To:
1st Value:
2nd Value:
Value Percent: **20.000**
Continuous Index:
Within 8" of Joint: **NO**
Remarks: **wad of tissue?**

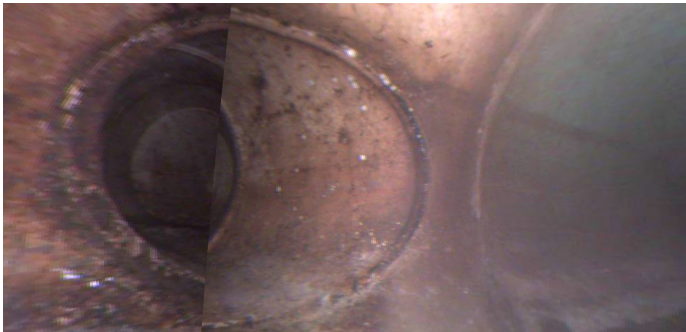
Code: **TF**
Description: **Tap Factory**

Distance (ft): **214.4**
Structural Grade: **0**
O&M Grade: **0**
Clock Start/From: **9**
Clock To:
1st Value: **4.000**
2nd Value:
Value Percent:
Continuous Index:
Within 8" of Joint: **YES**
Remarks:

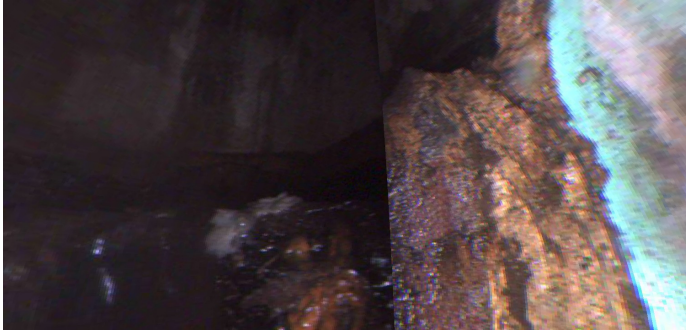
Code: **DSZ**
Description: **Deposits Settled Other**

Distance (ft): **217.0**
Structural Grade: **0**
O&M Grade: **2**
Clock Start/From: **6**
Clock To:
1st Value:
2nd Value:
Value Percent: **5.000**
Continuous Index: **F01**
Within 8" of Joint: **NO**
Remarks: **debris**

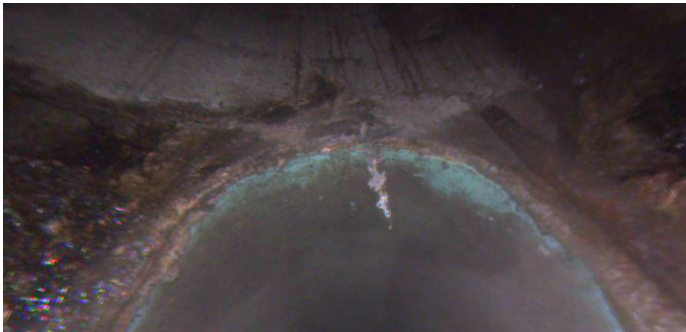
Code: **AMH**
Description: **Manhole**

Distance (ft): **218.6**
Structural Grade: **0**
O&M Grade: **0**
Clock Start/From:
Clock To:
1st Value:
2nd Value:
Value Percent:
Continuous Index:
Within 8" of Joint: **NO**
Remarks: **M-706-013.1**
