Profile/Photo Observation Report

Date:	04/18/2018	Weather:		Coding:	PACP 6.0
Pipe Length (ft):	373.0	Owner:	NA	Pre Clean:	Not Known
P.O.#:		Surveyor:	Byrd Fitzgerald	PSR:	P-806-024-018
Customer:		Clean Date:	01/01/1900	Shape:	C

Street:	Capitol	Flow Control:	Not Controlled
City:	Hobart, IN	Year Renewed:	
Location:	Light Highway	Tape/Media #:	
Purpose:	Maintenance Related	Dia/Height:	12"
Use:	Sanitary	Material:	VCP
Drain Area:	NA	Lining:	Cured in Place
Category:	NA		
Comment:	Reverse setup. tap at 170'.		
Location Details:		Direction of Survey:	Downstream
US MH:	M-706-018	DS MH:	M-806-024
		Total Length Surveyed (ft):	171.4

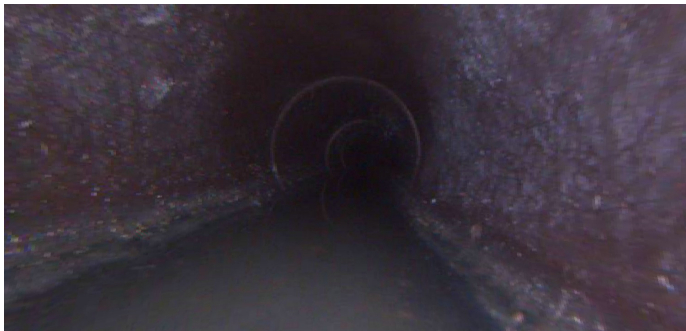
Code: **AMH**
Description: **Manhole**

Distance (ft): **.0**
Structural Grade: **0**
O&M Grade: **0**
Clock Start/From:
Clock To:
1st Value:
2nd Value:
Value Percent:
Continuous Index:
Within 8" of Joint: **NO**
Remarks: **M-706-018**

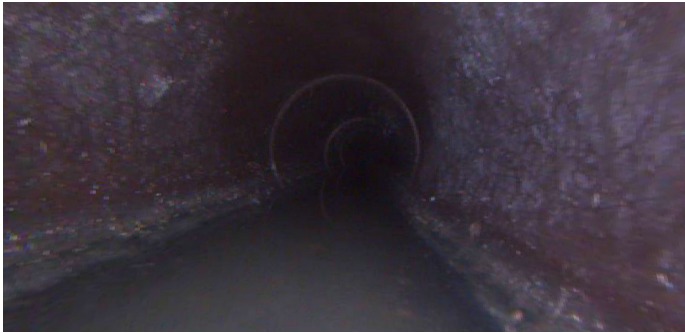
Code:	MWL
Description:	Water Level

Distance (ft):	.0
Structural Grade:	0
O&M Grade:	0
Clock Start/From:	
Clock To:	
1st Value:	
2nd Value:	
Value Percent:	5.000
Continuous Index:	
Within 8" of Joint:	NO
Remarks:

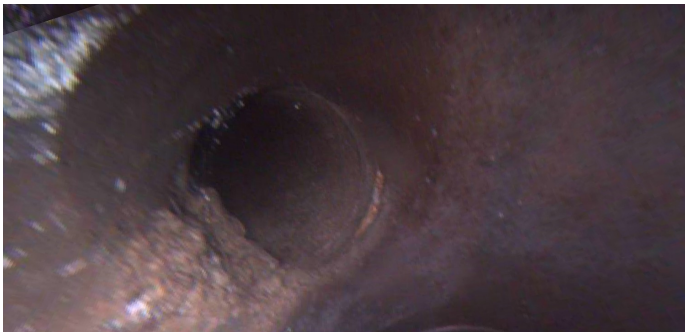
Code:	TF
Description:	Tap Factory

Distance (ft):	11.9
Structural Grade:	0
O&M Grade:	0
Clock Start/From:	11
Clock To:	
1st Value:	4.000
2nd Value:	
Value Percent:	
Continuous Index:	
Within 8" of Joint:	YES
Remarks:

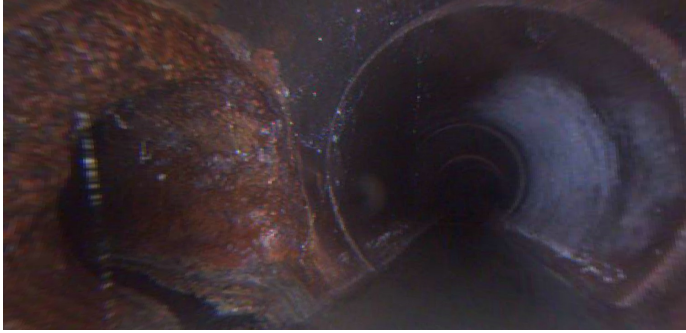
Code: **TB**
Description: **Tap Break-in**

Distance (ft): **24.4**
Structural Grade: **0**
O&M Grade: **0**
Clock Start/From: **9**
Clock To:
1st Value: **6.000**
2nd Value:
Value Percent:
Continuous Index:
Within 8" of Joint:
Remarks:

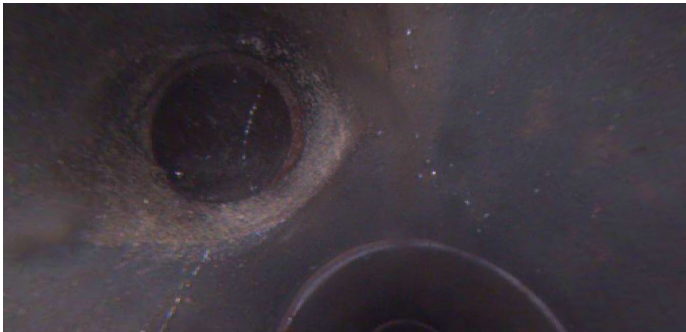
Code: **TF**
Description: **Tap Factory**

Distance (ft): **54.9**
Structural Grade: **0**
O&M Grade: **0**
Clock Start/From: **11**
Clock To:
1st Value: **4.000**
2nd Value:
Value Percent:
Continuous Index:
Within 8" of Joint: **YES**
Remarks:

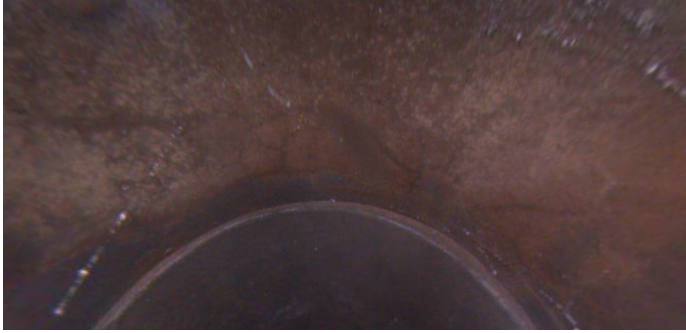
Code: **CM**
Description: **Crack Multiple**

Distance (ft): **61.5**
Structural Grade: **3**
O&M Grade: **0**
Clock Start/From: **10**
Clock To: **2**
1st Value:
2nd Value:
Value Percent:
Continuous Index:
Within 8" of Joint: **YES**
Remarks:

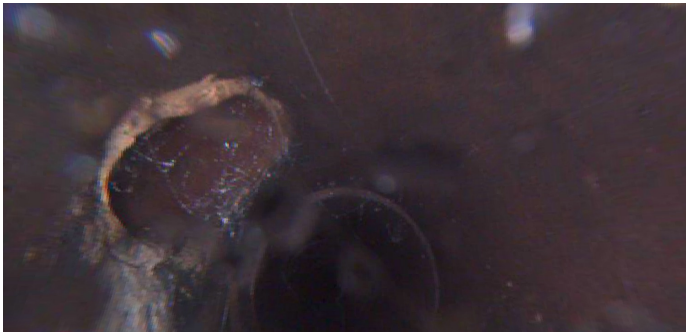
Code: **TB**
Description: **Tap Break-in**

Distance (ft): **105.3**
Structural Grade: **0**
O&M Grade: **0**
Clock Start/From: **10**
Clock To:
1st Value: **4.000**
2nd Value:
Value Percent:
Continuous Index:
Within 8" of Joint: **YES**
Remarks:

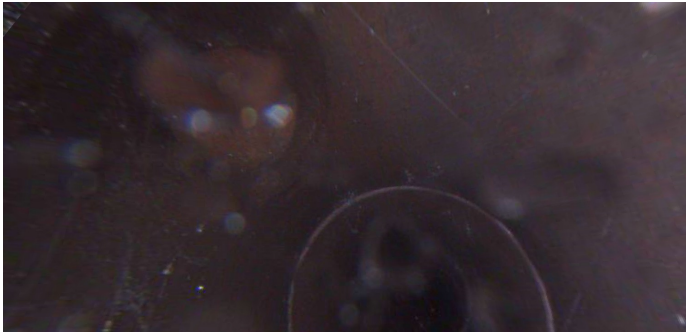
Code: **TFC**
Description: **Tap Factory Capped**

Distance (ft): **107.9**
Structural Grade: **0**
O&M Grade: **0**
Clock Start/From: **10**
Clock To:
1st Value: **4.000**
2nd Value:
Value Percent:
Continuous Index:
Within 8" of Joint:
Remarks:

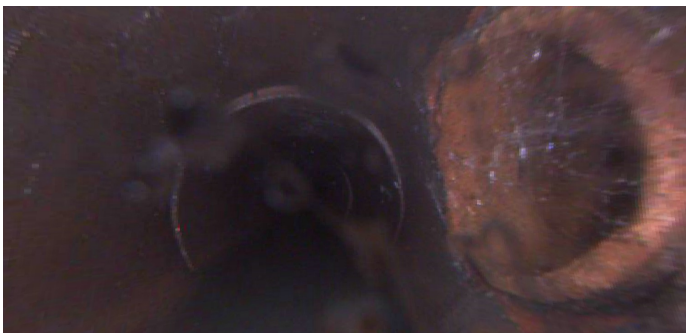
Code: **TBI**
Description: **Tap Break-in Intruding**

Distance (ft): **118.1**
Structural Grade: **0**
O&M Grade: **2**
Clock Start/From: **3**
Clock To:
1st Value: **4.000**
2nd Value: **1.000**
Value Percent:
Continuous Index:
Within 8" of Joint: **YES**
Remarks:

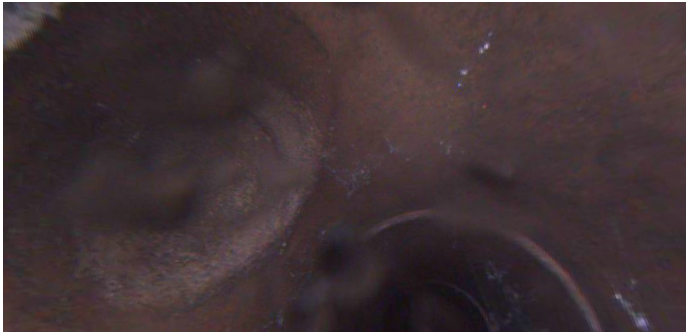
Code: **TFC**
Description: **Tap Factory Capped**

Distance (ft): **152.9**
Structural Grade: **0**
O&M Grade: **0**
Clock Start/From: **11**
Clock To:
1st Value: **4.000**
2nd Value:
Value Percent:
Continuous Index:
Within 8" of Joint: **YES**
Remarks:

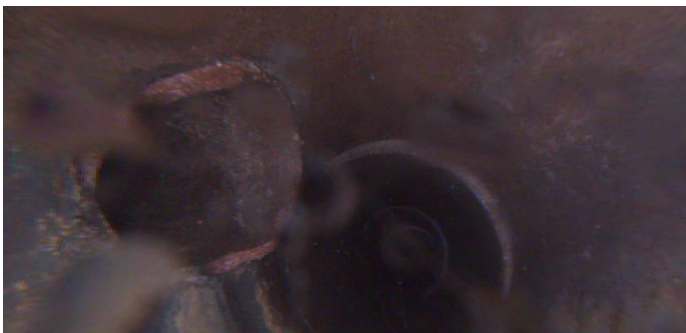
Code: **TBI**
Description: **Tap Break-in Intruding**

Distance (ft): **169.3**
Structural Grade: **0**
O&M Grade: **2**
Clock Start/From: **10**
Clock To:
1st Value: **4.000**
2nd Value: **1.000**
Value Percent:
Continuous Index:
Within 8" of Joint: **YES**
Remarks:

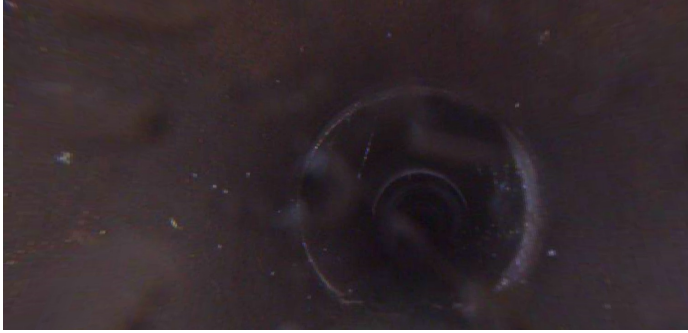
Code:	MSA
Description:	Abandoned Survey
Distance (ft):	171.4
Structural Grade:	0
O&M Grade:	0
Clock Start/From:	
Clock To:	
1st Value:	
2nd Value:	
Value Percent:	
Continuous Index:	
Within 8" of Joint:	NO
Remarks:	DAE
