Profile/Photo Observation Report

| Street: | Main Street | Flow Control: | Not Controlled |
| Comment: | YES501824 Submittal 2 | | |
| US MH: | M-706-020 | DS MH: | M-706-019 |

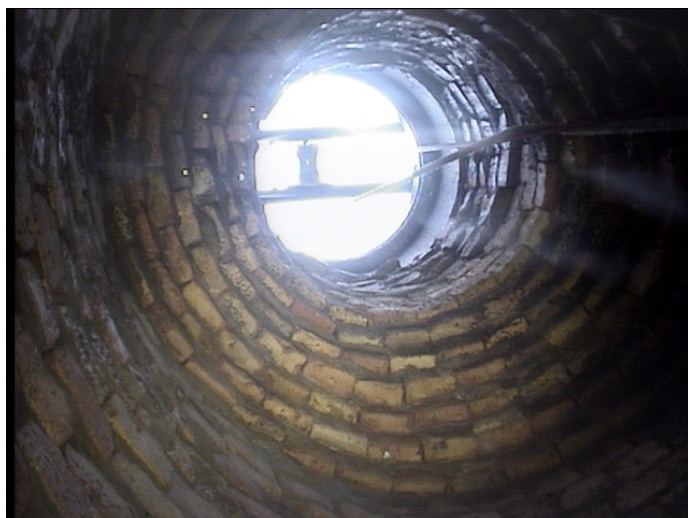
Code: **AMH**
Description: **Manhole**

Distance (ft): **.0**
Structural Grade: **0**
O&M Grade: **0**
Clock Start/From:
Clock To:
1st Value:
2nd Value:
Value Percent:
Continuous Index:
Within 8" of Joint: **NO**
Remarks: **M-706-020**

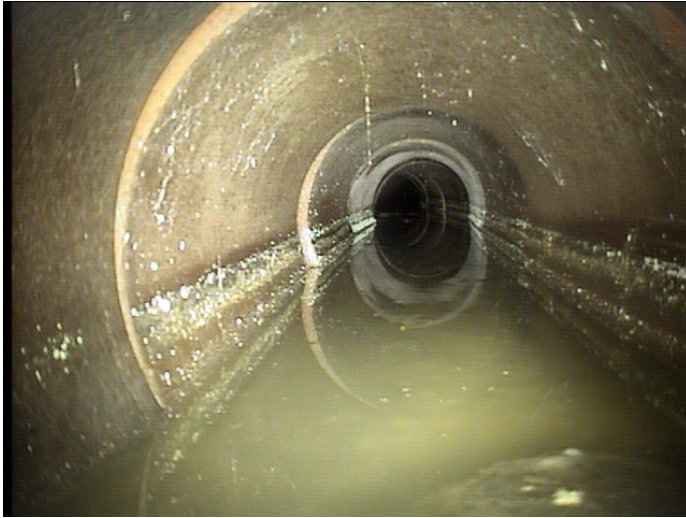
Code: **MWL**
Description: **Water Level**

Distance (ft): **.0**
Structural Grade: **0**
O&M Grade: **0**
Clock Start/From:
Clock To:
1st Value:
2nd Value:
Value Percent: **15.000**
Continuous Index:
Within 8" of Joint: **NO**
Remarks:

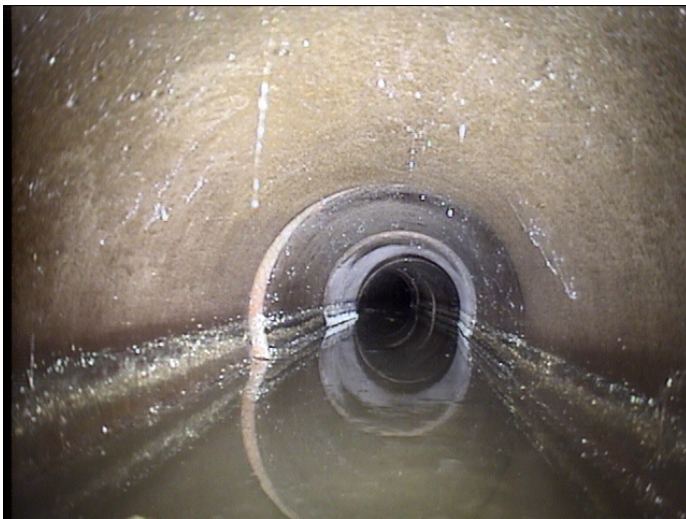
Code: **DSF**
Description: **Deposits Settled Fine**

Distance (ft): **.3**
Structural Grade: **0**
O&M Grade: **2**
Clock Start/From: **5**
Clock To: **7**
1st Value:
2nd Value:
Value Percent: **10.000**
Continuous Index: **S01**
Within 8" of Joint: **NO**
Remarks:

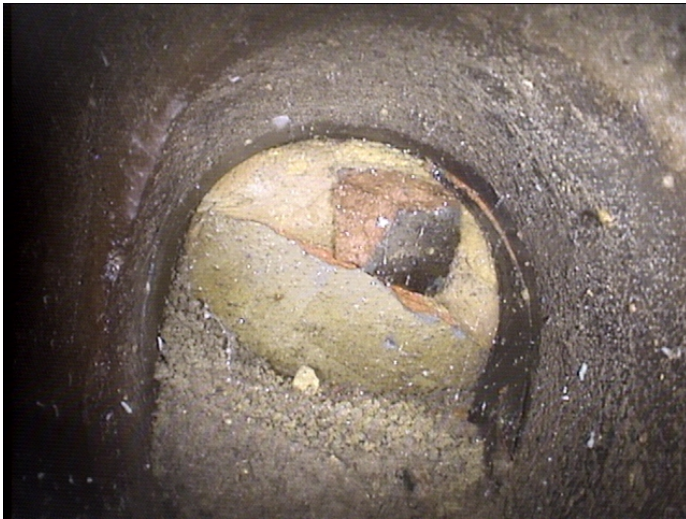
Code: **TFC**
Description: **Tap Factory Capped**

Distance (ft): **20.8**
Structural Grade: **0**
O&M Grade: **0**
Clock Start/From: **3**
Clock To:
1st Value: **4.000**
2nd Value:
Value Percent:
Continuous Index:
Within 8" of Joint: **NO**
Remarks:

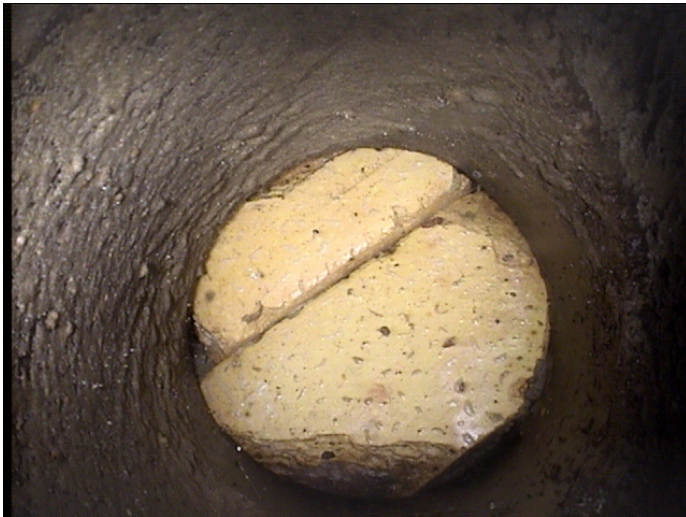
Code: **TFC**
Description: **Tap Factory Capped**

Distance (ft): **23.8**
Structural Grade: **0**
O&M Grade: **0**
Clock Start/From: **10**
Clock To:
1st Value: **4.000**
2nd Value:
Value Percent:
Continuous Index:
Within 8" of Joint: **NO**
Remarks:

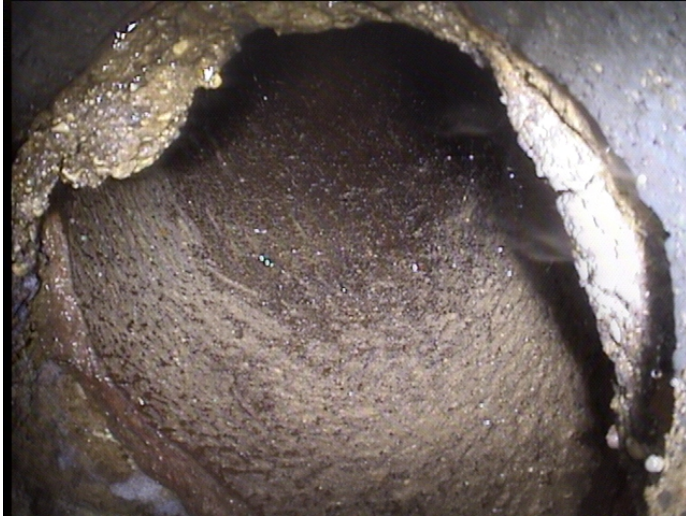
Code: **TB**
Description: **Tap Break-in**

Distance (ft): **29.9**
Structural Grade: **0**
O&M Grade: **0**
Clock Start/From: **12**
Clock To:
1st Value: **4.000**
2nd Value:
Value Percent:
Continuous Index:
Within 8" of Joint: **NO**
Remarks:

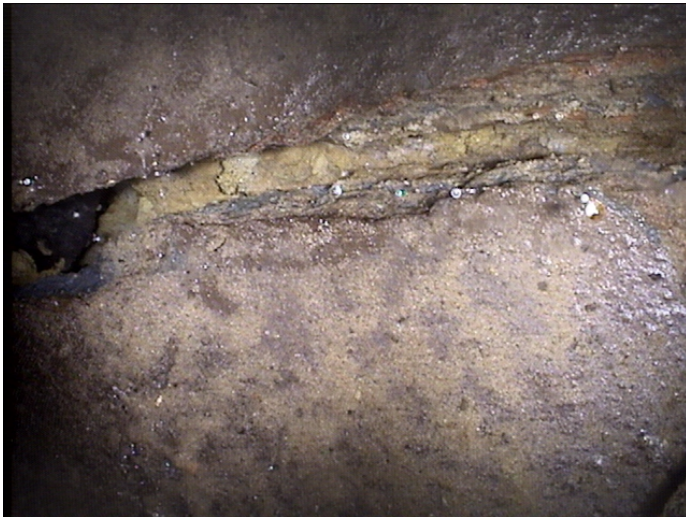
Code: **TBC**
Description: **Tap Break-in Capped**

Distance (ft): **39.4**
Structural Grade: **0**
O&M Grade: **2**
Clock Start/From: **12**
Clock To:
1st Value: **4.000**
2nd Value:
Value Percent:
Continuous Index:
Within 8" of Joint: **NO**
Remarks:

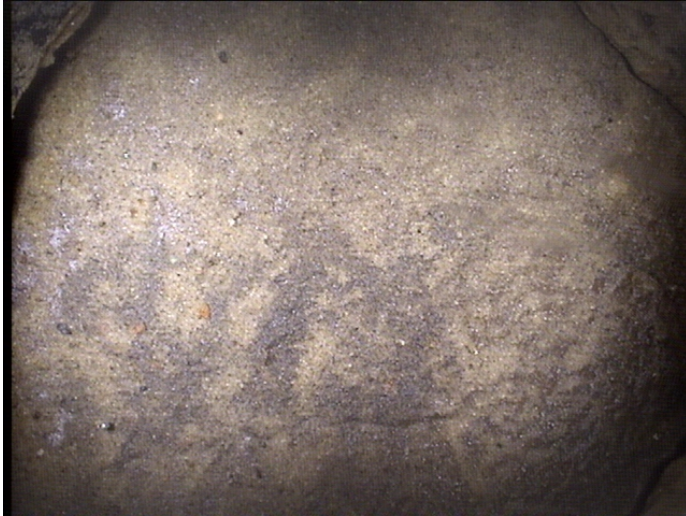
Code: **TBC**
Description: **Tap Break-in Capped**

Distance (ft): **54.8**
Structural Grade: **0**
O&M Grade: **2**
Clock Start/From: **11**
Clock To:
1st Value: **4.000**
2nd Value:
Value Percent:
Continuous Index:
Within 8" of Joint: **NO**
Remarks:

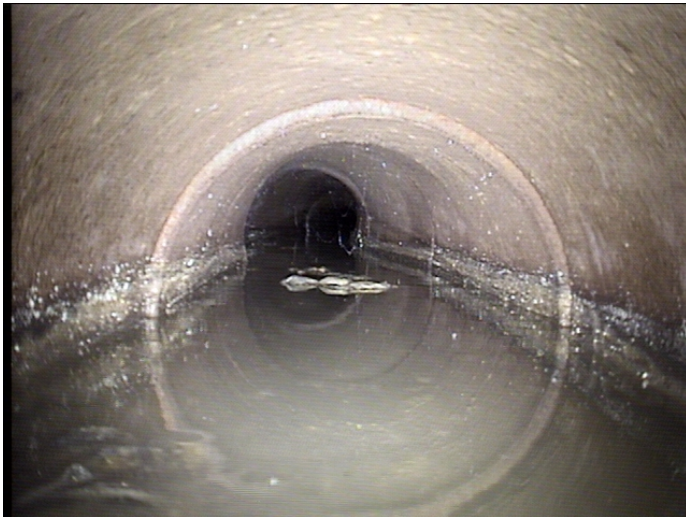
Code: **DSF**
Description: **Deposits Settled Fine**

Distance (ft): **66.2**
Structural Grade: **0**
O&M Grade: **2**
Clock Start/From: **5**
Clock To: **7**
1st Value:
2nd Value:
Value Percent: **10.000**
Continuous Index: **F01**
Within 8" of Joint: **NO**
Remarks:

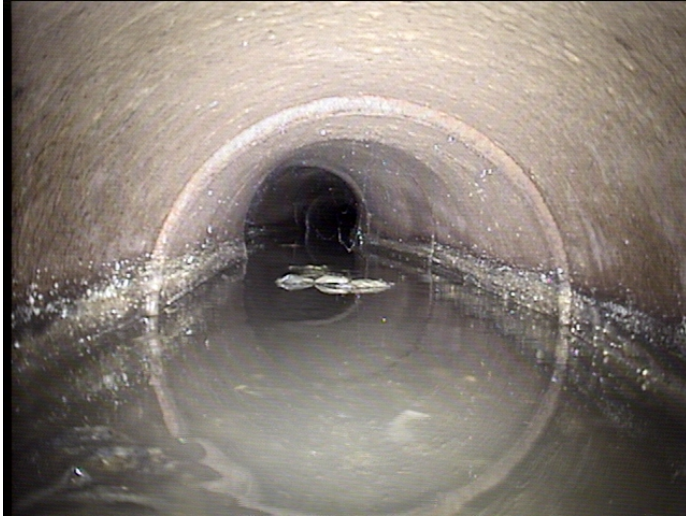
| Code: | MSA |
| Description: | Abandoned Survey |
| Distance (ft): | 66.2 |
| Remarks: | Sediment |
