Profile/Photo Observation Report						
Date: Pipe Length (ft): P.O.#: Customer:	03/03/2022 329.6 YES502259 City of Hobart, IN (R	Weather: Owner: Surveyor:	City of Hobart S. Bucklin 02/26/2022		Pre Clean: I PSR: I	PACP 7.0 Heavy Cleaning P-706-030-029 C
Street: City: Location:	South State Street Hobart, IN		Flow Control: Year Renewed:		Not Controlled	-
Purpose: Use: Drain Area:	Local rural streets v Routine Assessmen Sanitary Sewage Pij	t	Dia/Height: Material: Lining:		8" VCP None	
Category: Comment: Location Details:	ΝΑ		Direction of Surv		Downstream	
	1-706-029	DS MH:	M-706-030		th Surveyed (ft):	115.8
O&M Index:	1.95	O&M Quick:	332	E OS	&M Rating:	78.00
Structural Index:	3.53	Structural Qu	uick: 524	B Sti	ructural Rating:	106.00
Overall Index:	2.63	Overall Quick	<: 524	BOV	verall Rating:	184.00

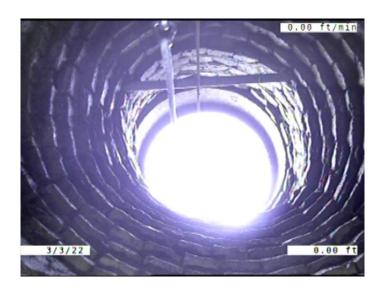
Code: Description:	AMH Manhole
Distance (ft):	.0
Structural Grade:	0
O&M Grade:	0
Clock Start/From:	
Clock To:	
1st Value:	
2nd Value:	
Value Percent:	
Continuous Index:	
Within 8" of Joint:	NO
Remarks:	M-706-029

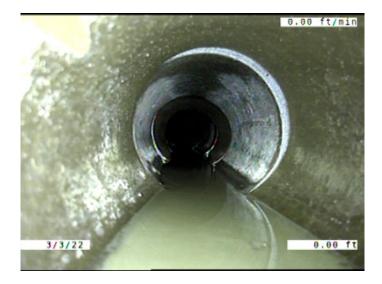
Code: Description:	MWL Miscellaneous Water Level
Distance (ft):	.0
Structural Grade:	0
O&M Grade:	0
Clock Start/From:	
Clock To:	
1st Value:	
2nd Value:	
Value Percent:	5.000
Continuous Index:	
Within 8" of Joint:	NO
Remarks:

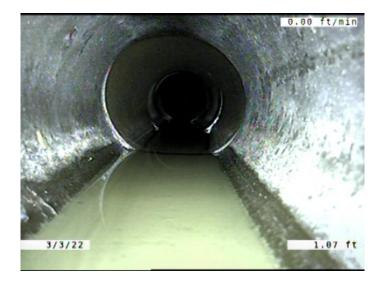
DSF
Deposits Settled Fine
1.1
1.1
0
2
5
7
5.000
S01
YES

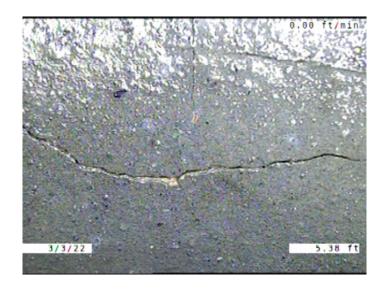
Code: Description:	FM Fracture Multiple
Distance (ft):	5.4
Structural Grade:	4
O&M Grade:	0
Clock Start/From:	1
Clock To:	4
1st Value:	
2nd Value:	
Value Percent:	
Continuous Index:	
Within 8" of Joint:	YES
Remarks:

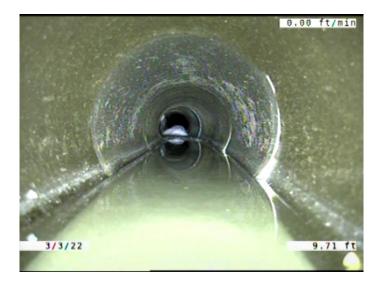
Code: Description:	MWLS Miscellaneous Water Level Sag
Distance (ft):	9.7
Structural Grade:	2
O&M Grade:	0
Clock Start/From:	
Clock To:	
1st Value:	
2nd Value:	
Value Percent:	15.000
Continuous Index:	S02
Within 8" of Joint:	NO
Remarks:

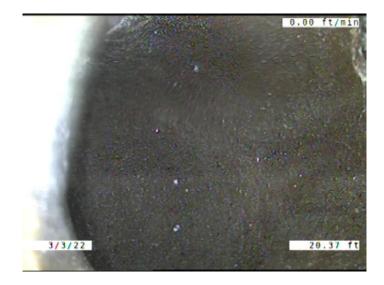
Code:	TBI
Description:	Tap Break-in Intruding
Distance (ft): Structural Grade: O&M Grade: Clock Start/From: Clock To:	20.4 0 2 11
1st Value:	4.000
2nd Value:	1.000
Value Percent: Continuous Index: Within 8" of Joint: Remarks:	YES ACTIVITY, HVV in tap

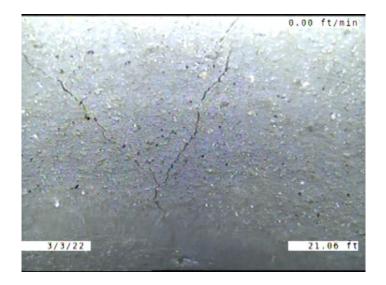
Code: Description:	CM Crack Multiple
Distance (ft):	21.1
Structural Grade:	3
O&M Grade:	0
Clock Start/From:	11
Clock To:	1
1st Value:	
2nd Value:	
Value Percent:	
Continuous Index:	
Within 8" of Joint:	YES
Remarks:

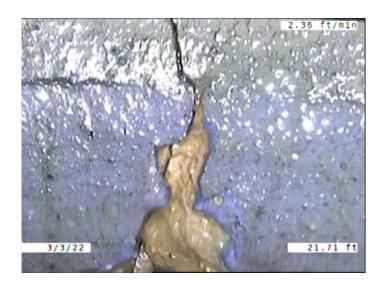
Code:	FL
Description:	Fracture Longitudinal
Distance (ft):	21.7
Structural Grade:	3
O&M Grade:	0
Clock Start/From:	1
Clock To: 1st Value: 2nd Value:	1
Value Percent: Continuous Index: Within 8" of Joint: Remarks:	ΝΟ

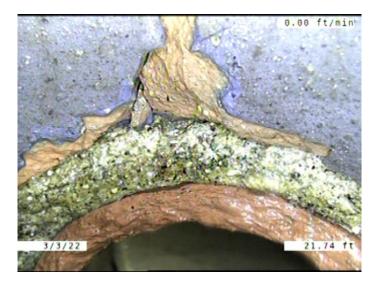
Code: Description:	SSS Surface Damage Surface Spalling
Distance (ft):	21.7
Structural Grade:	2
O&M Grade:	0
Clock Start/From:	12
Clock To:	3
1st Value:	
2nd Value:	
Value Percent:	
Continuous Index:	
Within 8" of Joint:	YES

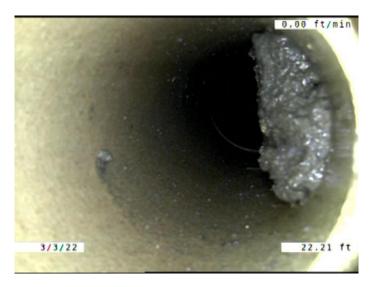
Code: Description:	TBI Tap Break-in Intruding
Distance (ft): Structural Grade: O&M Grade: Clock Start/From: Clock To: 1st Value: 2nd Value: Value Percent: Continuous Index: Within 8" of Joint: Remarks:	22.2 0 2 2 4.000 1.000 YES

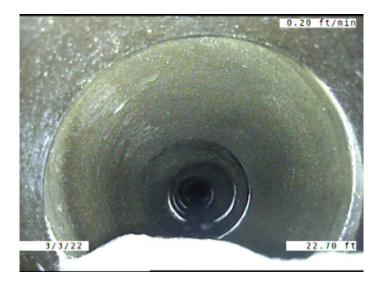
Code: Description:	MWLS Miscellaneous Water Level Sag
Distance (ft):	22.7
Structural Grade:	2
O&M Grade:	0
Clock Start/From:	
Clock To:	
1st Value:	
2nd Value:	
Value Percent:	15.000
Continuous Index:	F02
Within 8" of Joint:	NO
Remarks:

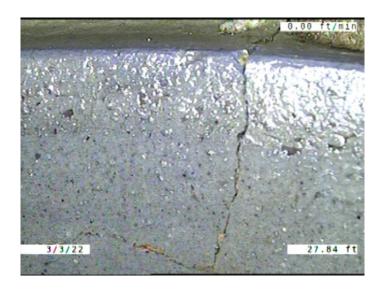
Code: Description:	FM Fracture Multiple
Distance (ft): Structural Grade: O&M Grade: Clock Start/From: Clock To: 1st Value: 2nd Value: Value Percent:	27.8 4 0 10 3
Continuous Index: Within 8" of Joint: Remarks:	YES

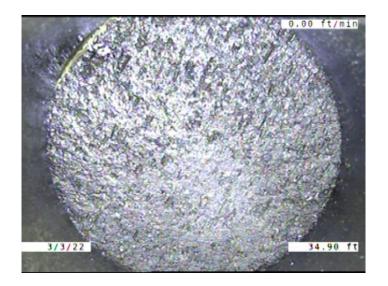
Code: Description:	TFC Tap Factory Capped
Distance (ft):	34.9
Structural Grade:	0
O&M Grade:	0
Clock Start/From:	11
Clock To:	
1st Value:	4.000
2nd Value:	
Value Percent:	
Continuous Index:	
Within 8" of Joint:	YES
Remarks:

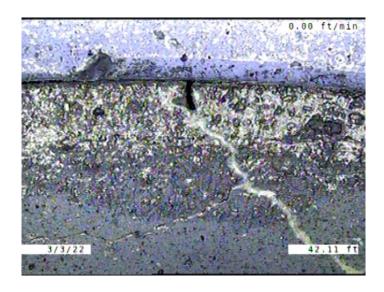
Code:	IWJ
Description:	Infiltration Weeper Joint
Distance (ft): Structural Grade: O&M Grade: Clock Start/From: Clock To: 1st Value: 2nd Value: Value Percent: Continuous Index: Within 8" of Joint: Remarks:	42.1 0 2 12 YES

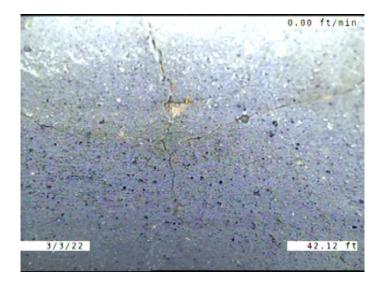
Code: Description:	FM Fracture Multiple
Distance (ft): Structural Grade: O&M Grade: Clock Start/From: Clock To: 1st Value: 2nd Value: Value Percent: Continuous Index: Within 8" of Joint: Remarks:	42.1 4 0 10 3 YES

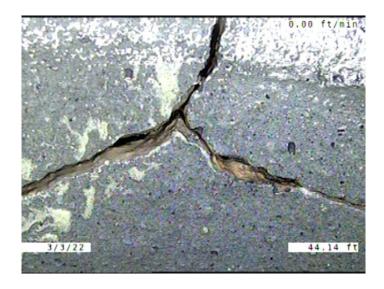
Code: Description:	IDB Infiltration Dripper Barrel
Distance (ft): Structural Grade: O&M Grade: Clock Start/From: Clock To: 1st Value: 2nd Value: Value Percent: Continuous Index: Within 8" of Joint:	44.1 0 3 11 1 YES
Remarks:

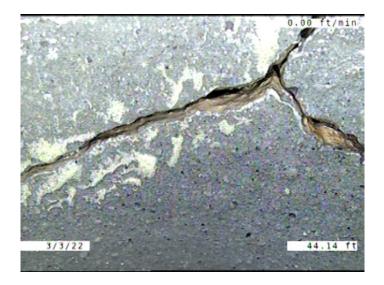
Code:	В
Description:	Broken
Distance (ft):	44.1
Structural Grade:	4
O&M Grade:	0
Clock Start/From:	8
Clock To:	4
1st Value:	
2nd Value:	
Value Percent:	
Continuous Index:	
Within 8" of Joint:	YES
Remarks:

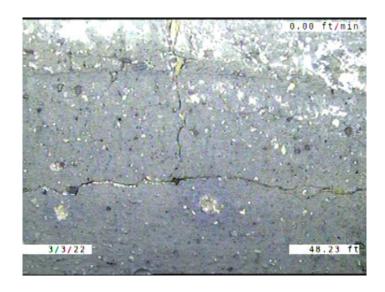
Code:	FM
Description:	Fracture Multiple
Distance (ft):	48.2
Structural Grade:	4
O&M Grade:	0
Clock Start/From: Clock To:	8
1st Value: 2nd Value: Value Percent:	
Continuous Index:	S03
Within 8" of Joint:	YES
Remarks:	Wandering

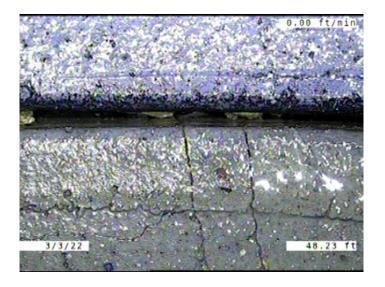
Code: Description:	IWJ Infiltration Weeper Joint
Distance (ft):	48.2
Structural Grade:	0
O&M Grade:	2
Clock Start/From:	1
Clock To:	
1st Value:	
2nd Value:	
Value Percent:	
Continuous Index:	
Within 8" of Joint:	YES
Remarks:

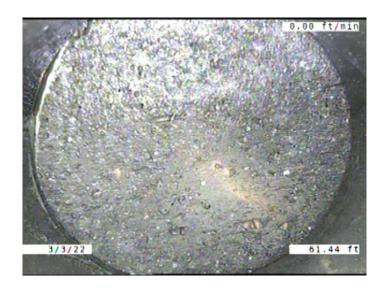
Code: Description:	TFC Tap Factory Capped
Distance (ft): Structural Grade: O&M Grade: Clock Start/From: Clock To: 1st Value: 2nd Value: Value Percent: Continuous Index: Within 8" of Joint: Remarks:	61.4 0 0 10 4.000 YES

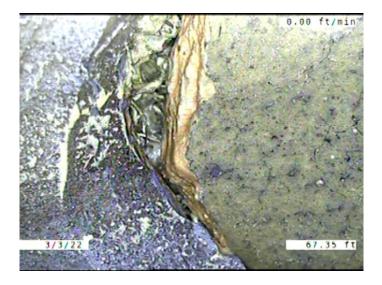
Code: Description:	IWB Infiltration Weeper Barrel
Distance (ft):	67.3
Structural Grade:	0
O&M Grade:	2
Clock Start/From:	11
Clock To:	1
1st Value:	
2nd Value:	
Value Percent:	
Continuous Index:	
Within 8" of Joint:	YES
Remarks:

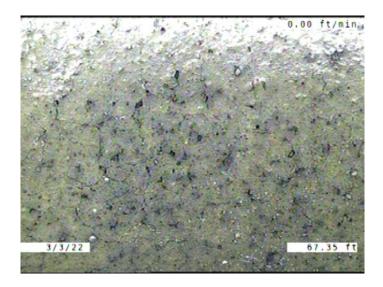
Code:	TFD
Description:	Tap Factory Defective
Distance (ft):	67.4
Structural Grade:	0
O&M Grade:	3
Clock Start/From:	12
Clock To: 1st Value: 2nd Value: Value Percent:	6.000
Continuous Index: Within 8" of Joint: Remarks:	YES Hole in cap

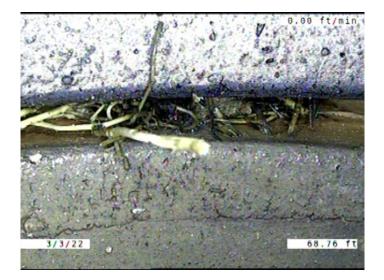
RFJ
Roots Fine Joint
68.8
0
1
8
12
YES

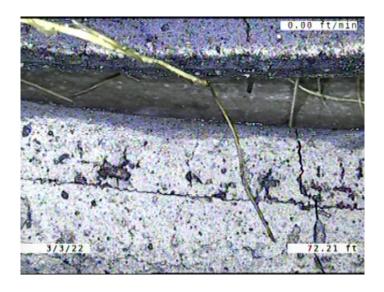
Code:	RFJ
Description:	Roots Fine Joint
Distance (ft):	72.2
Structural Grade:	0
O&M Grade:	1
Clock Start/From:	9
Clock To:	3
1st Value: 2nd Value: Value Percent: Continuous Index: Within 8" of Joint: Remarks:	YES

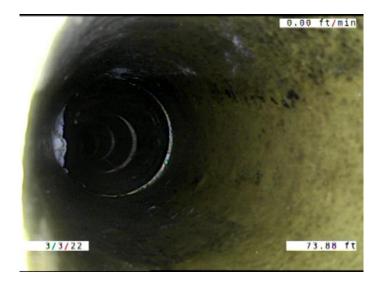
Code: Description:	TBI Tap Break-in Intruding
Distance (ft):	73.9
Structural Grade:	0
O&M Grade:	2
Clock Start/From:	10
Clock To:	
1st Value:	4.000
2nd Value:	3.000
Value Percent:	
Continuous Index:	
Within 8" of Joint:	YES
Remarks:

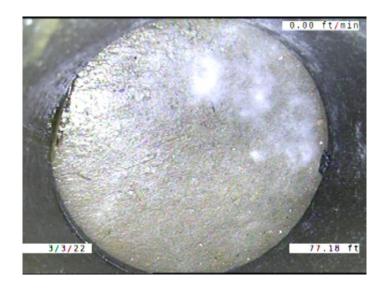
Code: Description:	TFC Tap Factory Capped
Distance (ft):	77.2
Structural Grade:	0
O&M Grade:	0
Clock Start/From:	10
Clock To:	
1st Value:	4.000
2nd Value:	
Value Percent:	
Continuous Index:	
Within 8" of Joint:	YES
Remarks:

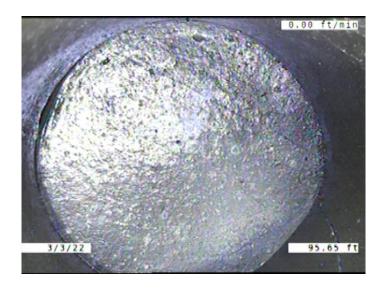
TFD
Tap Factory Defective
95.7
0
3
10
4.000
YES
BROKEN. CAPPED

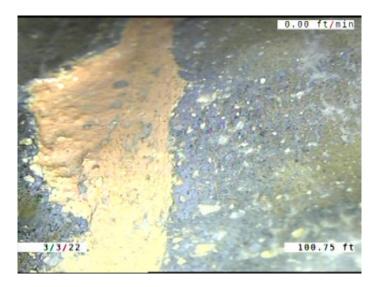
Code: Description:	SSS Surface Damage Surface Spalling
Distance (ft): Structural Grade: O&M Grade: Clock Start/From: Clock To: 1st Value: 2nd Value: Value Percent: Continuous Index: Within 8" of Joint: Remarks:	100.8 2 0 5 7 YES

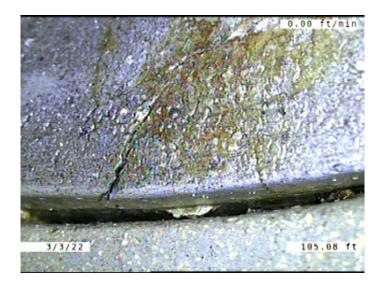
Code:	В
Description:	Broken
Distance (ft):	105.1
Structural Grade:	4
O&M Grade:	0
Clock Start/From:	3
Clock To:	9
1st Value:	
2nd Value:	
Value Percent:	
Continuous Index:	
Within 8" of Joint:	YES
Remarks:

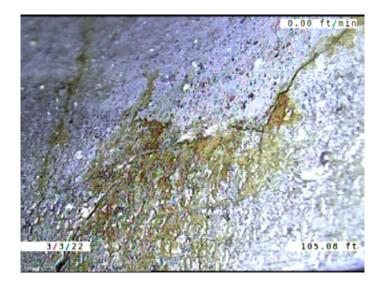
Code: Description:	ISB Infiltration Stain Barrel
Distance (ft):	105.1
Structural Grade:	0
O&M Grade:	1
Clock Start/From:	7
Clock To:	9
1st Value:	
2nd Value:	
Value Percent:	
Continuous Index:	
Within 8" of Joint:	YES
Remarks:

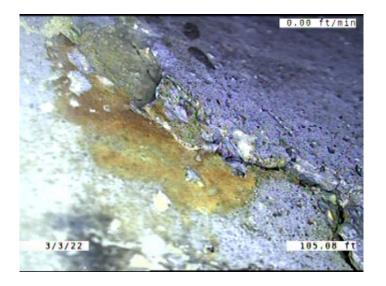
Code: Description:	ISB Infiltration Stain Barrel
Distance (ft):	105.1
Structural Grade:	0
O&M Grade:	1
Clock Start/From:	3
Clock To:	5
1st Value:	
2nd Value:	
Value Percent:	
Continuous Index:	
Within 8" of Joint:	YES
Remarks:

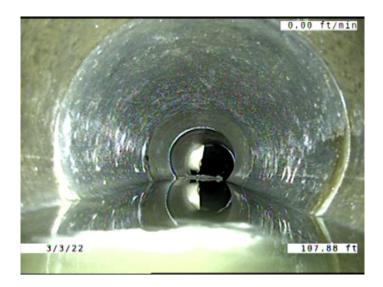
Code: Description:	MWLS Miscellaneous Water Level Sag
Distance (ft):	107.9
Structural Grade:	2
O&M Grade:	0
Clock Start/From:	
Clock To:	
1st Value:	
2nd Value:	
Value Percent:	15.000
Continuous Index:	S04
Within 8" of Joint:	NO
Remarks:

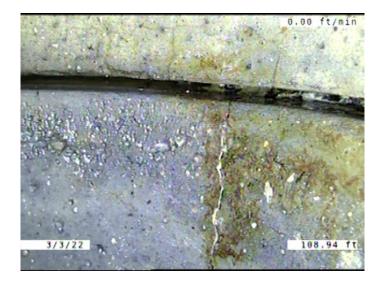
Code: Description:	ISJ Infiltration Stain Joint
Distance (ft):	108.9
Structural Grade:	0
O&M Grade:	1
Clock Start/From:	3
Clock To:	4
1st Value:	
2nd Value:	
Value Percent:	
Continuous Index:	
Within 8" of Joint:	YES
Remarks:

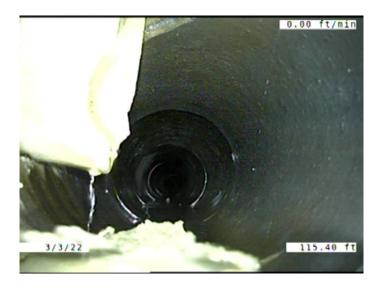
Code: Description:	MWLS Miscellaneous Water Level Sag
Distance (ft):	115.4
Structural Grade:	2
O&M Grade:	0
Clock Start/From:	
Clock To:	
1st Value:	
2nd Value:	
Value Percent:	15.000
Continuous Index:	F04
Within 8" of Joint:	NO
Remarks:

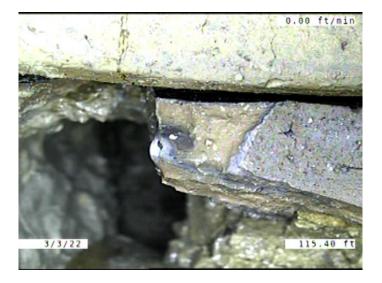
Code: Description:	IWB Infiltration Weeper Barrel
Distance (ft):	115.4
Structural Grade:	0
O&M Grade:	2
Clock Start/From:	10
Clock To:	
1st Value:	
2nd Value:	
Value Percent:	
Continuous Index:	
Within 8" of Joint:	YES
Remarks:

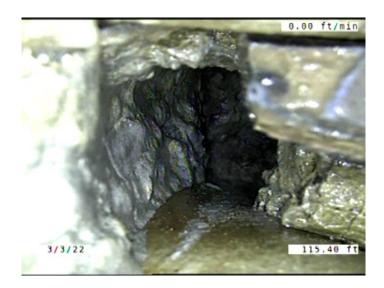
Code:	HVV
Description:	Hole Void Visible
Distance (ft): Structural Grade: O&M Grade: Clock Start/From: Clock To: 1st Value: 2nd Value: Value Percent: Continuous Index: Within 8" of Joint: Remarks:	115.4 5 0 9

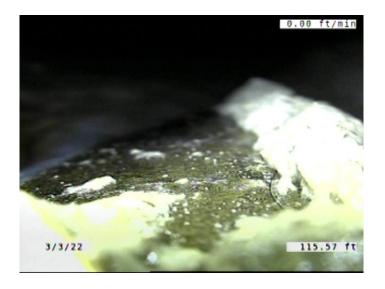
Code:OBMDescription:Obstruction Pipe Material in InvertDistance (ft):115.6Structural Grade:0O&M Grade:2Clock Start/From:5

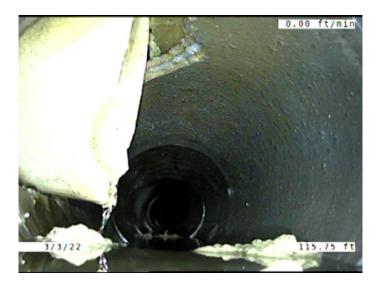
Code:	TBI
Description:	Tap Break-in Intruding
Distance (ft):	115.7
Structural Grade:	0
O&M Grade:	2
Clock Start/From: Clock To:	10
1st Value:	4.000
2nd Value: Value Percent: Continuous Index:	3.000
Within 8" of Joint:	YES
Remarks:	CONSTANTLY RUNNING WATER.

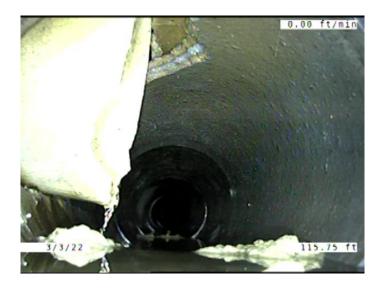
Code:	DSF
Description:	Deposits Settled Fine
Distance (ft):	115.7
Distance (ft):	113.7
Structural Grade:	0
O&M Grade:	2
Clock Start/From:	5
Clock To:	7
1st Value:	
2nd Value:	
Value Percent:	5.000
Continuous Index:	F01
Within 8" of Joint:	YES
Remarks:

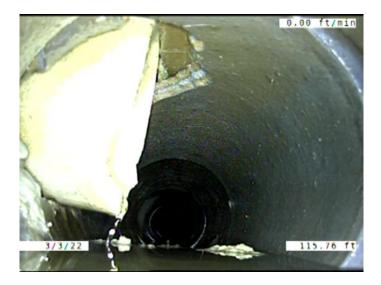
Code:	FM
Description:	Fracture Multiple
Distance (ft): Structural Grade: O&M Grade: Clock Start/From: Clock To: 1st Value: 2nd Value: Value Percent: Continuous Index:	115.7 4 0 8 4 F03
Within 8" of Joint:	YES
Remarks:	Wandering

Code:	MSA
Description:	Miscellaneous Survey Abandoned
Distance (ft):	115.8
Structural Grade:	0
O&M Grade:	0
Clock Start/From:	
Clock To:	
1st Value:	
2nd Value:	
Value Percent:	
Continuous Index:	
Within 8" of Joint:	NO
Remarks:	CAMERA CANT MAKE IT PAST PROTRUDING TAP.
