Profile/Photo Observation Report

Date:	04/20/2018	Weather:		Coding:	PACP 6.0
Pipe Length (ft):	177.1	Owner:	NA	Pre Clean:	Not Known
P.O.#:		Surveyor:	Jen Costello	PSR:	P-706-033-032
Customer:		Clean Date:	01/01/1900	Shape:	C

Street:	LAKE ST	Flow Control:	Not Controlled
City:	Hobart, IN	Year Renewed:	
Location:	Light Highway	Tape/Media #:	
Purpose:	Maintenance Related	Dia/Height:	10"
Use:	Sanitary	Material:	VCP
Drain Area:	NA	Lining:	Cured in Place
Category:	NA		
Comment:	heavy silt at 4'.

Location Details:		Direction of Survey:	Downstream
US MH:	M-706-032	DS MH:	M-706-033
		Total Length Surveyed (ft):	5.7

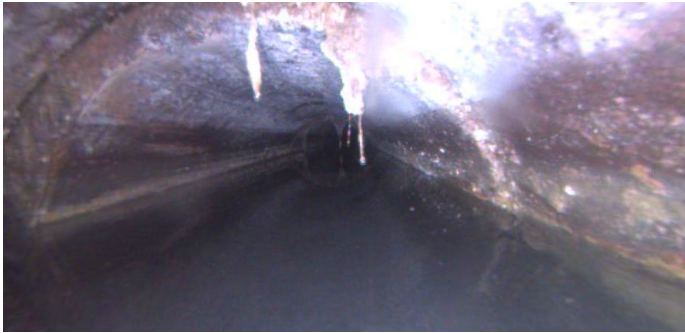
Code:	MWL
Description:	Water Level

Distance (ft):	.0
Structural Grade:	0
O&M Grade:	0
Clock Start/From:	
Clock To:	
1st Value:	
2nd Value:	
Value Percent:	30.000
Continuous Index:	
Within 8" of Joint:	NO
Remarks:

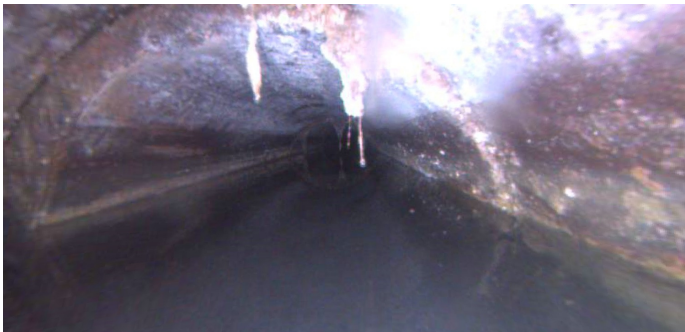
Code:	DAGS
Description:	Deposits Attached Grease

Distance (ft):	.0
Structural Grade:	0
O&M Grade:	2
Clock Start/From:	8
Clock To:	4
1st Value:	
2nd Value:	
Value Percent:	5.000
Continuous Index:	S01
Within 8" of Joint:	NO
Remarks:

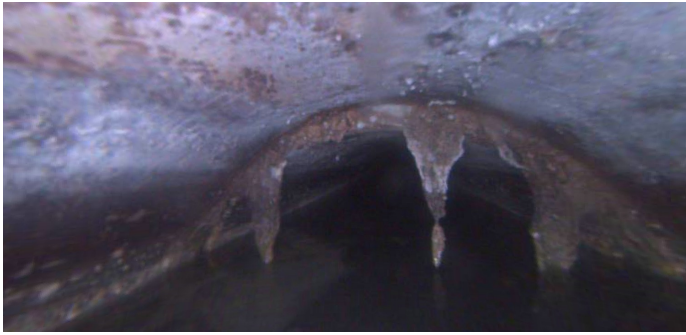
Code: **DAR**
Description: **Deposits Attached Ragging**

Distance (ft): **2.8**
Structural Grade: **0**
O&M Grade: **2**
Clock Start/From: **10**
Clock To: **2**
1st Value:
2nd Value:
Value Percent: **5.000**
Continuous Index:
Within 8" of Joint: **YES**
Remarks:

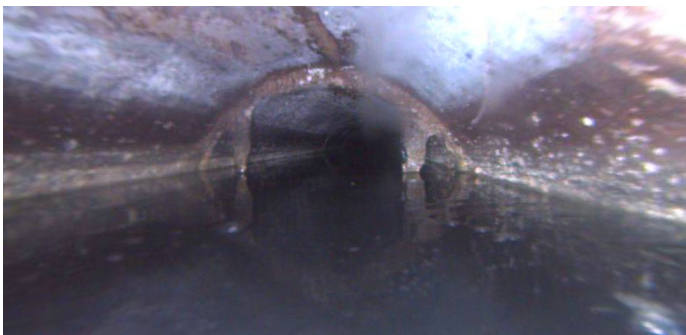
Code: **MSA**
Description: **Abandoned Survey**

Distance (ft): **5.7**
Structural Grade: **0**
O&M Grade: **0**
Clock Start/From:
Clock To:
1st Value:
2nd Value:
Value Percent:
Continuous Index:
Within 8" of Joint: **NO**
Remarks: **DEBRIS UNDER WATER**

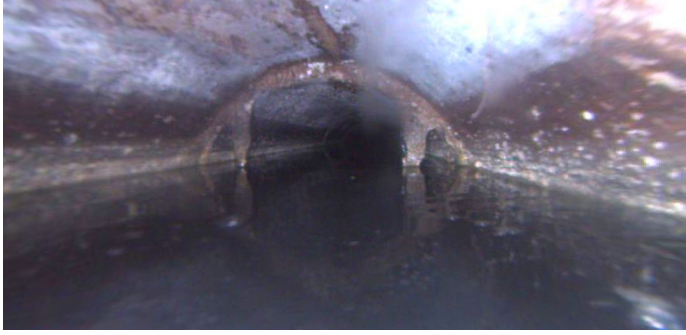
Code:	DAGS
Description:	Deposits Attached Grease
Distance (ft):	5.7
Structural Grade:	0
O&M Grade:	2
Clock Start/From:	8
Clock To:	4
1st Value:	
2nd Value:	
Value Percent:	5.000
Continuous Index:	F01
Within 8" of Joint:	NO
Remarks:
