Profile/Photo Observation Report

Street:	WATER ST & E 7TH ST	Flow Control:	Not Controlled
City:	Hobart, IN	Year Renewed:	
Location:	Light Highway	Tape/Media #:	
Purpose:	Maintenance Related	Dia/Height:	12"
Use:	Sanitary	Material:	PVC
Drain Area:	NA	Lining:	Cured in Place
Category:	NA		
Comment:	battery at 156'.

Location Details:		Direction of Survey:	Upstream
US MH:	M-706-041	DS MH:	M-706-042
		Total Length Surveyed (ft):	157.1

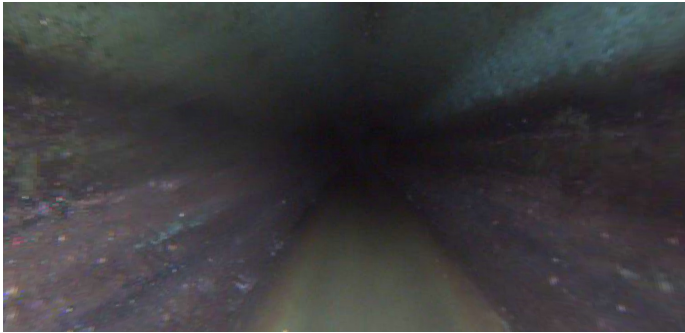
Code:	MWL
Description:	Water Level

Distance (ft):	.0
Structural Grade:	0
O&M Grade:	0
Clock Start/From:	
Clock To:	
1st Value:	
2nd Value:	
Value Percent:	5.000
Continuous Index:	
Within 8" of Joint:	NO
Remarks:

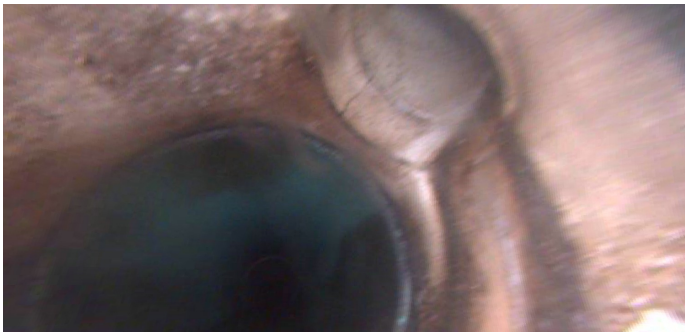
Code:	TF
Description:	Tap Factory

Distance (ft):	63.5
Structural Grade:	0
O&M Grade:	0
Clock Start/From:	1
Clock To:	
1st Value:	4.000
2nd Value:	
Value Percent:	
Continuous Index:	
Within 8" of Joint:	YES
Remarks:

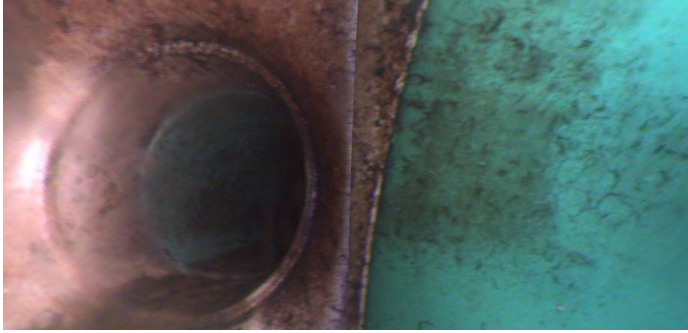
Code: **TF**
Description: **Tap Factory**

Distance (ft): **69.1**
Structural Grade: **0**
O&M Grade: **0**
Clock Start/From: **10**
Clock To:
1st Value: **4.000**
2nd Value:
Value Percent:
Continuous Index:
Within 8" of Joint: **YES**
Remarks:

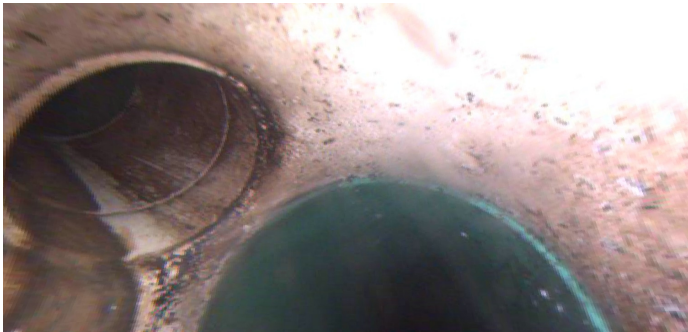
Code: **TF**
Description: **Tap Factory**

Distance (ft): **121.2**
Structural Grade: **0**
O&M Grade: **0**
Clock Start/From: **11**
Clock To:
1st Value: **4.000**
2nd Value:
Value Percent:
Continuous Index:
Within 8" of Joint: **YES**
Remarks:

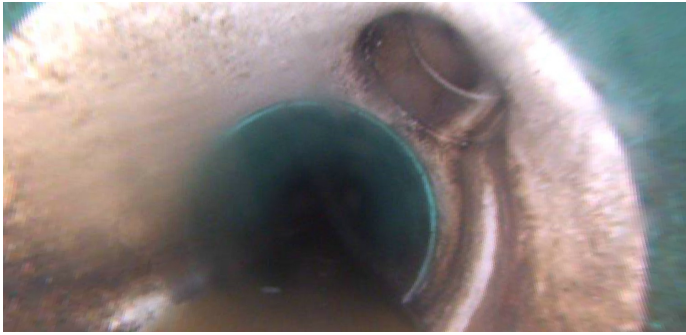
Code: **TF**
Description: **Tap Factory**

Distance (ft): **134.1**
Structural Grade: **0**
O&M Grade: **0**
Clock Start/From: **1**
Clock To:
1st Value: **4.000**
2nd Value:
Value Percent:
Continuous Index:
Within 8" of Joint: **YES**
Remarks:

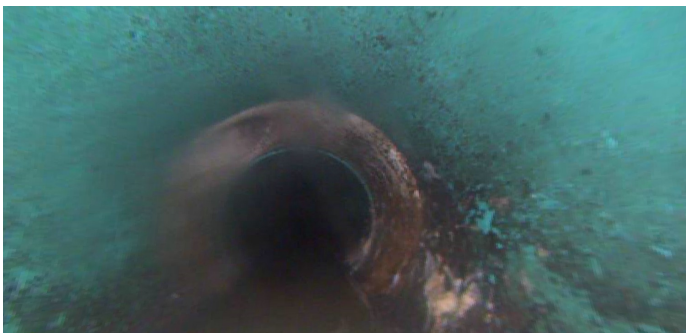
Code: **MSA**
Description: **Abandoned Survey**

Distance (ft): **157.1**
Structural Grade: **0**
O&M Grade: **0**
Clock Start/From:
Clock To:
1st Value:
2nd Value:
Value Percent:
Continuous Index:
Within 8" of Joint: **NO**
Remarks: **no blockage**
