Profile/Photo Observation Report

Date:	04/19/2018	Weather:		Coding:	PACP 6.0
Pipe Length (ft):	167.2	Owner:	NA	Pre Clean:	Not Known
P.O.#:		Surveyor:	Byrd Fitzgerald	PSR:	P-706-041-042
Customer:		Clean Date:	01/01/1900	Shape:	C

Street:	Capitol	Flow Control:	Not Controlled
City:	Hobart, IN	Year Renewed:	
Location:	Light Highway	Tape/Media #:	
Purpose:	Maintenance Related	Dia/Height:	12"
Use:	Sanitary	Material:	PVC
Drain Area:	NA	Lining:	Cured in Place
Category:	NA		
Comment:	battery at 156'.

Location Details:		Direction of Survey:	Upstream
US MH:	M-706-041	DS MH:	M-706-042
		Total Length Surveyed (ft):	157.1

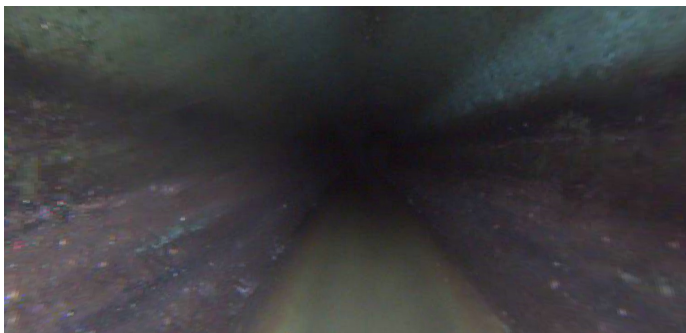
Code: **AMH**
Description: **Manhole**

Distance (ft): **.0**
Structural Grade: **0**
O&M Grade: **0**
Clock Start/From:
Clock To:
1st Value:
2nd Value:
Value Percent:
Continuous Index:
Within 8" of Joint: **NO**
Remarks: **M-706-042**

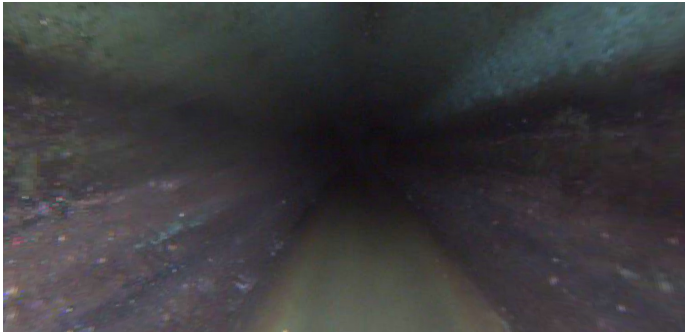
Code:	MWL
Description:	Water Level

Distance (ft):	.0
Structural Grade:	0
O&M Grade:	0
Clock Start/From:	
Clock To:	
1st Value:	
2nd Value:	
Value Percent:	5.000
Continuous Index:	
Within 8" of Joint:	NO
Remarks:

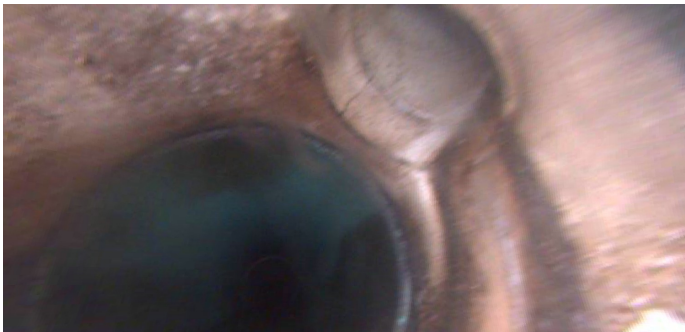
Code:	TF
Description:	Tap Factory

Distance (ft):	63.5
Structural Grade:	0
O&M Grade:	0
Clock Start/From:	1
Clock To:	
1st Value:	4.000
2nd Value:	
Value Percent:	
Continuous Index:	
Within 8" of Joint:	YES
Remarks:

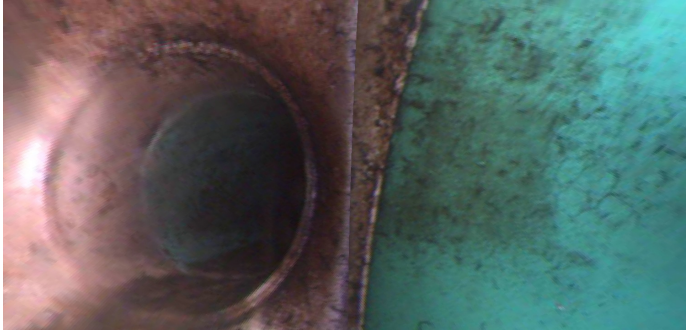
Code: **TF**
Description: **Tap Factory**

Distance (ft): **69.1**
Structural Grade: **0**
O&M Grade: **0**
Clock Start/From: **10**
Clock To:
1st Value: **4.000**
2nd Value:
Value Percent:
Continuous Index:
Within 8" of Joint: **YES**
Remarks:

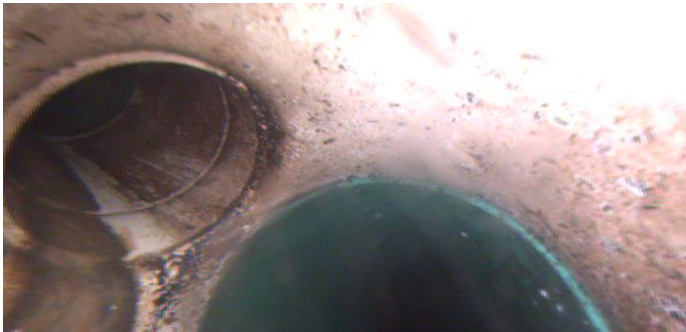
Code: **TF**
Description: **Tap Factory**

Distance (ft): **121.2**
Structural Grade: **0**
O&M Grade: **0**
Clock Start/From: **11**
Clock To:
1st Value: **4.000**
2nd Value:
Value Percent:
Continuous Index:
Within 8" of Joint: **YES**
Remarks:

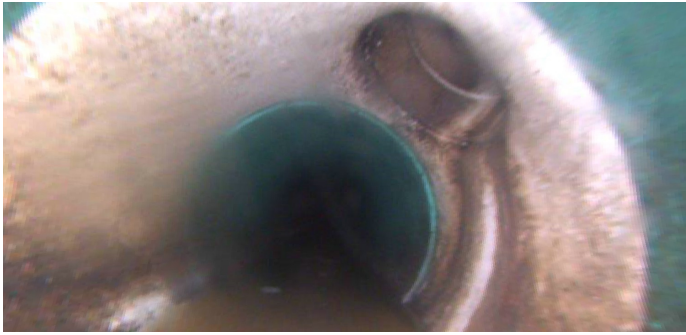
Code: **TF**
Description: **Tap Factory**

Distance (ft): **134.1**
Structural Grade: **0**
O&M Grade: **0**
Clock Start/From: **1**
Clock To:
1st Value: **4.000**
2nd Value:
Value Percent:
Continuous Index:
Within 8" of Joint: **YES**
Remarks:

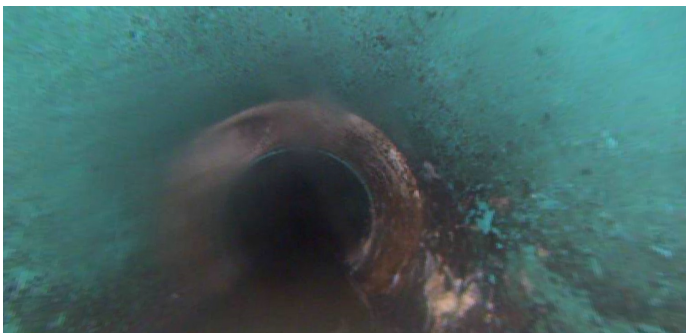
Code: **MSA**
Description: **Abandoned Survey**

Distance (ft): **157.1**
Structural Grade: **0**
O&M Grade: **0**
Clock Start/From:
Clock To:
1st Value:
2nd Value:
Value Percent:
Continuous Index:
Within 8" of Joint: **NO**
Remarks: **no blockage**
