Profile/Photo Observation Report

Date:	03/08/2022	Weather:		Coding:	PACP 7.0
Pipe Length (ft):	323.3	Owner:	City of Hobart	Pre Clean:	No Pre-Cleaning
P.O.#:	YES502259	Surveyor:	S. Bucklin	PSR:	P-706-042.1-042
Customer:	City of Hobart, IN (Red	Clean Date:		Shape:	C

Street:	Water Street	Flow Control:	Not Controlled
City:	Hobart, IN	Year Renewed:	
Location:	Local rural streets with light traffic, t	Tape/Media #:	
Purpose:	Routine Assessment	Dia/Height:	12"
Use:	Sanitary Sewage Pipe	Material:	VCP
Drain Area:		Lining:	None
Category:	NA		
Comment:			
Location Details:		Direction of Survey:	Upstream
US MH:	M-706-042	DS MH:	M-706-042.1
		Total Length Surveyed (ft):	323.8

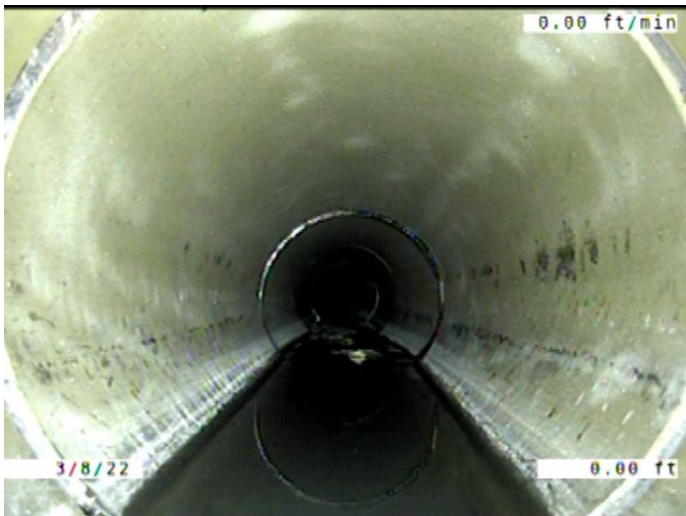
Code: **MWL**
Description: **Miscellaneous Water Level**

Distance (ft): **.0**
Structural Grade: **0**
O&M Grade: **0**
Clock Start/From:
Clock To:
1st Value:
2nd Value:
Value Percent: **5.000**
Continuous Index:
Within 8" of Joint: **NO**
Remarks:

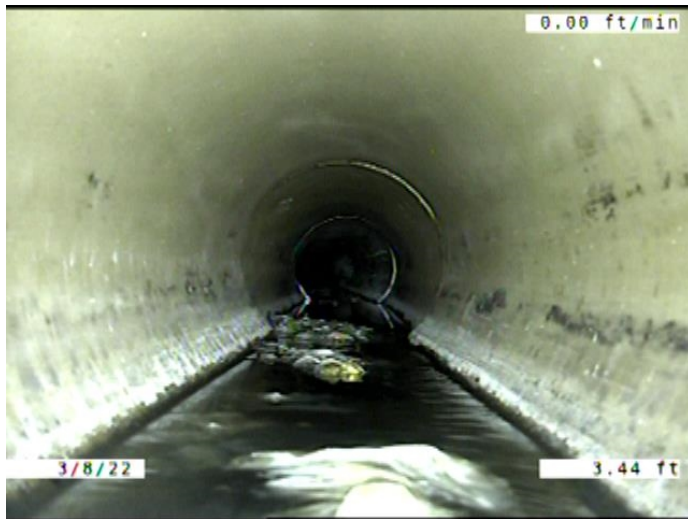
Code: **DSF**
 Description: **Deposits Settled Fine**

Distance (ft): **3.4**
 Structural Grade: **0**
 O&M Grade: **2**
 Clock Start/From: **5**
 Clock To: **7**
 1st Value:
 2nd Value:
 Value Percent: **5.000**
 Continuous Index: **S01**
 Within 8" of Joint: **YES**
 Remarks:

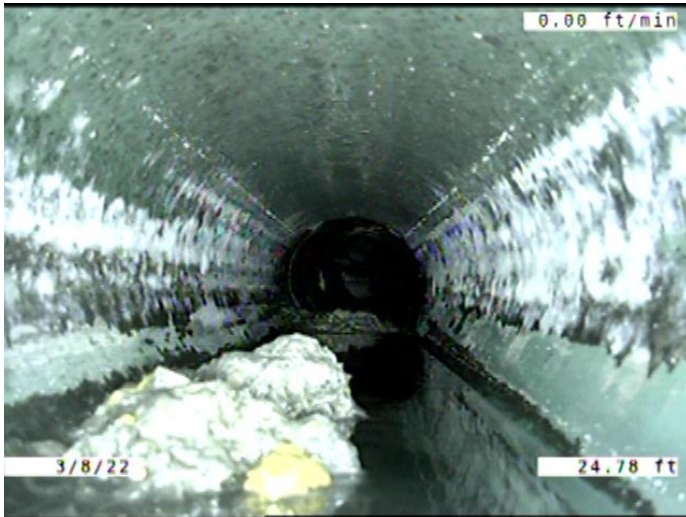
Code: **DAR**
Description: **Deposits Attached Ragging**

Distance (ft): **24.8**
Structural Grade: **0**
O&M Grade: **3**
Clock Start/From: **5**
Clock To: **8**
1st Value:
2nd Value:
Value Percent: **15.000**
Continuous Index: **S03**
Within 8" of Joint: **YES**
Remarks:

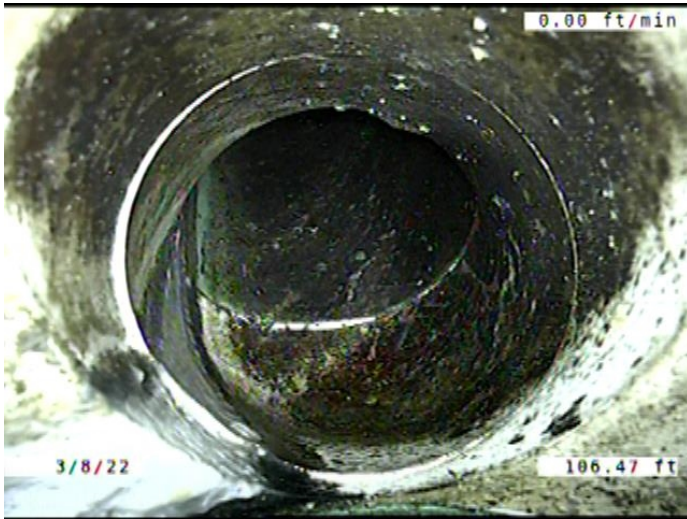
Code: **TF**
Description: **Tap Factory**

Distance (ft): **106.5**
Structural Grade: **0**
O&M Grade: **0**
Clock Start/From: **11**
Clock To:
1st Value: **6.000**
2nd Value:
Value Percent:
Continuous Index:
Within 8" of Joint: **YES**
Remarks:

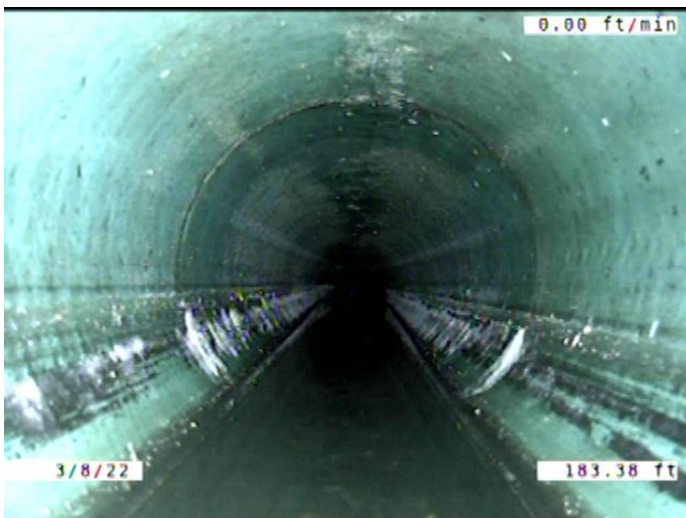
Code: **MWLS**
Description: **Miscellaneous Water Level Sag**

Distance (ft): **183.4**
Structural Grade: **2**
O&M Grade: **0**
Clock Start/From:
Clock To:
1st Value:
2nd Value:
Value Percent: **15.000**
Continuous Index: **S04**
Within 8" of Joint: **NO**
Remarks:

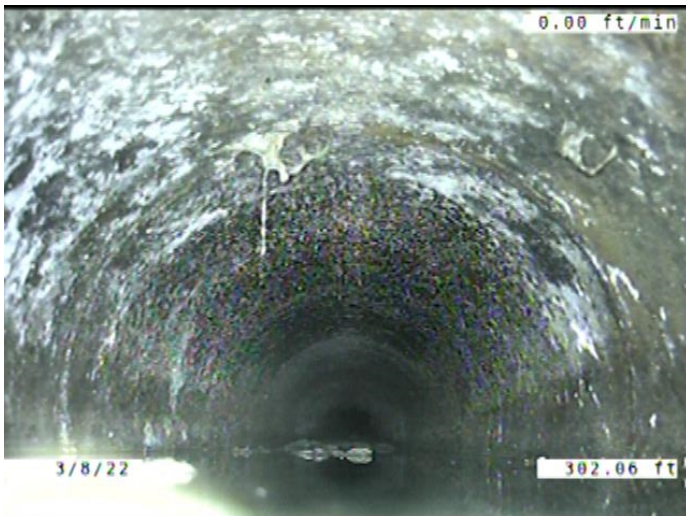
Code: **DSF**
 Description: **Deposits Settled Fine**

Distance (ft): **302.1**
 Structural Grade: **0**
 O&M Grade: **3**
 Clock Start/From: **4**
 Clock To: **8**
 1st Value:
 2nd Value:
 Value Percent: **20.000**
 Continuous Index: **S05**
 Within 8" of Joint: **YES**
 Remarks:

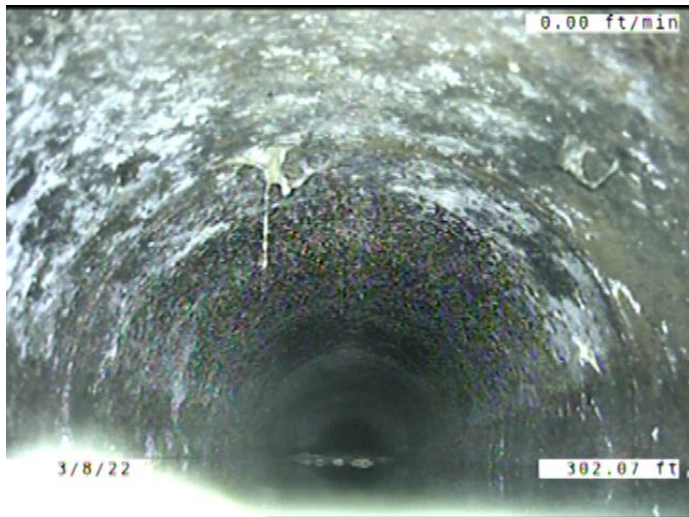
Code: **DSF**
Description: **Deposits Settled Fine**

Distance (ft): **302.1**
Structural Grade: **0**
O&M Grade: **2**
Clock Start/From: **5**
Clock To: **7**
1st Value:
2nd Value:
Value Percent: **5.000**
Continuous Index: **F01**
Within 8" of Joint: **YES**
Remarks:

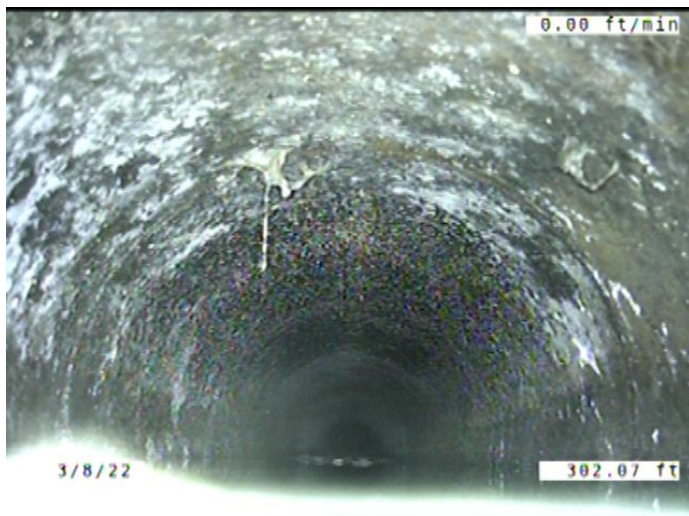
Code: **MWL**
Description: **Miscellaneous Water Level**

Distance (ft): **302.1**
Structural Grade: **0**
O&M Grade: **0**
Clock Start/From:
Clock To:
1st Value:
2nd Value:
Value Percent: **25.000**
Continuous Index:
Within 8" of Joint: **NO**
Remarks:

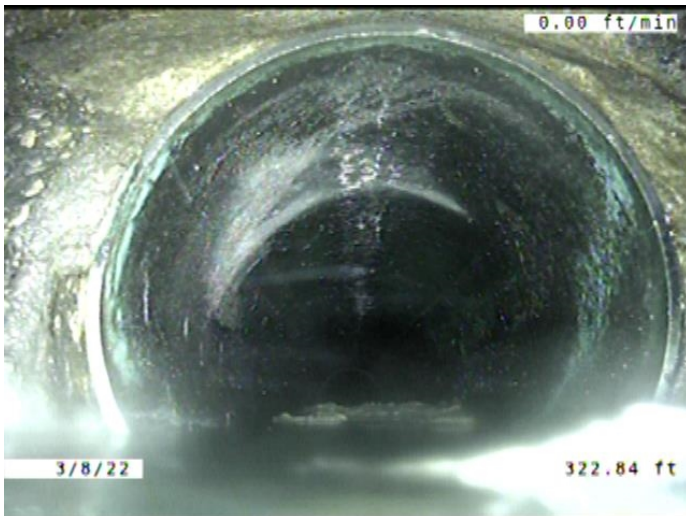
Code: **DSF**
 Description: **Deposits Settled Fine**

Distance (ft): **322.8**
 Structural Grade: **0**
 O&M Grade: **3**
 Clock Start/From: **4**
 Clock To: **8**
 1st Value:
 2nd Value:
 Value Percent: **20.000**
 Continuous Index: **F05**
 Within 8" of Joint: **YES**
 Remarks:

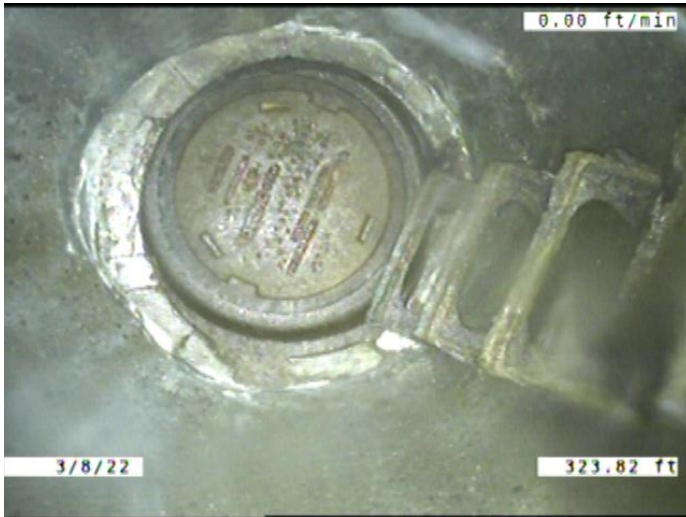
Code:	AMH
Description:	Manhole
Distance (ft):	323.8
Structural Grade:	0
O&M Grade:	0
Clock Start/From:	
Clock To:	
1st Value:	
2nd Value:	
Value Percent:	
Continuous Index:	
Within 8" of Joint:	NO
Remarks:	M-706-042
