Profile/Photo Observation Report

Date:	04/19/2018	Weather:		Coding:	PACP 6.0
Pipe Length (ft):	166.6	Owner:	NA	Pre Clean:	Not Known
P.O.#:		Surveyor:	Jen Costello	PSR:	P-706-043-042
Customer:		Clean Date:	01/01/1900	Shape:	C

Street:	Capitol	Flow Control:	Not Controlled
City:	Hobart, IN	Year Renewed:	
Location:	Alley	Tape/Media #:	
Purpose:	Maintenance Related	Dia/Height:	8"
Use:	Sanitary	Material:	PVC
Drain Area:	NA	Lining:	Cured in Place
Category:	NA		
Comment:	heavy silt at 11'.

Location Details:		Direction of Survey:	Upstream
US MH:	M-706-042	DS MH:	M-706-043
		Total Length Surveyed (ft):	12.5

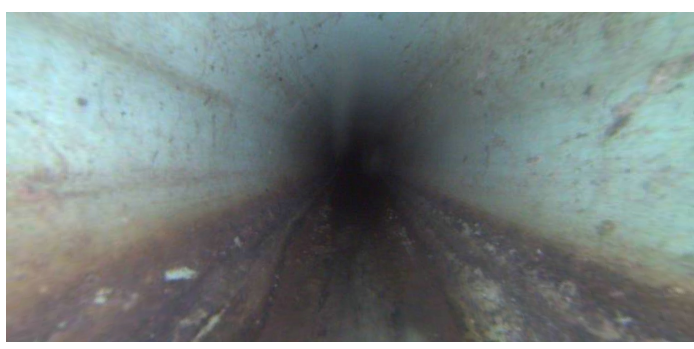
Code: **AMH**
Description: **Manhole**

Distance (ft): **.0**
Structural Grade: **0**
O&M Grade: **0**
Clock Start/From:
Clock To:
1st Value:
2nd Value:
Value Percent:
Continuous Index:
Within 8" of Joint: **NO**
Remarks: **M-706-043**

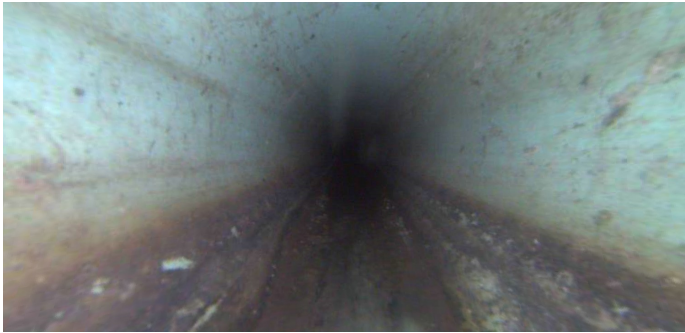
Code:	MWL
Description:	Water Level

Distance (ft):	.0
Structural Grade:	0
O&M Grade:	0
Clock Start/From:	
Clock To:	
1st Value:	
2nd Value:	
Value Percent:	5.000
Continuous Index:	
Within 8" of Joint:	NO
Remarks:

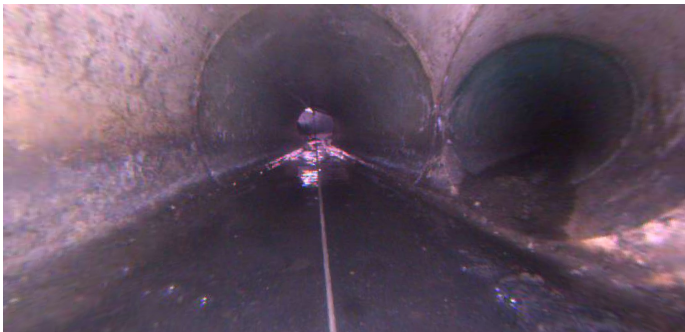
Code:	TF
Description:	Tap Factory

Distance (ft):	5.9
Structural Grade:	0
O&M Grade:	0
Clock Start/From:	9
Clock To:	
1st Value:	4.000
2nd Value:	
Value Percent:	
Continuous Index:	
Within 8" of Joint:	
Remarks:

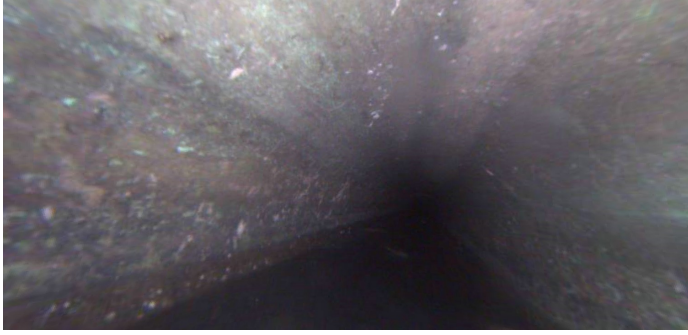
Code:	MSA
Description:	Abandoned Survey
Distance (ft):	12.5
Structural Grade:	0
O&M Grade:	0
Clock Start/From:	
Clock To:	
1st Value:	
2nd Value:	
Value Percent:	
Continuous Index:	
Within 8" of Joint:	NO
Remarks:	DEBRIS UNDER WATER
