Profile/Photo Observation Report

Street:	East 7th Street	Flow Control:	Not Controlled
City:	Hobart, IN	Year Renewed:	
Location:	Local rural streets with light traffic, t	Tape/Media #:	
Purpose:	Routine Assessment	Dia/Height:	10"
Use:	Sanitary Sewage Pipe	Material:	PVC
Drain Area:		Lining:	None
Category:	NA		
Comment:			
Location Details:		Direction of Survey:	Downstream
US MH:	M-706-042	DS MH:	M-706-043
		Total Length Surveyed (ft):	162.2

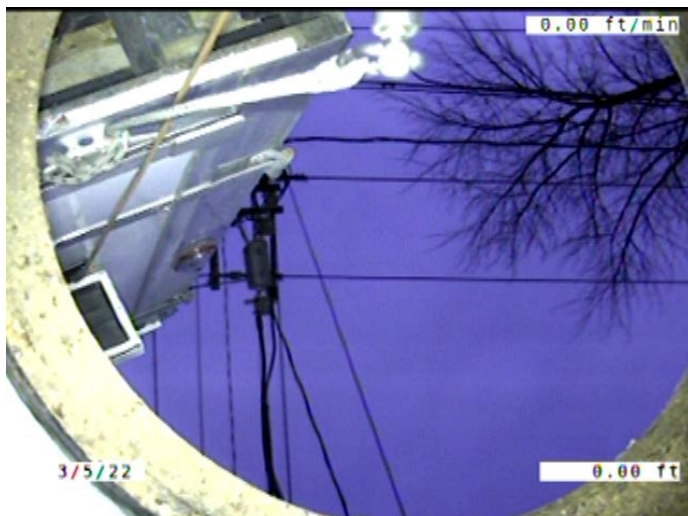
Code:	AMH
Description:	Manhole
Distance (ft):	.0
Structural Grade:	0
O&M Grade:	0
Clock Start/From:	
Clock To:	
1st Value:	
2nd Value:	
Value Percent:	
Continuous Index:	
Within 8" of Joint:	NO
Remarks:	M-706-042

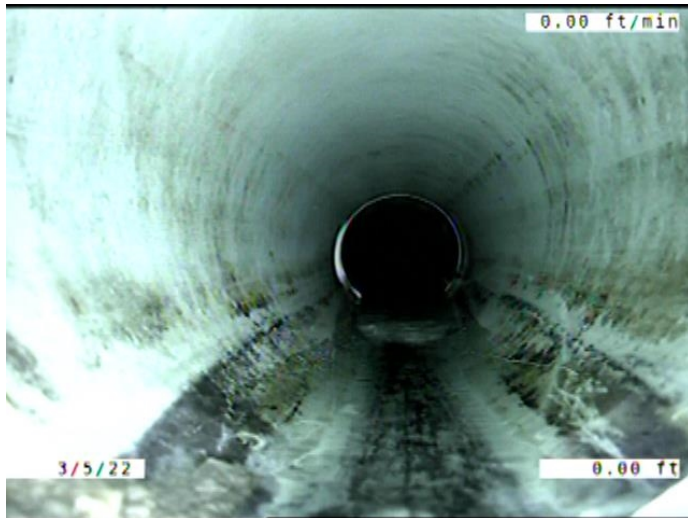
Code:	MWL
Description:	Miscellaneous Water Level
Distance (ft):	.0
Structural Grade:	0
O&M Grade:	0
Clock Start/From:	
Clock To:	
1st Value:	
2nd Value:	
Value Percent:	5.000
Continuous Index:	
Within 8" of Joint:	NO
Remarks:

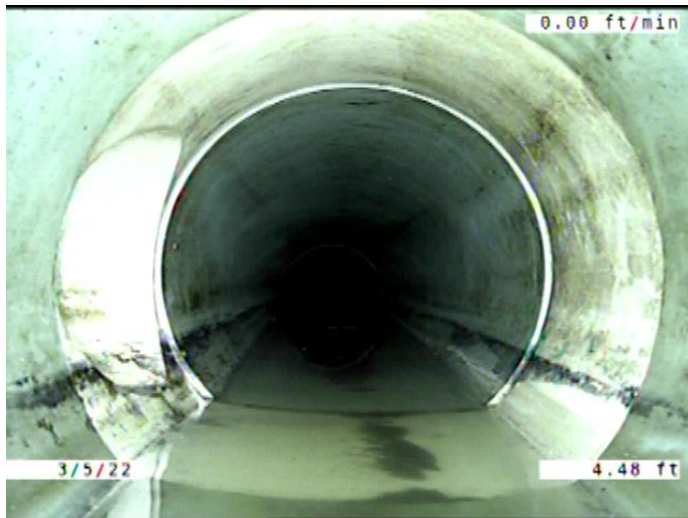
Code:	MWLS
Description:	Miscellaneous Water Level Sag
Distance (ft):	4.5
Structural Grade:	3
O&M Grade:	0
Clock Start/From:	
Clock To:	
1st Value:	
2nd Value:	
Value Percent:	50.000
Continuous Index:	S01
Within 8" of Joint:	NO
Remarks:

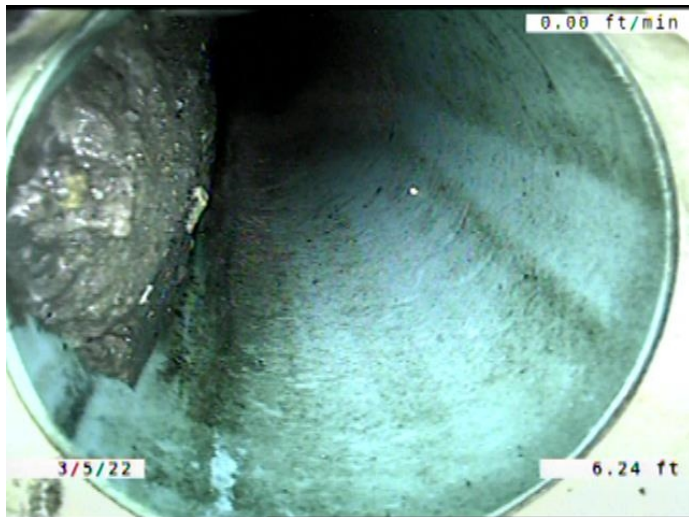
Code: **TF**
 Description: **Tap Factory**

Distance (ft): **6.2**
 Structural Grade: **0**
 O&M Grade: **0**
 Clock Start/From: **9**
 Clock To:
 1st Value: **4.000**
 2nd Value:
 Value Percent:
 Continuous Index:
 Within 8" of Joint: **YES**
 Remarks:

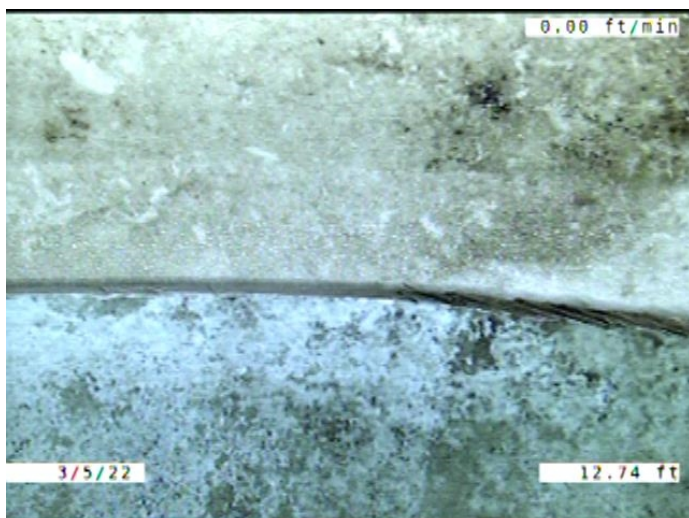
Code: **MGO**
 Description: **Miscellaneous General Observation**

Distance (ft): **12.7**
 Structural Grade: **0**
 O&M Grade: **0**
 Clock Start/From:
 Clock To:
 1st Value:
 2nd Value:
 Value Percent:
 Continuous Index:
 Within 8" of Joint: **NO**
 Remarks: **JOINT/ PIPES NOT PUSHED ALL THE WAY TOGETHER WHEN INSTALLED**

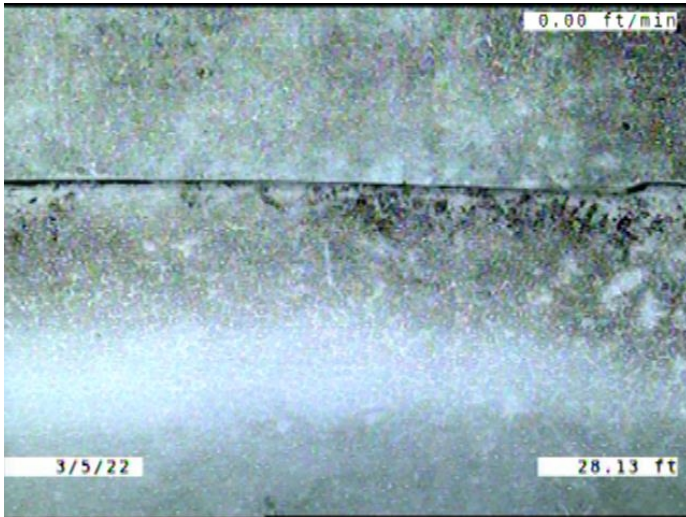
Code: **MGO**
Description: **Miscellaneous General Observation**

Distance (ft): **28.1**
Structural Grade: **0**
O&M Grade: **0**
Clock Start/From:
Clock To:
1st Value:
2nd Value:
Value Percent:
Continuous Index:
Within 8" of Joint: **NO**
Remarks: **JOINT/ PIPES NOT PUSHED ALL THE WAY TOGETHER WHEN INSTALLED**

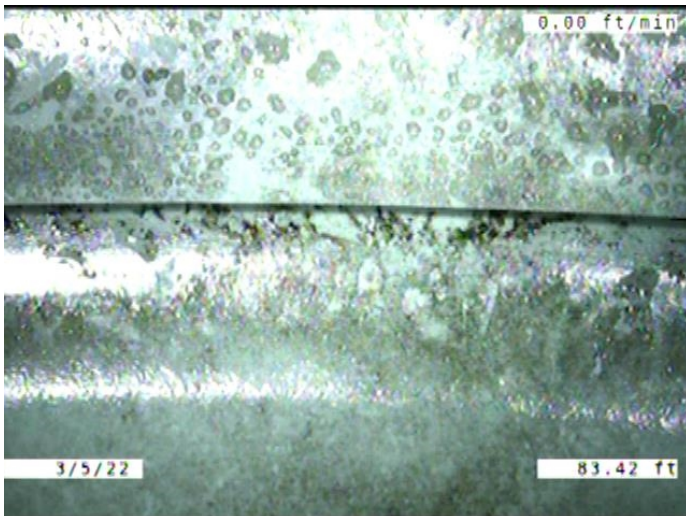
Code: **MGO**
Description: **Miscellaneous General Observation**

Distance (ft): **83.4**
Structural Grade: **0**
O&M Grade: **0**
Clock Start/From:
Clock To:
1st Value:
2nd Value:
Value Percent:
Continuous Index:
Within 8" of Joint: **NO**
Remarks: **JOINT/ PIPES NOT PUSHED ALL THE WAY TOGETHER WHEN INSTALLED**

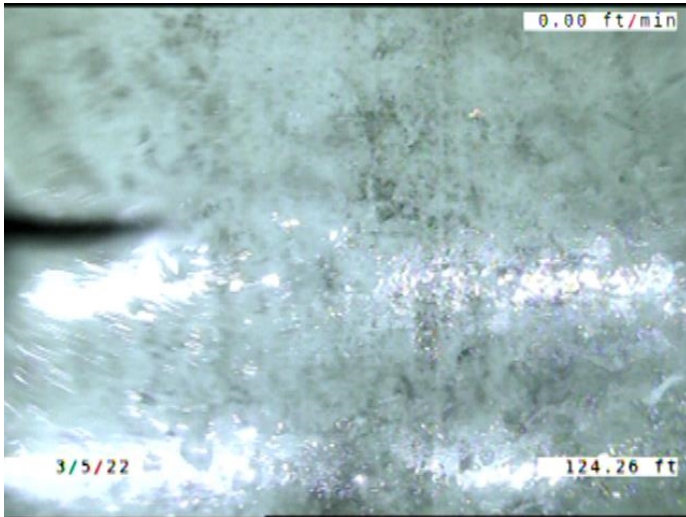
Code:	MCU
Description:	Miscellaneous Camera Underwater
Distance (ft):	124.3
Structural Grade:	0
O&M Grade:	4
Clock Start/From:	
Clock To:	
1st Value:	
2nd Value:	
Value Percent:	
Continuous Index:	S02
Within 8" of Joint:	NO
Remarks:

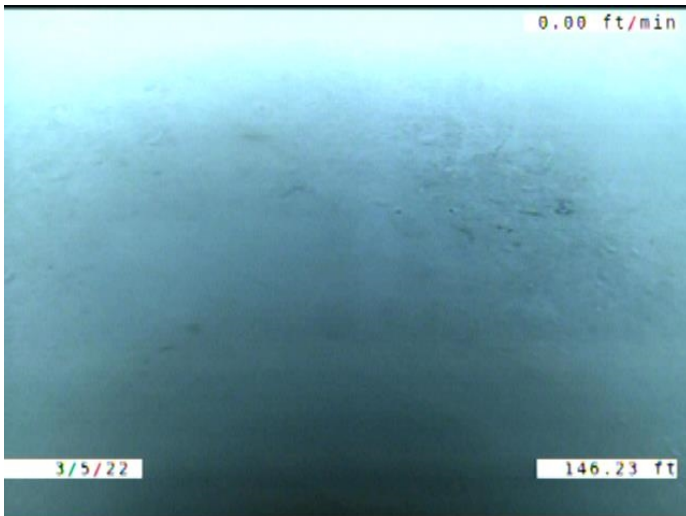
Code:	MCU
Description:	Miscellaneous Camera Underwater
Distance (ft):	146.2
Structural Grade:	0
O&M Grade:	4
Clock Start/From:	
Clock To:	
1st Value:	
2nd Value:	
Value Percent:	
Continuous Index:	F02
Within 8" of Joint:	NO
Remarks:

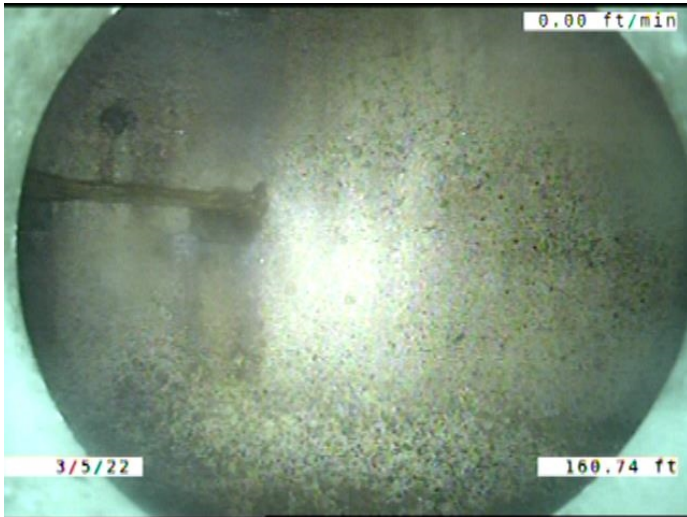
Code: **MWLS**
 Description: **Miscellaneous Water Level Sag**

Distance (ft): **160.7**
 Structural Grade: **3**
 O&M Grade: **0**
 Clock Start/From:
 Clock To:
 1st Value:
 2nd Value:
 Value Percent: **50.000**
 Continuous Index: **F01**
 Within 8" of Joint: **NO**
 Remarks:

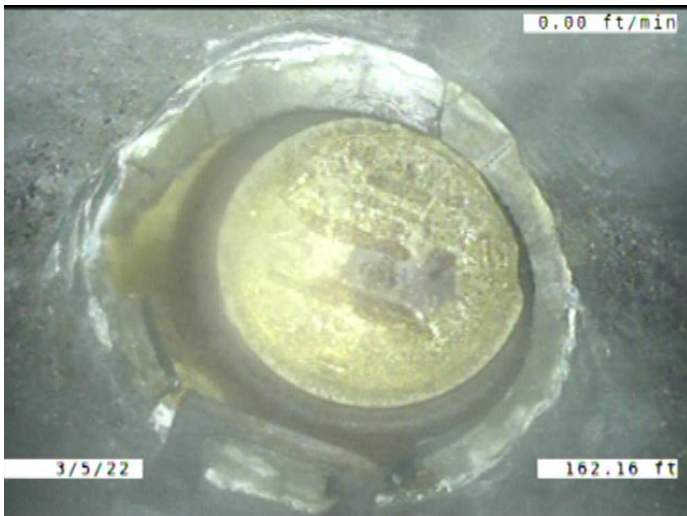
Code: **AMH**
 Description: **Manhole**

Distance (ft): **162.2**
 Structural Grade: **0**
 O&M Grade: **0**
 Clock Start/From:
 Clock To:
 1st Value:
 2nd Value:
 Value Percent:
 Continuous Index:
 Within 8" of Joint: **NO**
 Remarks: **M-706-043**
