Profile/Photo Observation Report

Date:	04/19/2018	Weather:		Coding:	PACP 6.0
Pipe Length (ft):	302.0	Owner:	NA	Pre Clean:	Not Known
P.O.#:		Surveyor:	Byrd Fitzgerald	PSR:	P-706-042.2-042.1
Customer:		Clean Date:	01/01/1900	Shape:	C

Location Details:		Direction of Survey:	Downstream
US MH:	M-706-042.1	DS MH:	M-706-042.2
		Total Length Surveyed (ft):	149.3

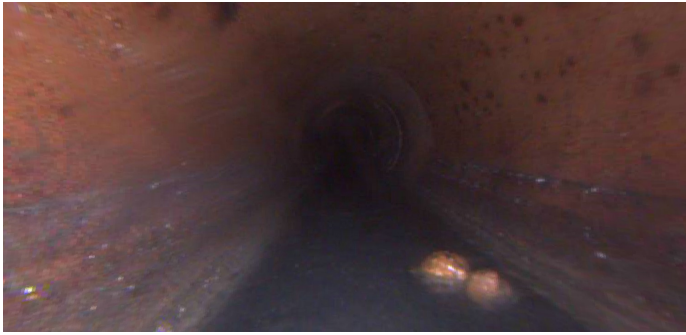
Code: **AMH**
Description: **Manhole**

Distance (ft): **.0**
Structural Grade: **0**
O&M Grade: **0**
Clock Start/From:
Clock To:
1st Value:
2nd Value:
Value Percent:
Continuous Index:
Within 8" of Joint: **NO**
Remarks: **M-706-042.1**

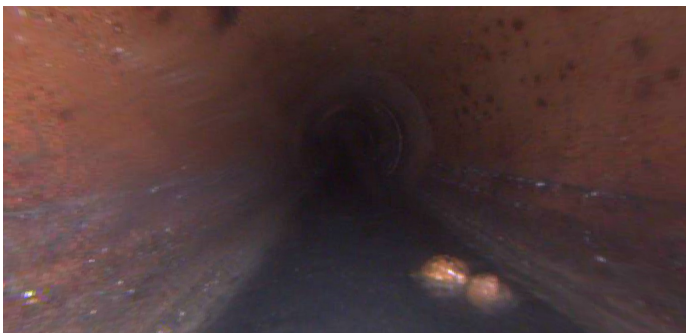
Code: **MWL**
Description: **Water Level**

Distance (ft): **.0**
Structural Grade: **0**
O&M Grade: **0**
Clock Start/From:
Clock To:
1st Value:
2nd Value:
Value Percent: **5.000**
Continuous Index:
Within 8" of Joint: **NO**
Remarks:

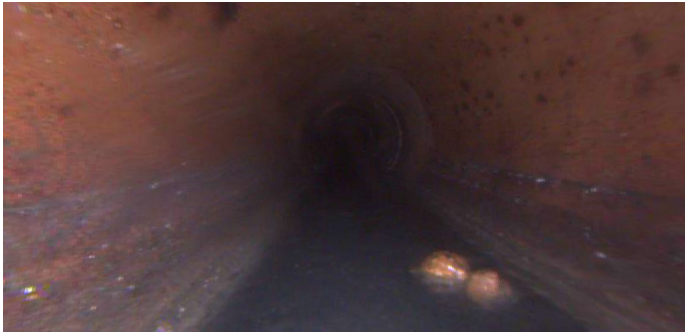
Code: **DSZ**
Description: **Deposits Settled Other**

Distance (ft): **.0**
Structural Grade: **0**
O&M Grade: **2**
Clock Start/From: **6**
Clock To:
1st Value:
2nd Value:
Value Percent: **5.000**
Continuous Index:
Within 8" of Joint: **NO**
Remarks: **debris**

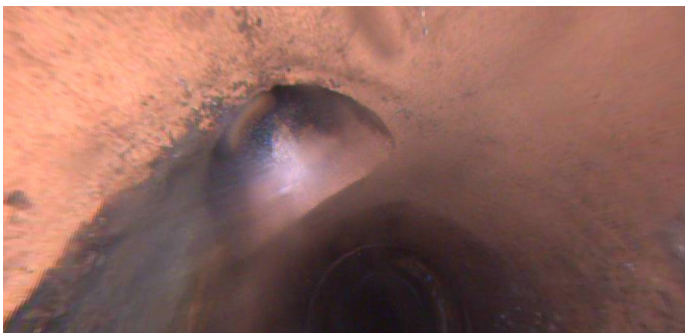
Code: **TF**
Description: **Tap Factory**

Distance (ft): **4.3**
Structural Grade: **0**
O&M Grade: **0**
Clock Start/From: **11**
Clock To:
1st Value: **4.000**
2nd Value:
Value Percent:
Continuous Index:
Within 8" of Joint: **YES**
Remarks:

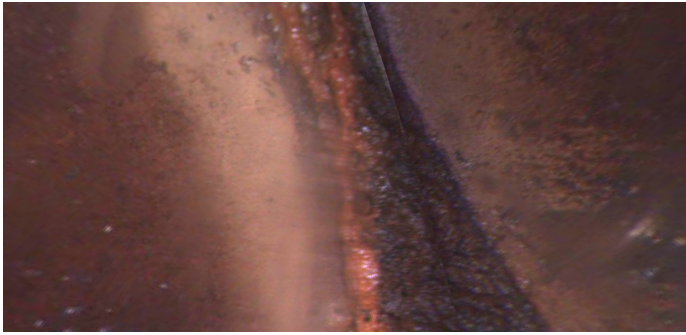
Code: **DAE**
Description: **Deposits Attached Encrustation**

Distance (ft): **11.9**
Structural Grade: **0**
O&M Grade: **2**
Clock Start/From: **7**
Clock To: **5**
1st Value:
2nd Value:
Value Percent: **5.000**
Continuous Index:
Within 8" of Joint: **YES**
Remarks:

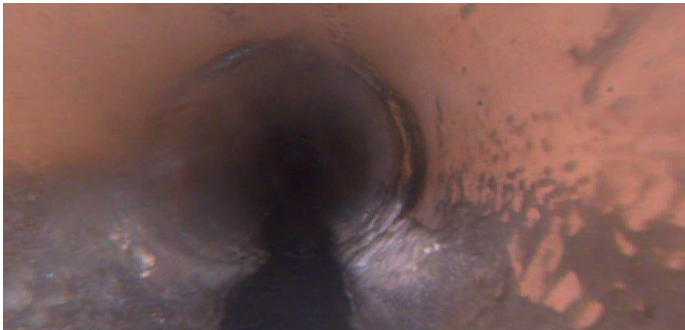
Code: DAGS
Description: Deposits Attached Grease

Distance (ft): 49.9
Structural Grade: 0
O&M Grade: 2
Clock Start/From: 7
Clock To: 5
1st Value:
2nd Value:
Value Percent: 5.000
Continuous Index:
Within 8" of Joint: YES
Remarks:

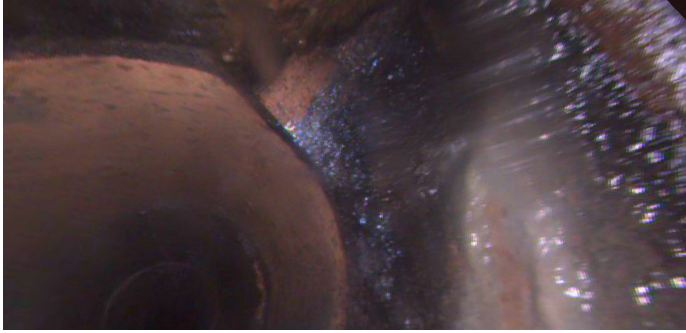
Code: **TF**
Description: **Tap Factory**

Distance (ft): **55.4**
Structural Grade: **0**
O&M Grade: **0**
Clock Start/From: **1**
Clock To:
1st Value: **4.000**
2nd Value:
Value Percent:
Continuous Index:
Within 8" of Joint: **YES**
Remarks:

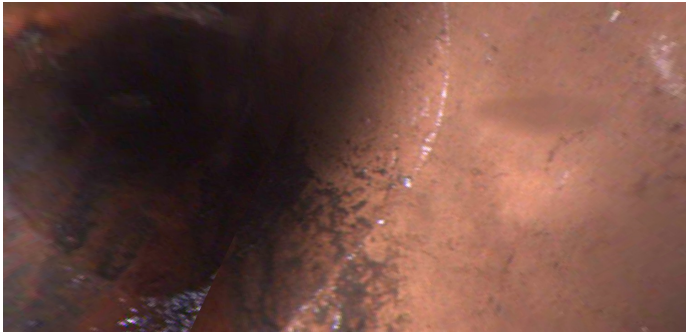
Code: **TF**
Description: **Tap Factory**

Distance (ft): **83.5**
Structural Grade: **0**
O&M Grade: **0**
Clock Start/From: **10**
Clock To:
1st Value: **4.000**
2nd Value:
Value Percent:
Continuous Index:
Within 8" of Joint: **YES**
Remarks:

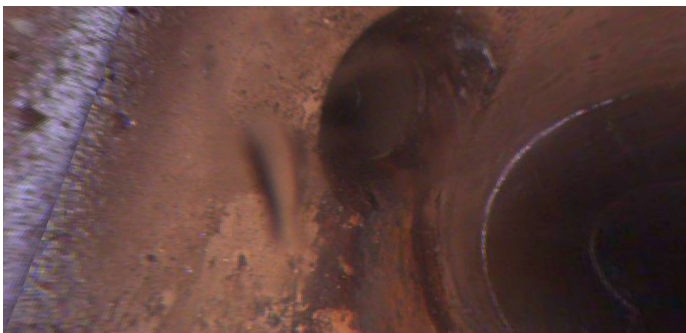
Code: **TF**
Description: **Tap Factory**

Distance (ft): **87.9**
Structural Grade: **0**
O&M Grade: **0**
Clock Start/From: **2**
Clock To:
1st Value: **4.000**
2nd Value:
Value Percent:
Continuous Index:
Within 8" of Joint: **YES**
Remarks:

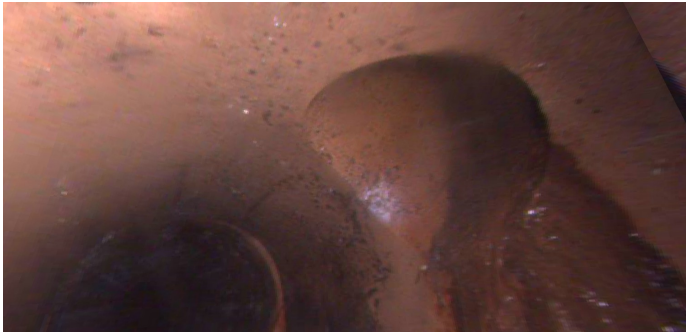
Code: **TF**
Description: **Tap Factory**

Distance (ft): **98.8**
Structural Grade: **0**
O&M Grade: **0**
Clock Start/From: **2**
Clock To:
1st Value: **4.000**
2nd Value:
Value Percent:
Continuous Index:
Within 8" of Joint: **YES**
Remarks:

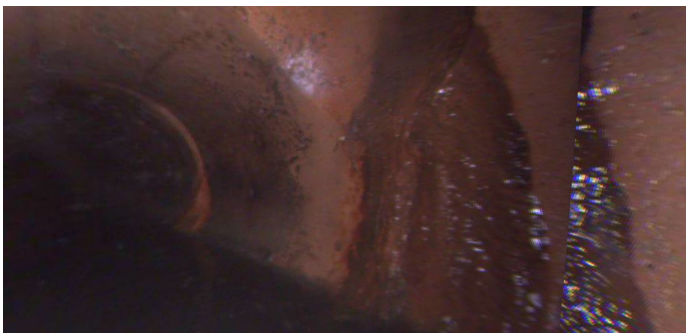
Code: **DAE**
Description: **Deposits Attached Encrustation**

Distance (ft): **98.8**
Structural Grade: **0**
O&M Grade: **2**
Clock Start/From: **3**
Clock To: **5**
1st Value:
2nd Value:
Value Percent: **5.000**
Continuous Index:
Within 8" of Joint: **NO**
Remarks:

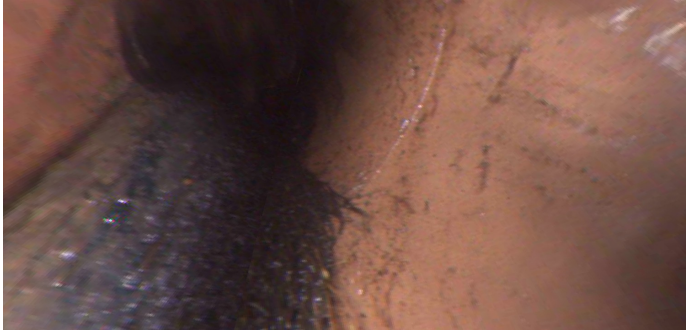
Code: **TF**
Description: **Tap Factory**

Distance (ft): **132.5**
Structural Grade: **0**
O&M Grade: **0**
Clock Start/From: **10**
Clock To:
1st Value: **4.000**
2nd Value:
Value Percent:
Continuous Index:
Within 8" of Joint: **YES**
Remarks:

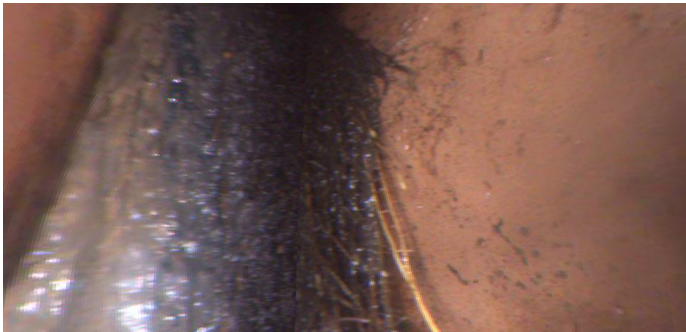
Code: **RML**
Description: **Roots Medium Lateral**

Distance (ft): **132.5**
Structural Grade: **0**
O&M Grade: **3**
Clock Start/From: **7**
Clock To: **10**
1st Value:
2nd Value:
Value Percent: **5.000**
Continuous Index:
Within 8" of Joint: **NO**
Remarks:

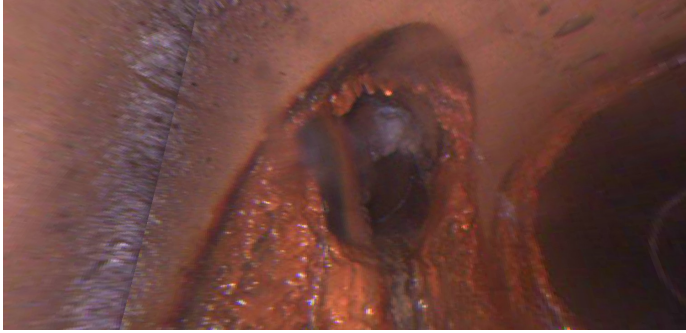
Code: **TF**
Description: **Tap Factory**

Distance (ft): **137.0**
Structural Grade: **0**
O&M Grade: **0**
Clock Start/From: **2**
Clock To:
1st Value: **4.000**
2nd Value:
Value Percent:
Continuous Index:
Within 8" of Joint: **YES**
Remarks:

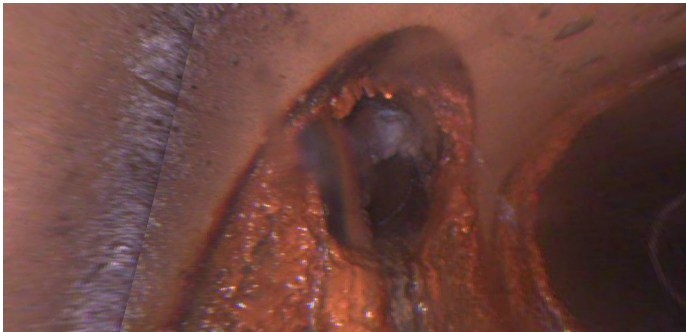
Code: **DAE**
Description: **Deposits Attached Encrustation**

Distance (ft): **137.0**
Structural Grade: **0**
O&M Grade: **2**
Clock Start/From: **2**
Clock To: **5**
1st Value:
2nd Value:
Value Percent: **5.000**
Continuous Index:
Within 8" of Joint: **NO**
Remarks:

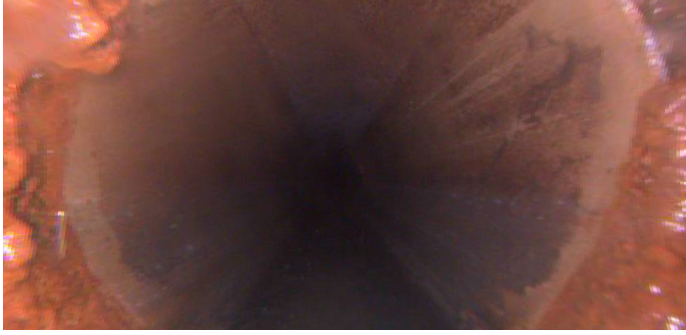
Code:	DAE
Description:	Deposits Attached Encrustation
Distance (ft):	149.3
Structural Grade:	0
O&M Grade:	2
Clock Start/From:	2
Clock To:	5
1st Value:	
2nd Value:	
Value Percent:	5.000
Continuous Index:	F01
Within 8" of Joint:	YES
Remarks:	wandering
