## Profile/Photo Observation Report

O&M Index:	2.05	O&M Quick:	4232	O&M Rating:	197.00
Structural Index:	2.00	Structural Quick:	2B00	Structural Rating:	34.00
Overall Index:	2.04	Overall Quick:	4232	Overall Rating:	231.00

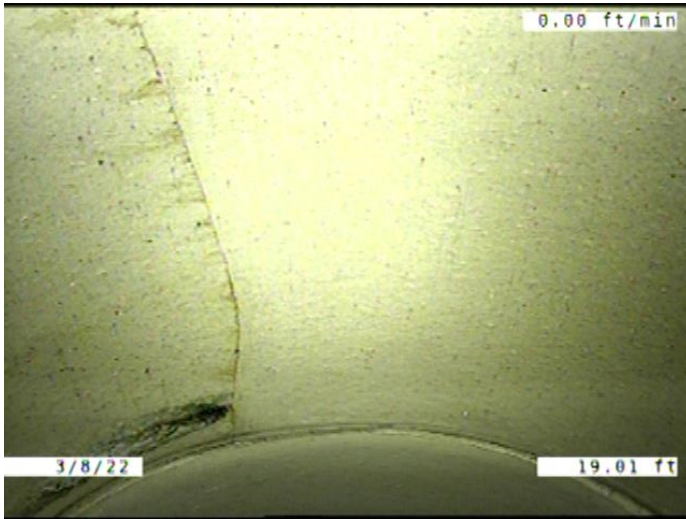
Code: **CS**  
Description: **Crack Spiral**

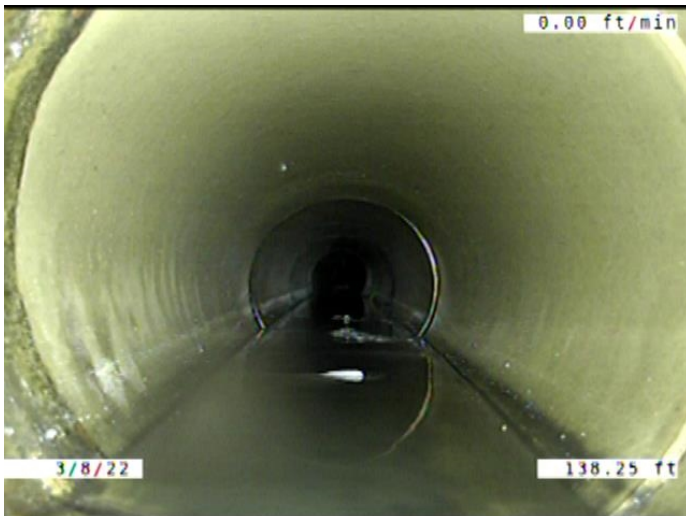
Code: **MWLS**  
 Description: **Miscellaneous Water Level Sag**

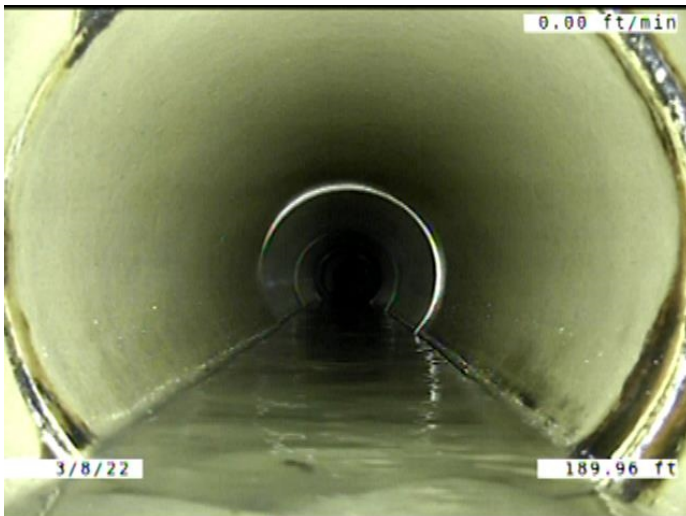
Code: **MWLS**  
 Description: **Miscellaneous Water Level Sag**
