Profile/Photo Observation Report

Date:	04/19/2018	Weather:		Coding:	PACP 6.0
Pipe Length (ft):	168.5	Owner:	NA	Pre Clean:	Not Known
P.O.#:		Surveyor:	Curtis Montgomery	PSR:	P-706-044-043
Customer:		Clean Date:	01/01/1900	Shape:	C

Street:	ALLEY BETWEEN WATER ST & FLEMI	Flow Control:	Not Controlled
City:	Hobart, IN	Year Renewed:	
Location:	Alley	Tape/Media #:	
Purpose:	Maintenance Related	Dia/Height:	8"
Use:	Sanitary	Material:	VCP
Drain Area:	NA	Lining:	Cured in Place
Category:	NA		
Comment:	blk rocks stuck in wheels at 72'.		
Location Details:		Direction of Survey:	Upstream
US MH:	M-706-043	DS MH:	M-706-044
		Total Length Surveyed (ft):	74.0

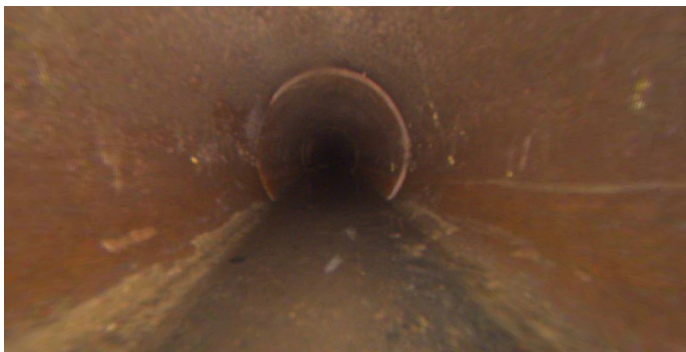
Code: **AMH**
Description: **Manhole**

Distance (ft): **.0**
Structural Grade: **0**
O&M Grade: **0**
Clock Start/From:
Clock To:
1st Value:
2nd Value:
Value Percent:
Continuous Index:
Within 8" of Joint: **NO**
Remarks: **M-706-044**

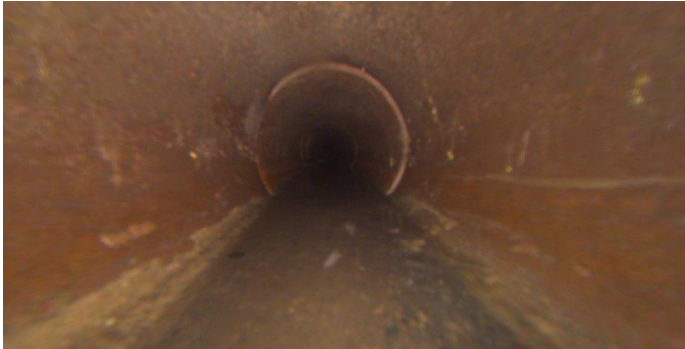
Code:	MWL
Description:	Water Level

Distance (ft):	.0
Structural Grade:	0
O&M Grade:	0
Clock Start/From:	
Clock To:	
1st Value:	
2nd Value:	
Value Percent:	5.000
Continuous Index:	
Within 8" of Joint:	NO
Remarks:

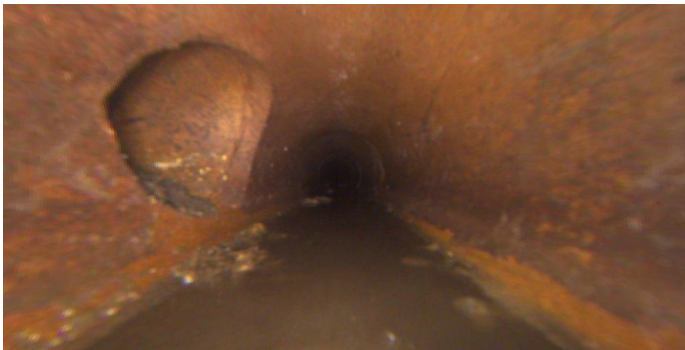
Code:	TF
Description:	Tap Factory

Distance (ft):	4.4
Structural Grade:	0
O&M Grade:	0
Clock Start/From:	9
Clock To:	
1st Value:	6.000
2nd Value:	
Value Percent:	
Continuous Index:	
Within 8" of Joint:	
Remarks:

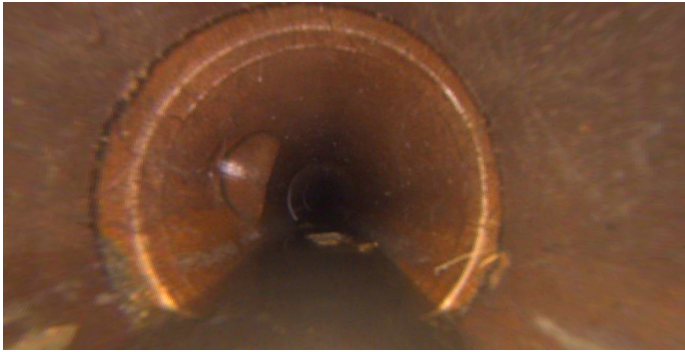
Code: **RFB**
Description: **Roots Fine Barrel**

Distance (ft): **32.5**
Structural Grade: **0**
O&M Grade: **2**
Clock Start/From: **4**
Clock To:
1st Value:
2nd Value:
Value Percent:
Continuous Index:
Within 8" of Joint: **NO**
Remarks:

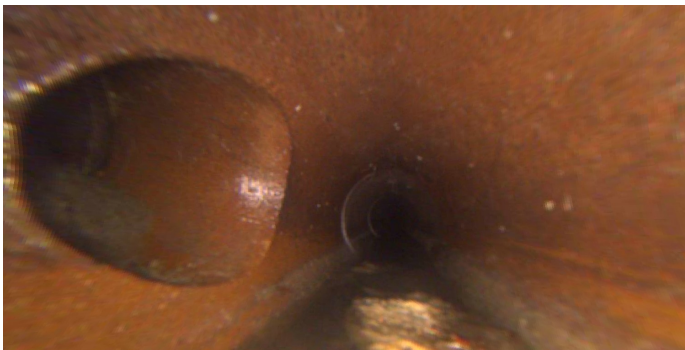
Code: **TFD**
Description: **Tap Factory Defective**

Distance (ft): **33.3**
Structural Grade: **0**
O&M Grade: **2**
Clock Start/From: **9**
Clock To:
1st Value: **6.000**
2nd Value:
Value Percent:
Continuous Index:
Within 8" of Joint:
Remarks: **DSZ 10% in wye**

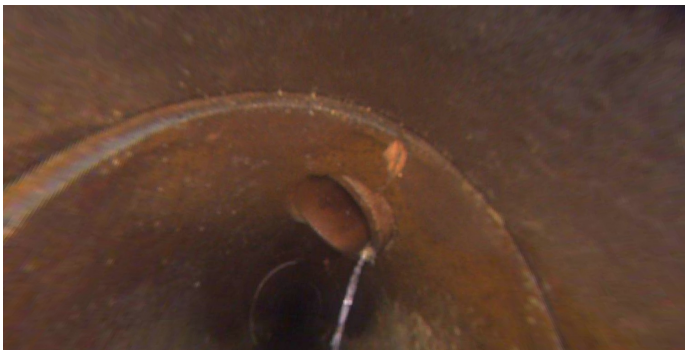
Code: **CL**
Description: **Crack Longitudinal**

Distance (ft): **49.2**
Structural Grade: **2**
O&M Grade: **0**
Clock Start/From: **1**
Clock To:
1st Value:
2nd Value:
Value Percent:
Continuous Index:
Within 8" of Joint: **YES**
Remarks:

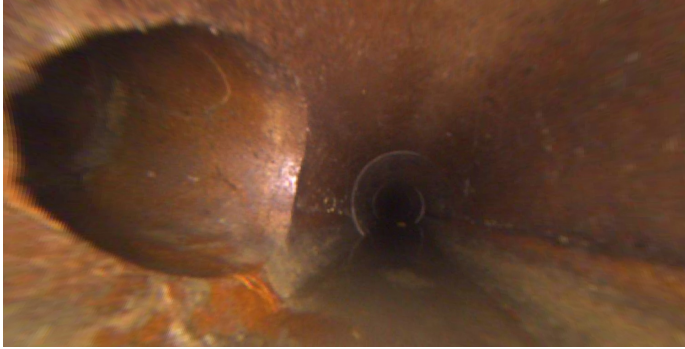
Code: **TF**
Description: **Tap Factory**

Distance (ft): **72.5**
Structural Grade: **0**
O&M Grade: **0**
Clock Start/From: **9**
Clock To:
1st Value: **6.000**
2nd Value:
Value Percent:
Continuous Index:
Within 8" of Joint:
Remarks:

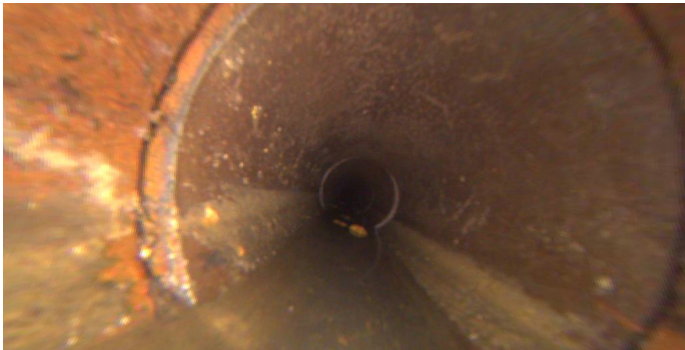
Code: **MSA**
Description: **Abandoned Survey**

Distance (ft): **74.0**
Structural Grade: **0**
O&M Grade: **0**
Clock Start/From:
Clock To:
1st Value:
2nd Value:
Value Percent:
Continuous Index:
Within 8" of Joint: **NO**
Remarks: **debris**
