Profile/Photo Observation Report

Date:	04/19/2018	Weather:		Coding:	PACP 6.0
Pipe Length (ft):	191.6	Owner:	NA	Pre Clean:	Not Known
P.O.#:		Surveyor:	Jen Costello	PSR:	P-706-045-044
Customer:		Clean Date:	01/01/1900	Shape:	C

Street:	ALLEY BETWEEN WATER ST & FLEMI	Flow Control:	Not Controlled
City:	Hobart, IN	Year Renewed:	
Location:	Alley	Tape/Media #:	
Purpose:	Maintenance Related	Dia/Height:	8"
Use:	Sanitary	Material:	VCP
Drain Area:	NA	Lining:	Cured in Place
Category:	NA		
Comment:	Reverse setup. heavy silt at 10'.		
Location Details:		Direction of Survey:	Downstream
US MH:	M-706-044	DS MH:	M-706-045
		Total Length Surveyed (ft):	11.1

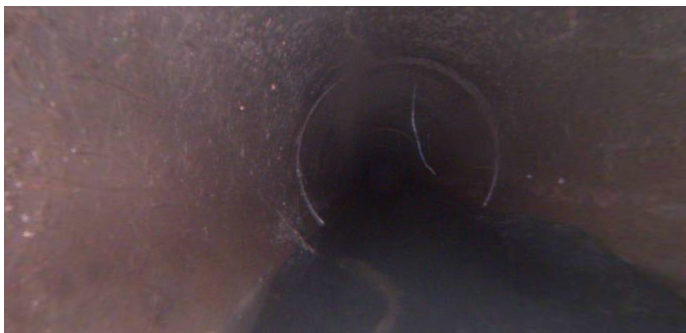
Code: **AMH**
Description: **Manhole**

Distance (ft): **.0**
Structural Grade: **0**
O&M Grade: **0**
Clock Start/From:
Clock To:
1st Value:
2nd Value:
Value Percent:
Continuous Index:
Within 8" of Joint: **NO**
Remarks: **M-706-044**

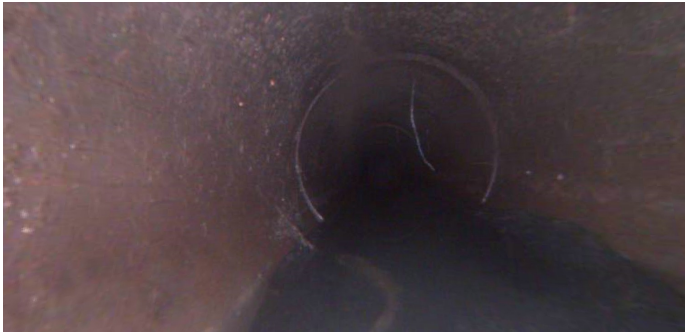
Code:	MWL
Description:	Water Level

Distance (ft):	.0
Structural Grade:	0
O&M Grade:	0
Clock Start/From:	
Clock To:	
1st Value:	
2nd Value:	
Value Percent:	10.000
Continuous Index:	
Within 8" of Joint:	NO
Remarks:

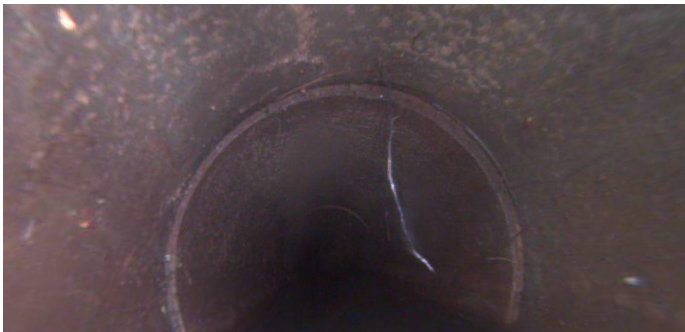
Code:	RFJ
Description:	Roots Fine Joint

Distance (ft):	.8
Structural Grade:	0
O&M Grade:	1
Clock Start/From:	8
Clock To:	4
1st Value:	
2nd Value:	
Value Percent:	
Continuous Index:	
Within 8" of Joint:	YES
Remarks:

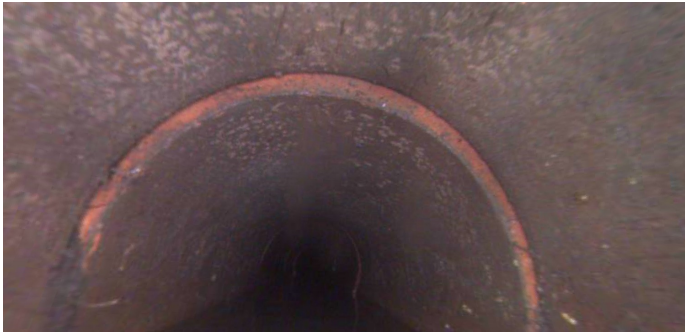
Code: **RFJ**
Description: **Roots Fine Joint**

Distance (ft): **5.6**
Structural Grade: **0**
O&M Grade: **1**
Clock Start/From: **8**
Clock To: **4**
1st Value:
2nd Value:
Value Percent:
Continuous Index: **S01**
Within 8" of Joint: **YES**
Remarks:

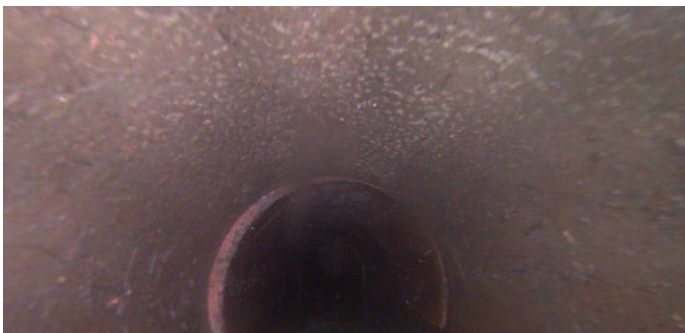
Code: **RFJ**
Description: **Roots Fine Joint**

Distance (ft): **11.1**
Structural Grade: **0**
O&M Grade: **1**
Clock Start/From: **8**
Clock To: **4**
1st Value:
2nd Value:
Value Percent:
Continuous Index: **F01**
Within 8" of Joint: **YES**
Remarks:

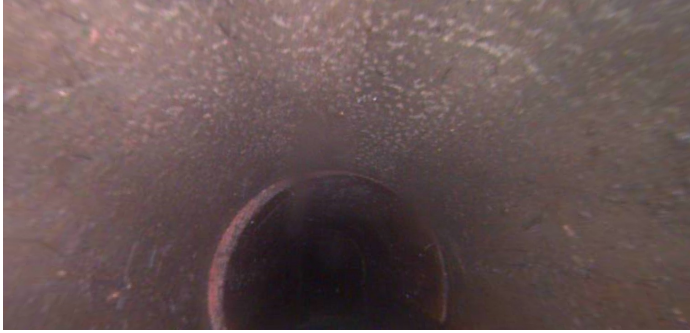
Code:	MSA
Description:	Abandoned Survey
Distance (ft):	11.1
Structural Grade:	0
O&M Grade:	0
Clock Start/From:	
Clock To:	
1st Value:	
2nd Value:	
Value Percent:	
Continuous Index:	
Within 8" of Joint:	NO
Remarks:	debris under water
