Profile/Photo Observation Report

Date:	04/19/2018	Weather:		Coding:	PACP 6.0
Pipe Length (ft):	191.6	Owner:	NA	Pre Clean:	Not Known
P.O.#:		Surveyor:	Jen Costello	PSR:	P-706-045-044
Customer:		Clean Date:	01/01/1900	Shape:	C

Street:	Capitol	Flow Control:	Not Controlled
City:	Hobart, IN	Year Renewed:	
Location:	Alley	Tape/Media #:	
Purpose:	Maintenance Related	Dia/Height:	8"
Use:	Sanitary	Material:	VCP
Drain Area:	NA	Lining:	Cured in Place
Category:	NA		
Comment:	Reverse setup. heavy silt at 10'.		
Location Details:		Direction of Survey:	Downstream
US MH:	M-706-044	DS MH:	M-706-045
		Total Length Surveyed (ft):	11.1

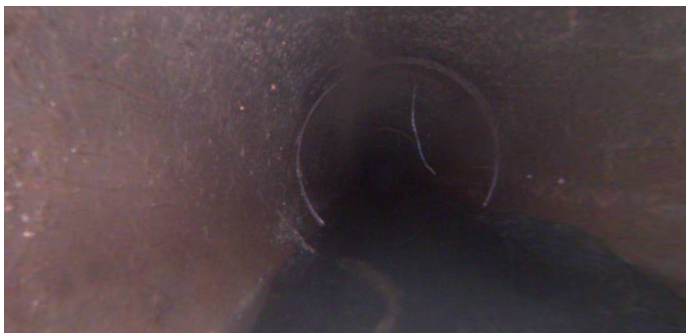
Code: **AMH**
Description: **Manhole**

Distance (ft): **.0**
Structural Grade: **0**
O&M Grade: **0**
Clock Start/From:
Clock To:
1st Value:
2nd Value:
Value Percent:
Continuous Index:
Within 8" of Joint: **NO**
Remarks: **M-706-044**

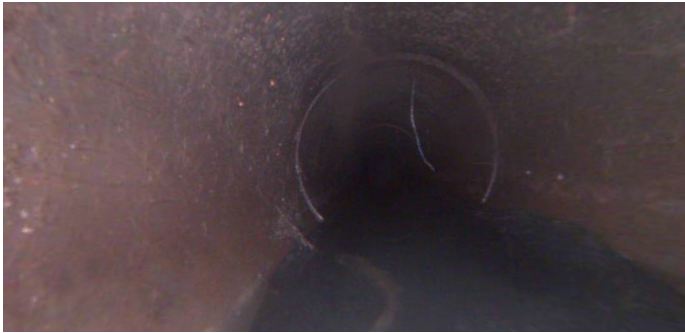
Code:	MWL
Description:	Water Level

Distance (ft):	.0
Structural Grade:	0
O&M Grade:	0
Clock Start/From:	
Clock To:	
1st Value:	
2nd Value:	
Value Percent:	10.000
Continuous Index:	
Within 8" of Joint:	NO
Remarks:

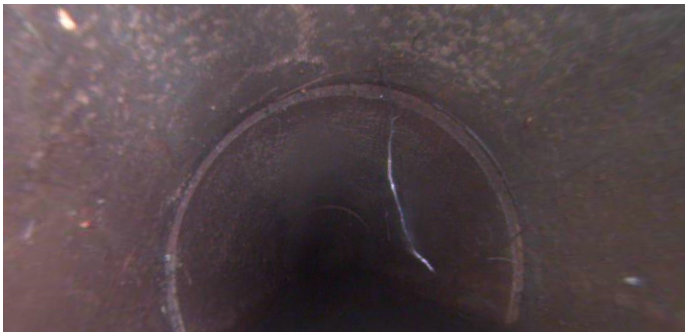
Code:	RFJ
Description:	Roots Fine Joint

Distance (ft):	.8
Structural Grade:	0
O&M Grade:	1
Clock Start/From:	8
Clock To:	4
1st Value:	
2nd Value:	
Value Percent:	
Continuous Index:	
Within 8" of Joint:	YES
Remarks:

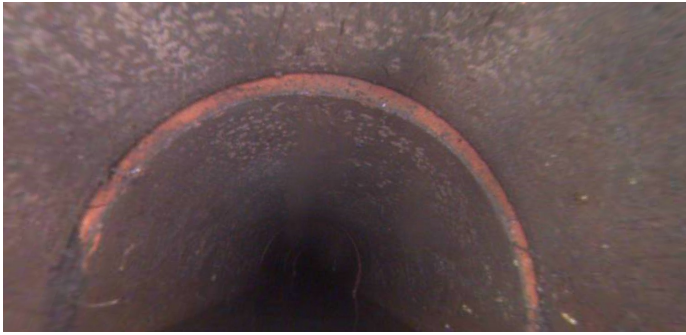
Code: **RFJ**
Description: **Roots Fine Joint**

Distance (ft): **5.6**
Structural Grade: **0**
O&M Grade: **1**
Clock Start/From: **8**
Clock To: **4**
1st Value:
2nd Value:
Value Percent:
Continuous Index: **S01**
Within 8" of Joint: **YES**
Remarks:

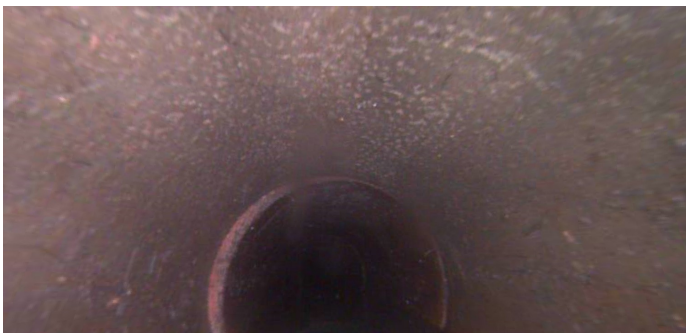
Code: **RFJ**
Description: **Roots Fine Joint**

Distance (ft): **11.1**
Structural Grade: **0**
O&M Grade: **1**
Clock Start/From: **8**
Clock To: **4**
1st Value:
2nd Value:
Value Percent:
Continuous Index: **F01**
Within 8" of Joint: **YES**
Remarks:

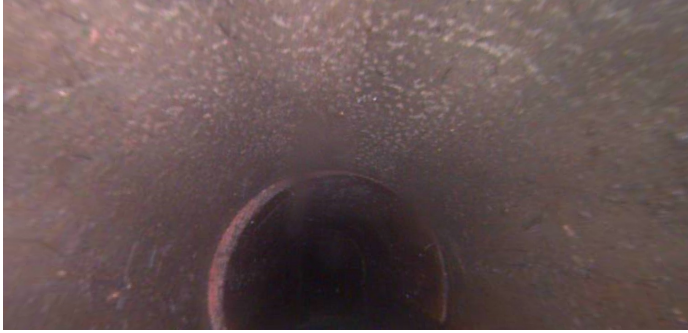
Code:	MSA
Description:	Abandoned Survey
Distance (ft):	11.1
Structural Grade:	0
O&M Grade:	0
Clock Start/From:	
Clock To:	
1st Value:	
2nd Value:	
Value Percent:	
Continuous Index:	
Within 8" of Joint:	NO
Remarks:	debris under water
