Profile/Photo Observation Report

Date:	04/14/2018	Weather:		Coding:	PACP 6.0
Pipe Length (ft):		Owner:	City of Hobart	Pre Clean:	Not Known
P.O.#:	248	Surveyor:	B. Helbling	PSR:	P-706-020-048
Customer:	City of Hobart	Clean Date:		Shape:	C

Street:	Main Street	Flow Control:	Not Controlled
City:	Hobart, IN	Year Renewed:	
Location:	Light Highway	Tape/Media #:	DEP248
Purpose:	Routine Assessment	Dia/Height:	15"
Use:	Sanitary	Material:	VCP
Drain Area:		Lining:	
Category:	NA		
Comment:	YES501824 Submittal 2		
Location Details:		Direction of Survey:	Upstream
US MH:	M-706-048	DS MH:	M-706-020
		Total Length Surveyed (ft):	20.7

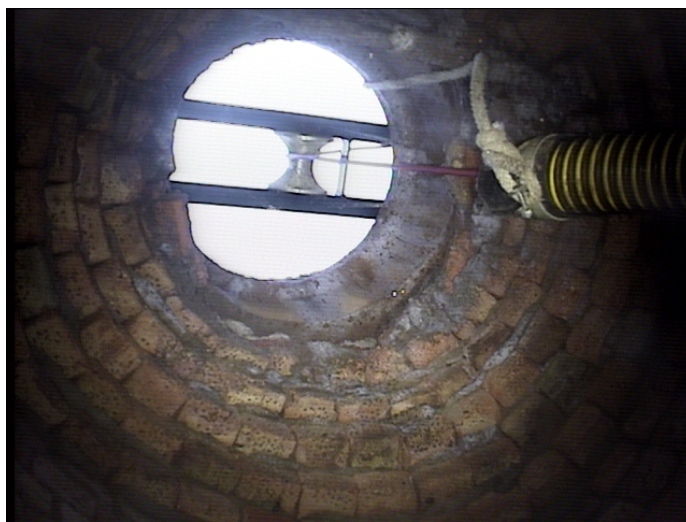
Code: **AMH**
 Description: **Manhole**

Distance (ft): **.0**
 Structural Grade: **0**
 O&M Grade: **0**
 Clock Start/From:
 Clock To:
 1st Value:
 2nd Value:
 Value Percent:
 Continuous Index:
 Within 8" of Joint: **NO**
 Remarks: **M-706-048**

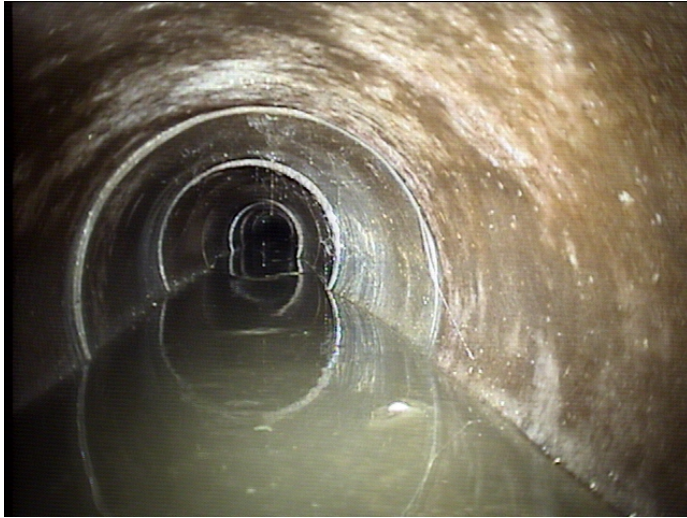
Code: **MWL**
Description: **Water Level**

Distance (ft): **.0**
Structural Grade: **0**
O&M Grade: **0**
Clock Start/From:
Clock To:
1st Value:
2nd Value:
Value Percent: **20.000**
Continuous Index:
Within 8" of Joint: **NO**
Remarks:

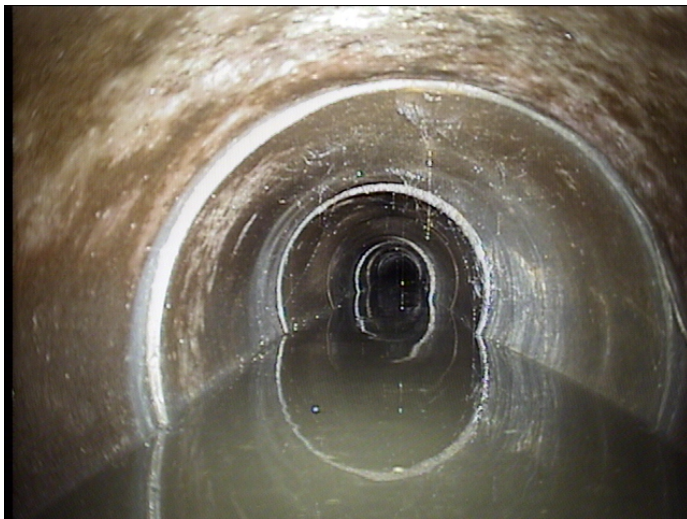
Code: **DSF**
Description: **Deposits Settled Fine**

Distance (ft): **.1**
Structural Grade: **0**
O&M Grade: **3**
Clock Start/From: **4**
Clock To: **8**
1st Value:
2nd Value:
Value Percent: **15.000**
Continuous Index: **S01**
Within 8" of Joint: **NO**
Remarks:

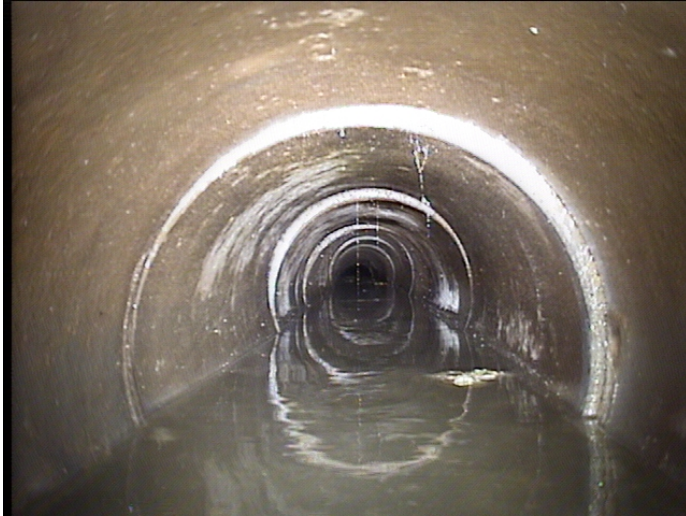
Code: **DSF**
Description: **Deposits Settled Fine**

Distance (ft): **20.7**
Structural Grade: **0**
O&M Grade: **3**
Clock Start/From: **4**
Clock To: **8**
1st Value:
2nd Value:
Value Percent: **15.000**
Continuous Index: **F01**
Within 8" of Joint: **NO**
Remarks:

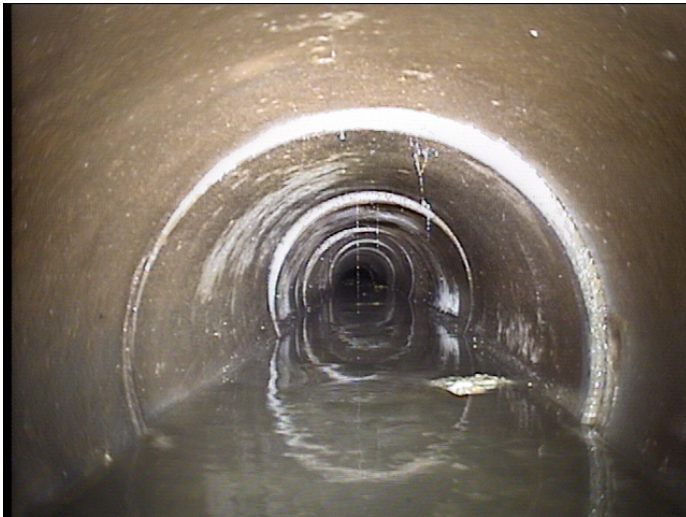
Code: **MSA**
Description: **Abandoned Survey**

Distance (ft): **20.7**
Structural Grade: **0**
O&M Grade: **0**
Clock Start/From:
Clock To:
1st Value:
2nd Value:
Value Percent:
Continuous Index:
Within 8" of Joint: **NO**
Remarks: **Heavy sediment**
