## Profile/Photo Observation Report

Date:	<b>04/18/2018</b>	Weather:		Coding:	<b>PACP 6.0</b>
Pipe Length (ft):	<b>235.2</b>	Owner:	<b>NA</b>	Pre Clean:	<b>Not Known</b>
P.O.#:		Surveyor:	<b>Byrd Fitzgerald</b>	PSR:	<b>P-706-049-018</b>
Customer:		Clean Date:	<b>01/01/1900</b>	Shape:	<b>C</b>

Street:	<b>GARFIELD ST &amp; MAIN ST</b>	Flow Control:	<b>Not Controlled</b>
City:	<b>Hobart, IN</b>	Year Renewed:	
Location:	<b>Light Highway</b>	Tape/Media #:	
Purpose:	<b>Maintenance Related</b>	Dia/Height:	<b>8"</b>
Use:	<b>Sanitary</b>	Material:	<b>VCP</b>
Drain Area:	<b>NA</b>	Lining:	<b>Cured in Place</b>
Category:	<b>NA</b>		
Comment:	<b>Reverse setup. roots at 26'.</b>		
Location Details:		Direction of Survey:	<b>Downstream</b>
US MH:	<b>M-706-049</b>	DS MH:	<b>M-706-018</b>
		Total Length Surveyed (ft):	<b>27.4</b>

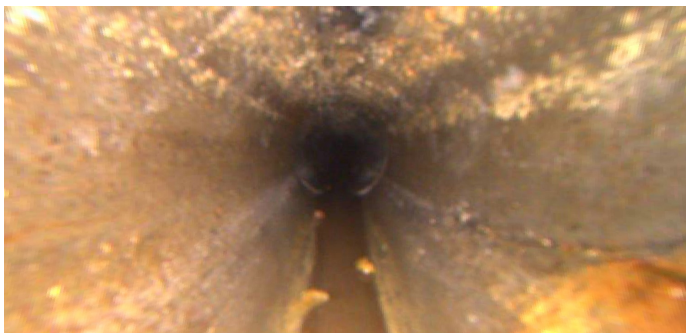
Code: **AMH**  
Description: **Manhole**

Distance (ft): **.0**  
Structural Grade: **0**  
O&M Grade: **0**  
Clock Start/From:  
Clock To:  
1st Value:  
2nd Value:  
Value Percent:  
Continuous Index:  
Within 8" of Joint: **NO**  
Remarks: **M-706-049**

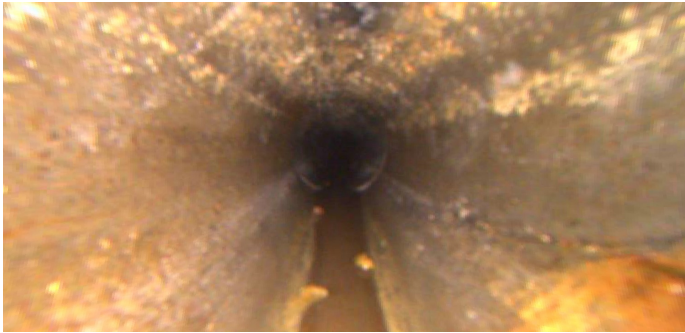
Code:	<b>MWL</b>
Description:	<b>Water Level</b>

Distance (ft):	<b>.0</b>
Structural Grade:	<b>0</b>
O&M Grade:	<b>0</b>
Clock Start/From:	
Clock To:	
1st Value:	
2nd Value:	
Value Percent:	<b>5.000</b>
Continuous Index:	
Within 8" of Joint:	<b>NO</b>
Remarks:

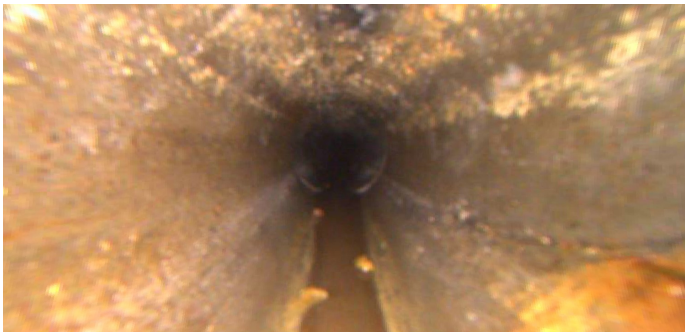
Code:	<b>DAGS</b>
Description:	<b>Deposits Attached Grease</b>

Distance (ft):	<b>.0</b>
Structural Grade:	<b>0</b>
O&M Grade:	<b>2</b>
Clock Start/From:	<b>11</b>
Clock To:	<b>1</b>
1st Value:	
2nd Value:	
Value Percent:	<b>5.000</b>
Continuous Index:	<b>S01</b>
Within 8" of Joint:	<b>NO</b>
Remarks:

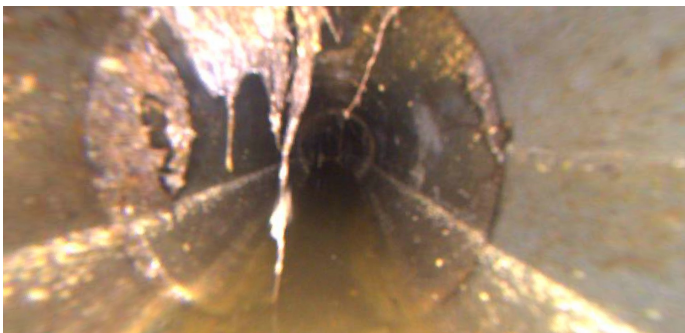
Code: **RMJ**  
Description: **Roots Medium Joint**

Distance (ft): **14.6**  
Structural Grade: **0**  
O&M Grade: **3**  
Clock Start/From: **8**  
Clock To: **4**  
1st Value:  
2nd Value:  
Value Percent: **20.000**  
Continuous Index:  
Within 8" of Joint: **YES**  
Remarks:

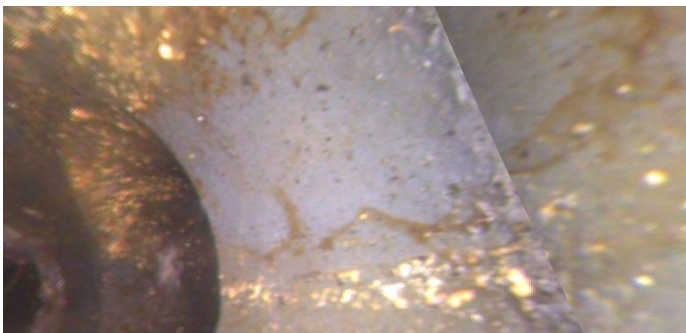
Code: **TF**  
Description: **Tap Factory**

Distance (ft): **18.6**  
Structural Grade: **0**  
O&M Grade: **0**  
Clock Start/From: **10**  
Clock To:  
1st Value: **4.000**  
2nd Value:  
Value Percent:  
Continuous Index:  
Within 8" of Joint: **YES**  
Remarks:

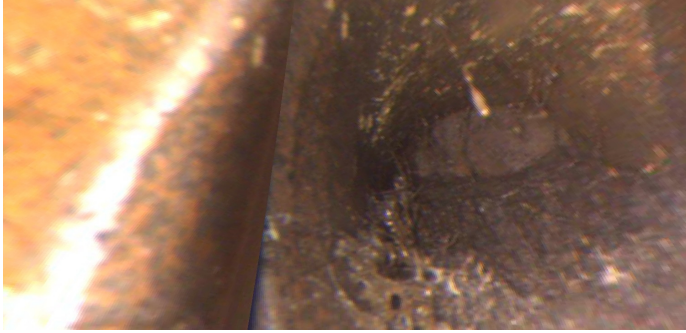
Code: **TFC**  
Description: **Tap Factory Capped**

Distance (ft): **20.3**  
Structural Grade: **0**  
O&M Grade: **0**  
Clock Start/From: **2**  
Clock To:  
1st Value: **4.000**  
2nd Value:  
Value Percent:  
Continuous Index:  
Within 8" of Joint: **YES**  
Remarks:

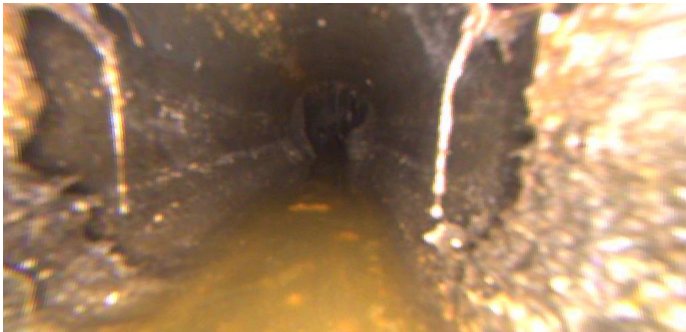
Code: **RMJ**  
Description: **Roots Medium Joint**

Distance (ft): **21.1**  
Structural Grade: **0**  
O&M Grade: **3**  
Clock Start/From: **7**  
Clock To: **5**  
1st Value:  
2nd Value:  
Value Percent: **10.000**  
Continuous Index: **S03**  
Within 8" of Joint: **YES**  
Remarks:

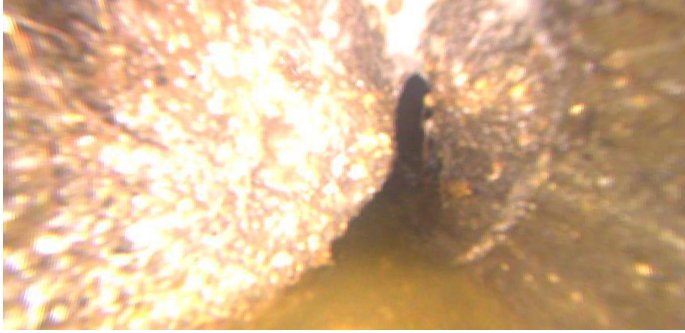
Code: **RBJ**  
Description: **Roots Ball Joint**

Distance (ft): **26.9**  
Structural Grade: **0**  
O&M Grade: **4**  
Clock Start/From: **7**  
Clock To: **5**  
1st Value:  
2nd Value:  
Value Percent: **55.000**  
Continuous Index:  
Within 8" of Joint: **YES**  
Remarks:
