Profile/Photo Observation Report

Date:	04/18/2018	Weather:		Coding:	PACP 6.0
Pipe Length (ft):	235.2	Owner:	NA	Pre Clean:	Not Known
P.O.#:		Surveyor:	Byrd Fitzgerald	PSR:	P-706-049-018
Customer:		Clean Date:	01/01/1900	Shape:	C

Street:	Capitol	Flow Control:	Not Controlled
City:	Hobart, IN	Year Renewed:	
Location:	Light Highway	Tape/Media #:	
Purpose:	Maintenance Related	Dia/Height:	8"
Use:	Sanitary	Material:	VCP
Drain Area:	NA	Lining:	Cured in Place
Category:	NA		
Comment:	Reverse setup. roots at 26'.		
Location Details:		Direction of Survey:	Downstream
US MH:	M-706-049	DS MH:	M-706-018
		Total Length Surveyed (ft):	27.4

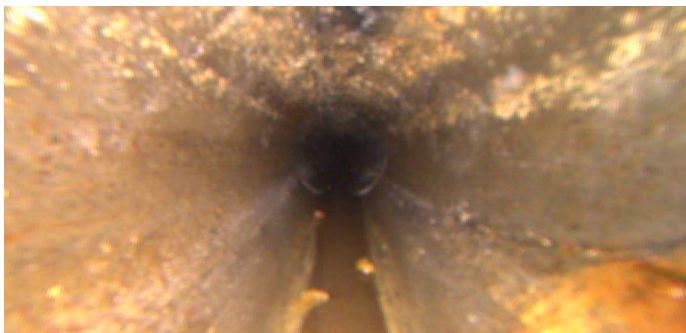
Code: **AMH**
Description: **Manhole**

Distance (ft): **.0**
Structural Grade: **0**
O&M Grade: **0**
Clock Start/From:
Clock To:
1st Value:
2nd Value:
Value Percent:
Continuous Index:
Within 8" of Joint: **NO**
Remarks: **M-706-049**

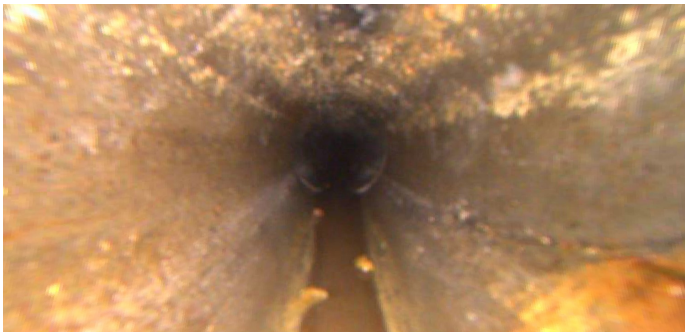
Code:	DAGS
Description:	Deposits Attached Grease

Distance (ft):	.0
Structural Grade:	0
O&M Grade:	2
Clock Start/From:	11
Clock To:	1
1st Value:	
2nd Value:	
Value Percent:	5.000
Continuous Index:	S01
Within 8" of Joint:	NO
Remarks:

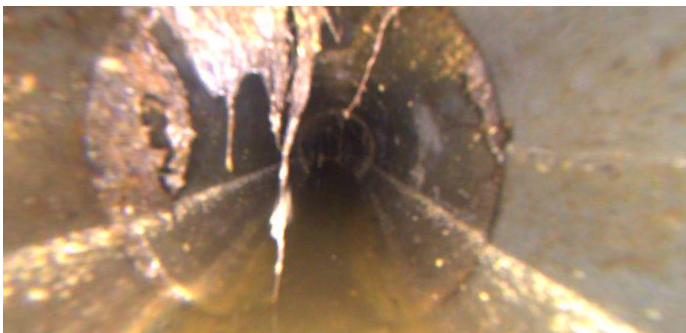
Code: **RMJ**
Description: **Roots Medium Joint**

Distance (ft): **14.6**
Structural Grade: **0**
O&M Grade: **3**
Clock Start/From: **8**
Clock To: **4**
1st Value:
2nd Value:
Value Percent: **20.000**
Continuous Index:
Within 8" of Joint: **YES**
Remarks:

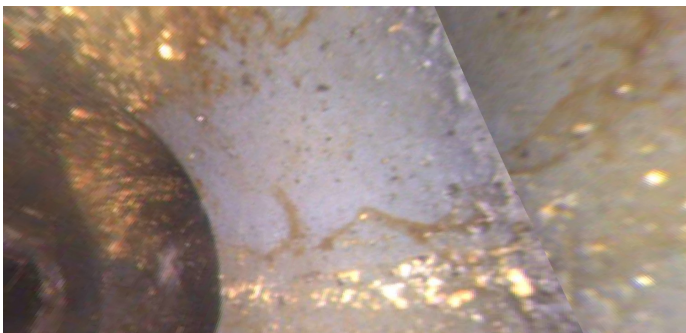
Code: **TF**
Description: **Tap Factory**

Distance (ft): **18.6**
Structural Grade: **0**
O&M Grade: **0**
Clock Start/From: **10**
Clock To:
1st Value: **4.000**
2nd Value:
Value Percent:
Continuous Index:
Within 8" of Joint: **YES**
Remarks:

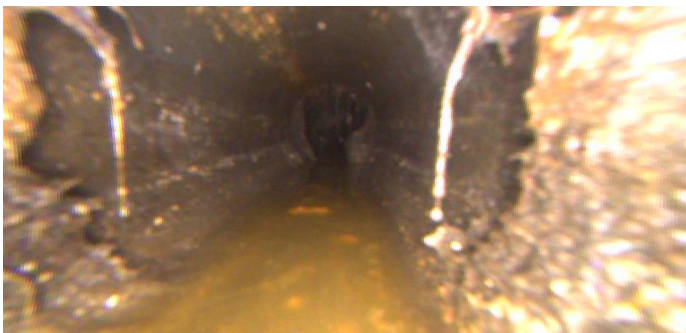
Code: **RMJ**
Description: **Roots Medium Joint**

Distance (ft): **21.1**
Structural Grade: **0**
O&M Grade: **3**
Clock Start/From: **7**
Clock To: **5**
1st Value:
2nd Value:
Value Percent: **10.000**
Continuous Index: **S03**
Within 8" of Joint: **YES**
Remarks:

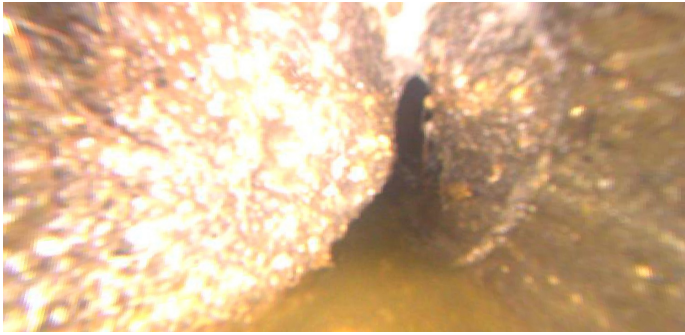
Code: **RBJ**
Description: **Roots Ball Joint**

Distance (ft): **26.9**
Structural Grade: **0**
O&M Grade: **4**
Clock Start/From: **7**
Clock To: **5**
1st Value:
2nd Value:
Value Percent: **55.000**
Continuous Index:
Within 8" of Joint: **YES**
Remarks:
