Profile/Photo Observation Report

Street:	FLEMING ST & BEACON DR	Flow Control:	Not Controlled
City:	Hobart, IN	Year Renewed:	
Location:	Light Highway	Tape/Media #:	
Purpose:	Maintenance Related	Dia/Height:	8"
Use:	Sanitary	Material:	PVC
Drain Area:	NA	Lining:	Cured in Place
Category:	NA		
Comment:	mh confirmed at 204'. heavy debris in U/S chamber.		
Location Details:		Direction of Survey:	Upstream
US MH:	M-706-051	DS MH:	M-706-055
		Total Length Surveyed (ft):	205.7

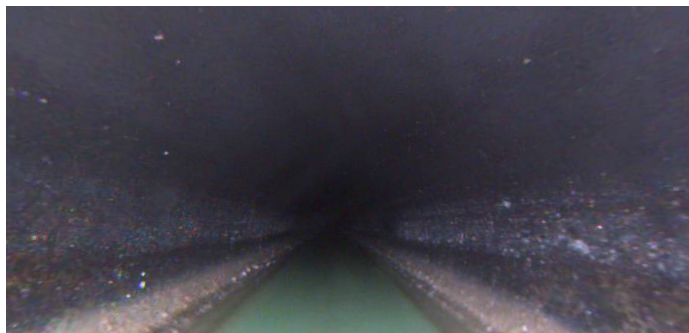
Code: **AMH**
Description: **Manhole**

Distance (ft): **.0**
Structural Grade: **0**
O&M Grade: **0**
Clock Start/From:
Clock To:
1st Value:
2nd Value:
Value Percent:
Continuous Index:
Within 8" of Joint: **NO**
Remarks: **M-706-055**

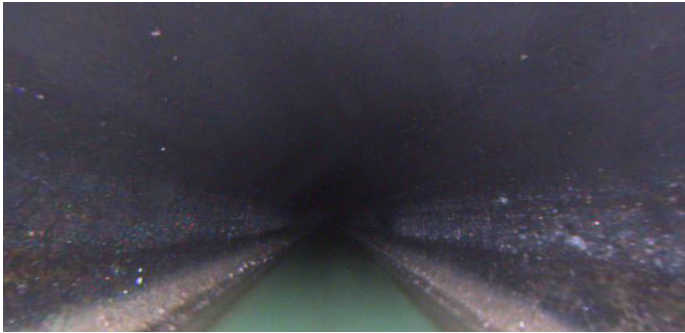
Code:	MWL
Description:	Water Level

Distance (ft):	.0
Structural Grade:	0
O&M Grade:	0
Clock Start/From:	
Clock To:	
1st Value:	
2nd Value:	
Value Percent:	10.000
Continuous Index:	
Within 8" of Joint:	NO
Remarks:

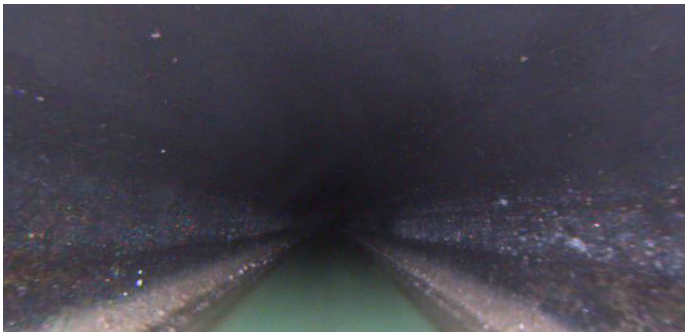
Code:	DAGS
Description:	Deposits Attached Grease

Distance (ft):	.0
Structural Grade:	0
O&M Grade:	2
Clock Start/From:	8
Clock To:	4
1st Value:	
2nd Value:	
Value Percent:	5.000
Continuous Index:	S01
Within 8" of Joint:	NO
Remarks:

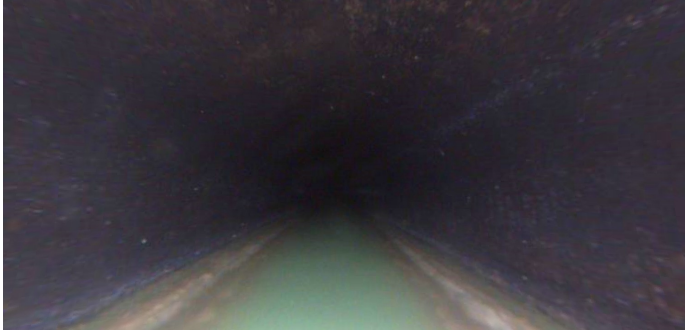
Code: **DAGS**
Description: **Deposits Attached Grease**

Distance (ft): **12.8**
Structural Grade: **0**
O&M Grade: **2**
Clock Start/From: **8**
Clock To: **4**
1st Value:
2nd Value:
Value Percent: **5.000**
Continuous Index: **F01**
Within 8" of Joint: **NO**
Remarks:

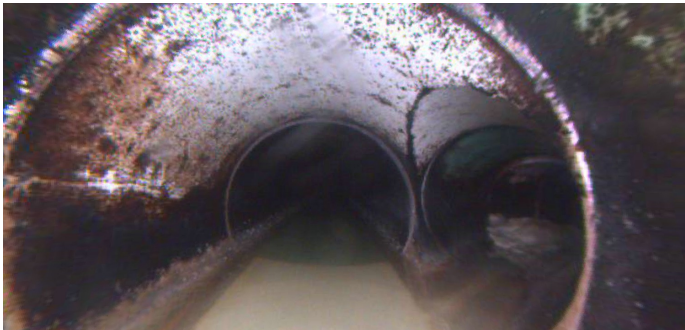
Code: **TFA**
Description: **Tap Factory Active**

Distance (ft): **55.9**
Structural Grade: **0**
O&M Grade: **0**
Clock Start/From: **3**
Clock To:
1st Value: **4.000**
2nd Value:
Value Percent:
Continuous Index:
Within 8" of Joint:
Remarks:

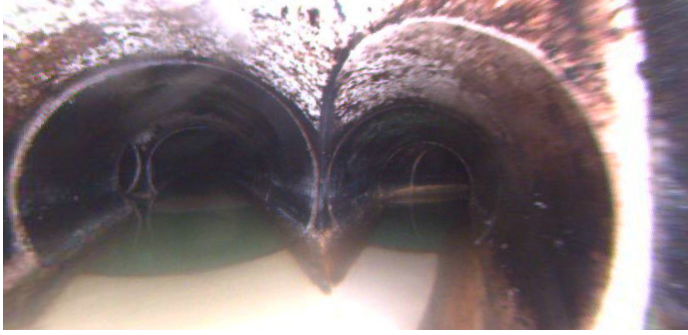
Code: **TFA**
Description: **Tap Factory Active**

Distance (ft): **67.9**
Structural Grade: **0**
O&M Grade: **0**
Clock Start/From: **3**
Clock To:
1st Value: **4.000**
2nd Value:
Value Percent:
Continuous Index:
Within 8" of Joint:
Remarks:

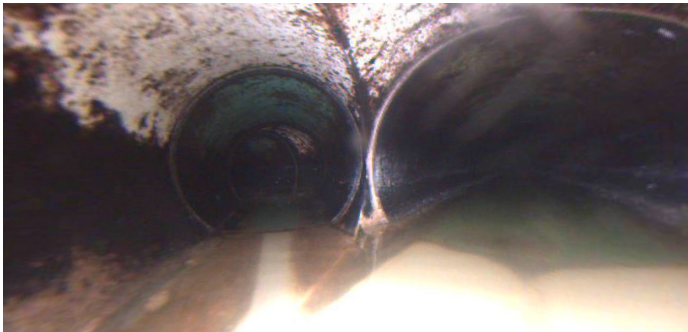
Code: **TFA**
Description: **Tap Factory Active**

Distance (ft): **69.5**
Structural Grade: **0**
O&M Grade: **0**
Clock Start/From: **9**
Clock To:
1st Value: **4.000**
2nd Value:
Value Percent:
Continuous Index:
Within 8" of Joint:
Remarks:

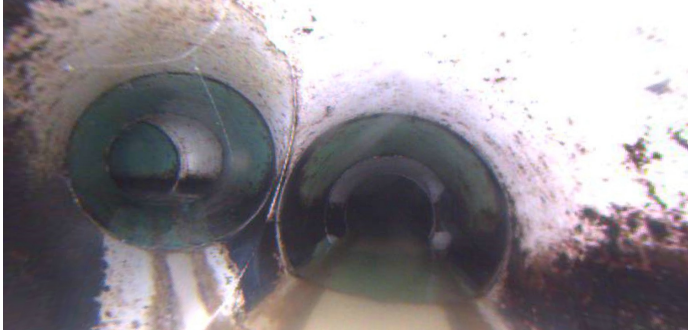
Code: **TFA**
Description: **Tap Factory Active**

Distance (ft): **100.7**
Structural Grade: **0**
O&M Grade: **0**
Clock Start/From: **9**
Clock To:
1st Value: **4.000**
2nd Value:
Value Percent:
Continuous Index:
Within 8" of Joint:
Remarks:

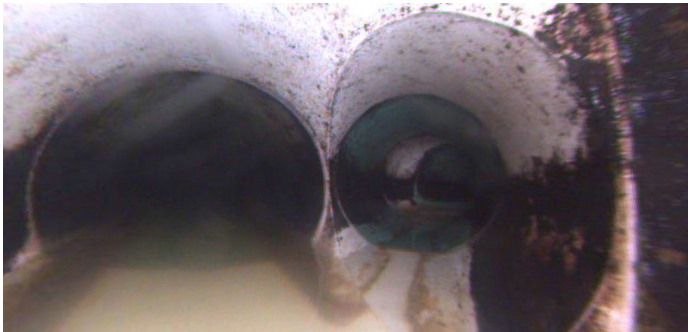
Code: **TFA**
Description: **Tap Factory Active**

Distance (ft): **102.1**
Structural Grade: **0**
O&M Grade: **0**
Clock Start/From: **3**
Clock To:
1st Value: **4.000**
2nd Value:
Value Percent:
Continuous Index:
Within 8" of Joint:
Remarks:

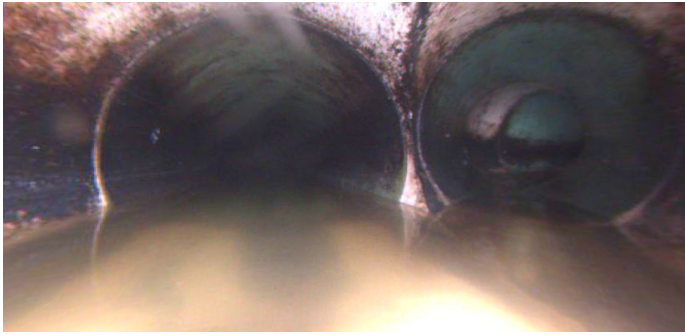
Code: **TFA**
Description: **Tap Factory Active**

Distance (ft): **106.8**
Structural Grade: **0**
O&M Grade: **0**
Clock Start/From: **3**
Clock To:
1st Value: **4.000**
2nd Value:
Value Percent:
Continuous Index:
Within 8" of Joint:
Remarks:

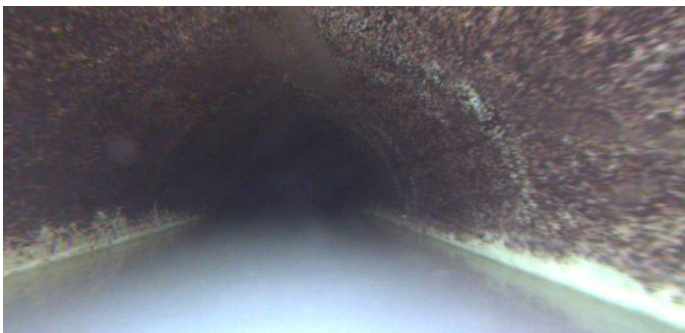
Code: **MWL**
Description: **Water Level**

Distance (ft): **134.2**
Structural Grade: **0**
O&M Grade: **0**
Clock Start/From:
Clock To:
1st Value:
2nd Value:
Value Percent: **30.000**
Continuous Index:
Within 8" of Joint: **NO**
Remarks:

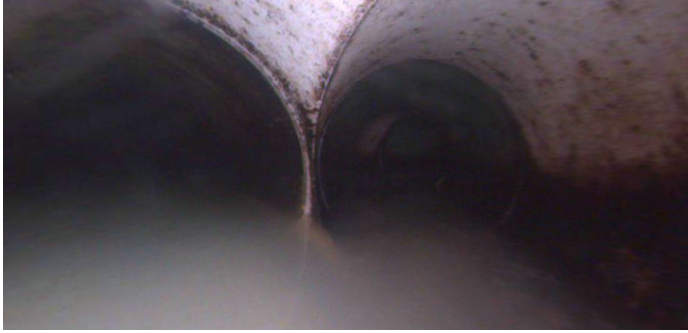
Code: **TFA**
Description: **Tap Factory Active**

Distance (ft): **140.9**
Structural Grade: **0**
O&M Grade: **0**
Clock Start/From: **3**
Clock To:
1st Value: **4.000**
2nd Value:
Value Percent:
Continuous Index:
Within 8" of Joint:
Remarks:

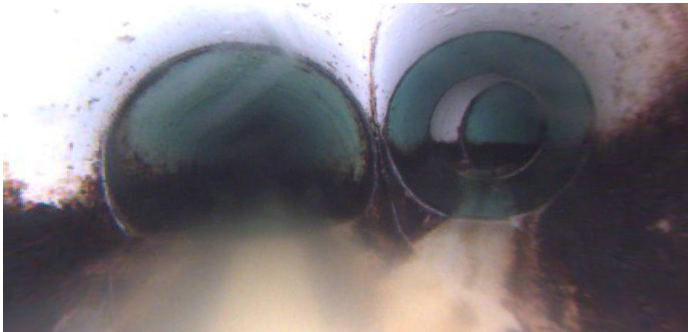
Code: **TFA**
Description: **Tap Factory Active**

Distance (ft): **146.3**
Structural Grade: **0**
O&M Grade: **0**
Clock Start/From: **3**
Clock To:
1st Value: **4.000**
2nd Value:
Value Percent:
Continuous Index:
Within 8" of Joint:
Remarks:

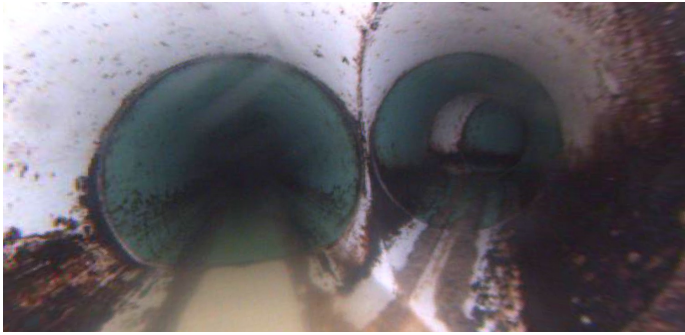
Code: **TFA**
Description: **Tap Factory Active**

Distance (ft): **177.8**
Structural Grade: **0**
O&M Grade: **0**
Clock Start/From: **3**
Clock To:
1st Value: **4.000**
2nd Value:
Value Percent:
Continuous Index:
Within 8" of Joint:
Remarks:

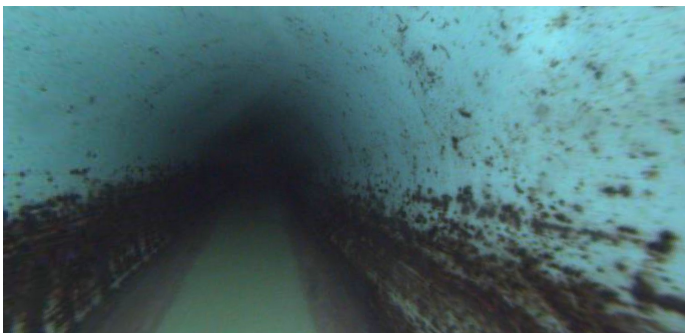
Code: **MWL**
Description: **Water Level**

Distance (ft): **182.5**
Structural Grade: **0**
O&M Grade: **0**
Clock Start/From:
Clock To:
1st Value:
2nd Value:
Value Percent: **5.000**
Continuous Index:
Within 8" of Joint: **NO**
Remarks:

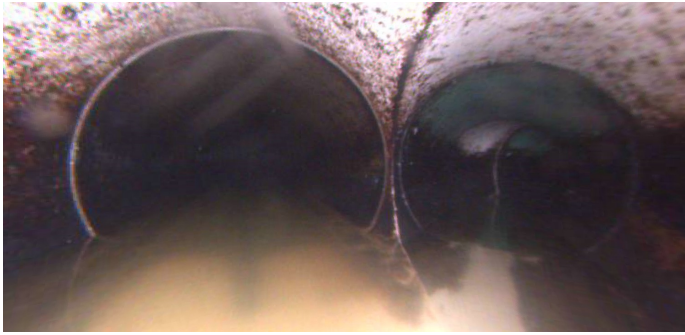
Code: **TFA**
Description: **Tap Factory Active**

Distance (ft): **188.9**
Structural Grade: **0**
O&M Grade: **0**
Clock Start/From: **3**
Clock To:
1st Value: **4.000**
2nd Value:
Value Percent:
Continuous Index:
Within 8" of Joint:
Remarks:

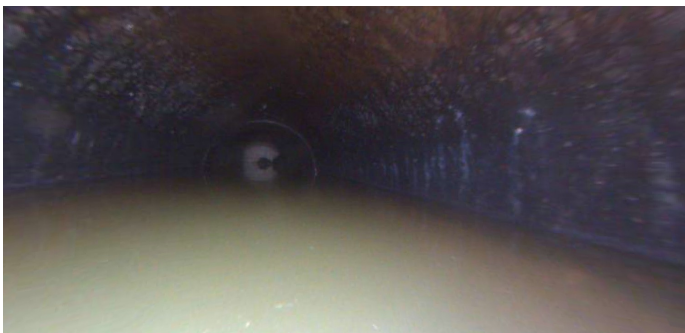
Code: **MWL**
Description: **Water Level**

Distance (ft): **200.3**
Structural Grade: **0**
O&M Grade: **0**
Clock Start/From:
Clock To:
1st Value:
2nd Value:
Value Percent: **40.000**
Continuous Index:
Within 8" of Joint: **NO**
Remarks:

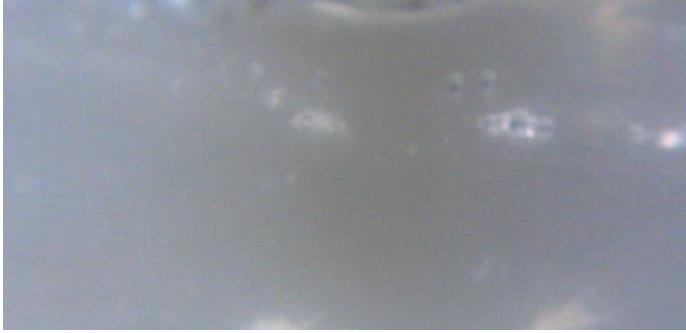
Code: **MWL**
Description: **Water Level**

Distance (ft): **204.7**
Structural Grade: **0**
O&M Grade: **0**
Clock Start/From:
Clock To:
1st Value:
2nd Value:
Value Percent: **100.000**
Continuous Index:
Within 8" of Joint: **NO**
Remarks:

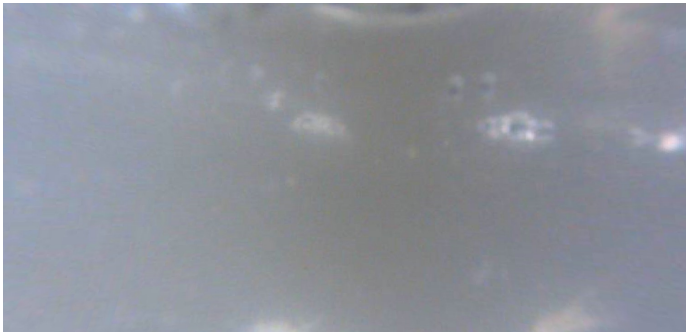
Code: **MCU**
Description: **Camera Underwater**

Distance (ft): **204.7**
Structural Grade: **0**
O&M Grade: **4**
Clock Start/From:
Clock To:
1st Value:
2nd Value:
Value Percent:
Continuous Index:
Within 8" of Joint: **NO**
Remarks:

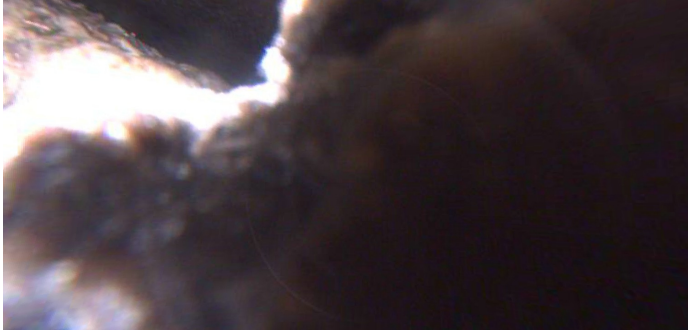
Code:	AMH
Description:	Manhole
Distance (ft):	205.7
Structural Grade:	0
O&M Grade:	0
Clock Start/From:	
Clock To:	
1st Value:	
2nd Value:	
Value Percent:	
Continuous Index:	
Within 8" of Joint:	NO
Remarks:	M-706-051
