Profile/Photo Observation Report

Date:	04/14/2018	Weather:		Coding:	PACP 6.0
Pipe Length (ft):	216.8	Owner:	NA	Pre Clean:	Not Known
P.O.#:		Surveyor:	Jen Costello	PSR:	P-706-051-055
Customer:		Clean Date:	01/01/1900	Shape:	C

Street:	Capitol	Flow Control:	Not Controlled
City:	Hobart, IN	Year Renewed:	
Location:	Light Highway	Tape/Media #:	
Purpose:	Maintenance Related	Dia/Height:	8"
Use:	Sanitary	Material:	PVC
Drain Area:	NA	Lining:	Cured in Place
Category:	NA		
Comment:	mh confirmed at 204'. heavy debris in U/S chamber.		
Location Details:		Direction of Survey:	Upstream
US MH:	M-706-051	DS MH:	M-706-055
		Total Length Surveyed (ft):	205.7

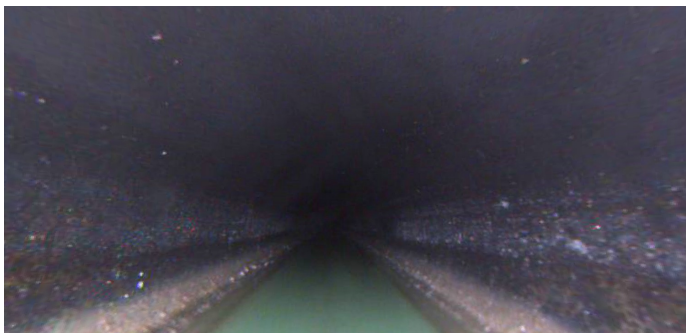
Code: **AMH**
Description: **Manhole**

Distance (ft): **.0**
Structural Grade: **0**
O&M Grade: **0**
Clock Start/From:
Clock To:
1st Value:
2nd Value:
Value Percent:
Continuous Index:
Within 8" of Joint: **NO**
Remarks: **M-706-055**

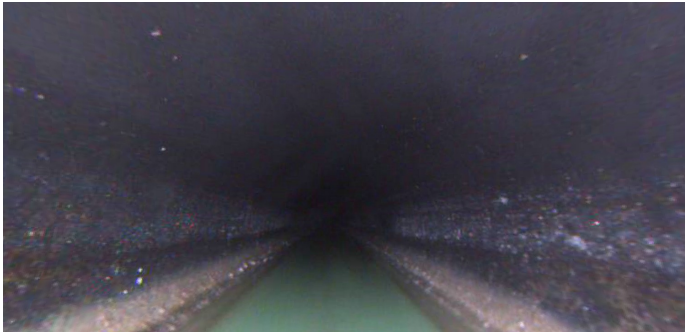
Code:	MWL
Description:	Water Level

Distance (ft):	.0
Structural Grade:	0
O&M Grade:	0
Clock Start/From:	
Clock To:	
1st Value:	
2nd Value:	
Value Percent:	10.000
Continuous Index:	
Within 8" of Joint:	NO
Remarks:

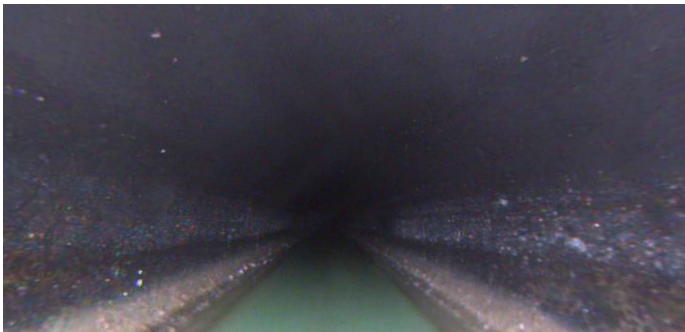
Code:	DAGS
Description:	Deposits Attached Grease

Distance (ft):	.0
Structural Grade:	0
O&M Grade:	2
Clock Start/From:	8
Clock To:	4
1st Value:	
2nd Value:	
Value Percent:	5.000
Continuous Index:	S01
Within 8" of Joint:	NO
Remarks:

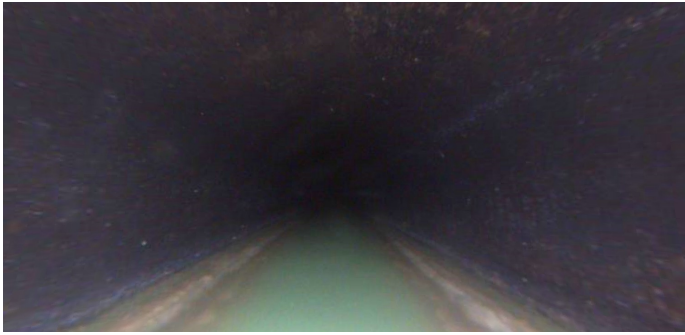
Code: **DAGS**
Description: **Deposits Attached Grease**

Distance (ft): **12.8**
Structural Grade: **0**
O&M Grade: **2**
Clock Start/From: **8**
Clock To: **4**
1st Value:
2nd Value:
Value Percent: **5.000**
Continuous Index: **F01**
Within 8" of Joint: **NO**
Remarks:

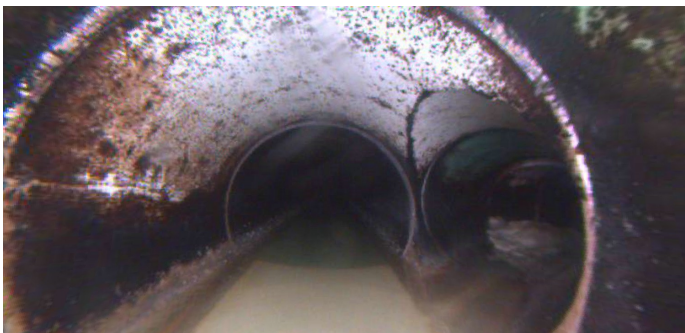
Code: **TFA**
Description: **Tap Factory Active**

Distance (ft): **55.9**
Structural Grade: **0**
O&M Grade: **0**
Clock Start/From: **3**
Clock To:
1st Value: **4.000**
2nd Value:
Value Percent:
Continuous Index:
Within 8" of Joint:
Remarks:

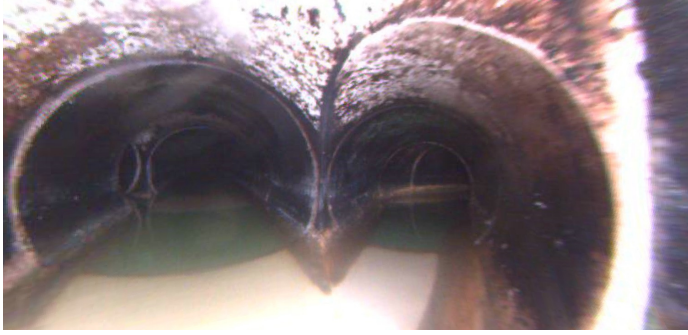
Code: **TFA**
Description: **Tap Factory Active**

Distance (ft): **67.9**
Structural Grade: **0**
O&M Grade: **0**
Clock Start/From: **3**
Clock To:
1st Value: **4.000**
2nd Value:
Value Percent:
Continuous Index:
Within 8" of Joint:
Remarks:

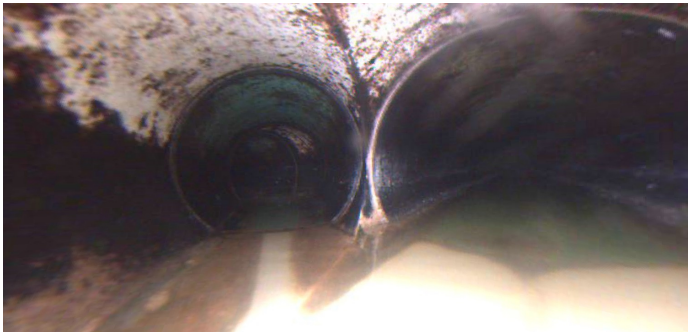
Code: **TFA**
Description: **Tap Factory Active**

Distance (ft): **69.5**
Structural Grade: **0**
O&M Grade: **0**
Clock Start/From: **9**
Clock To:
1st Value: **4.000**
2nd Value:
Value Percent:
Continuous Index:
Within 8" of Joint:
Remarks:

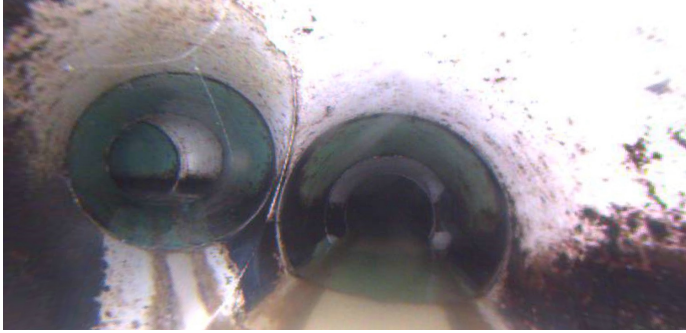
Code: **TFA**
Description: **Tap Factory Active**

Distance (ft): **100.7**
Structural Grade: **0**
O&M Grade: **0**
Clock Start/From: **9**
Clock To:
1st Value: **4.000**
2nd Value:
Value Percent:
Continuous Index:
Within 8" of Joint:
Remarks:

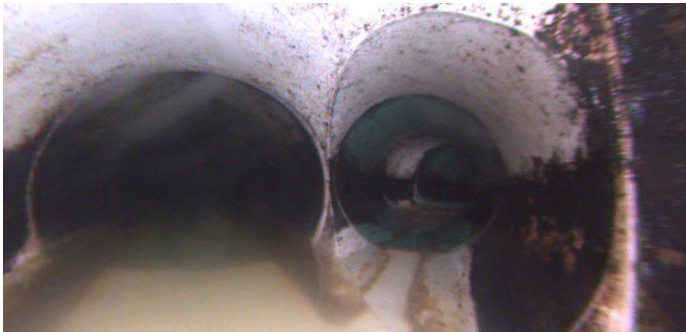
Code: **TFA**
Description: **Tap Factory Active**

Distance (ft): **102.1**
Structural Grade: **0**
O&M Grade: **0**
Clock Start/From: **3**
Clock To:
1st Value: **4.000**
2nd Value:
Value Percent:
Continuous Index:
Within 8" of Joint:
Remarks:

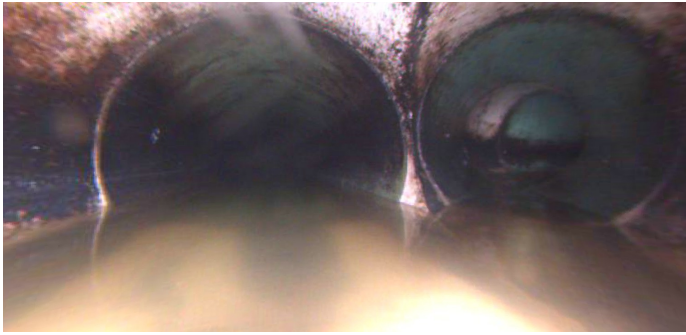
Code: **TFA**
Description: **Tap Factory Active**

Distance (ft): **106.8**
Structural Grade: **0**
O&M Grade: **0**
Clock Start/From: **3**
Clock To:
1st Value: **4.000**
2nd Value:
Value Percent:
Continuous Index:
Within 8" of Joint:
Remarks:

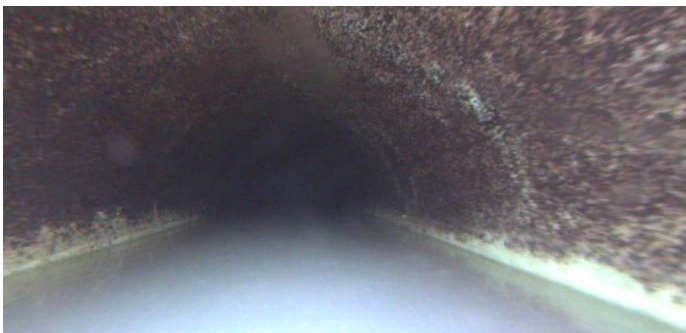
Code: **MWL**
Description: **Water Level**

Distance (ft): **134.2**
Structural Grade: **0**
O&M Grade: **0**
Clock Start/From:
Clock To:
1st Value:
2nd Value:
Value Percent: **30.000**
Continuous Index:
Within 8" of Joint: **NO**
Remarks:

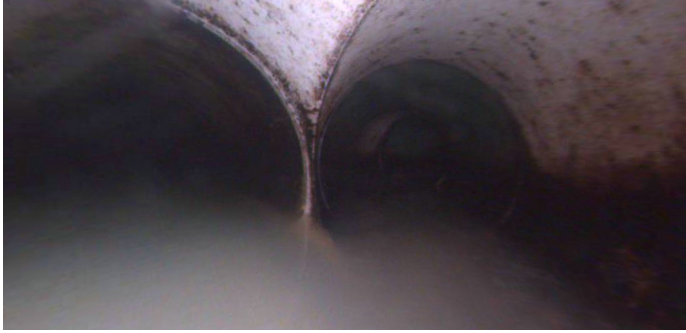
Code: **TFA**
Description: **Tap Factory Active**

Distance (ft): **140.9**
Structural Grade: **0**
O&M Grade: **0**
Clock Start/From: **3**
Clock To:
1st Value: **4.000**
2nd Value:
Value Percent:
Continuous Index:
Within 8" of Joint:
Remarks:

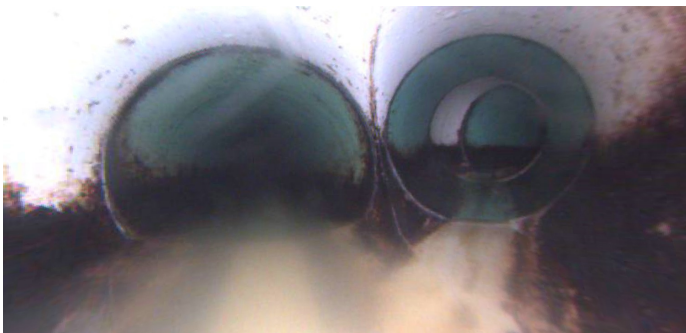
Code: **TFA**
Description: **Tap Factory Active**

Distance (ft): **146.3**
Structural Grade: **0**
O&M Grade: **0**
Clock Start/From: **3**
Clock To:
1st Value: **4.000**
2nd Value:
Value Percent:
Continuous Index:
Within 8" of Joint:
Remarks:

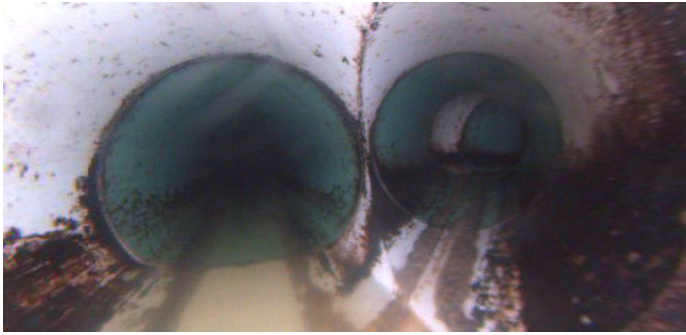
Code: **TFA**
Description: **Tap Factory Active**

Distance (ft): **177.8**
Structural Grade: **0**
O&M Grade: **0**
Clock Start/From: **3**
Clock To:
1st Value: **4.000**
2nd Value:
Value Percent:
Continuous Index:
Within 8" of Joint:
Remarks:

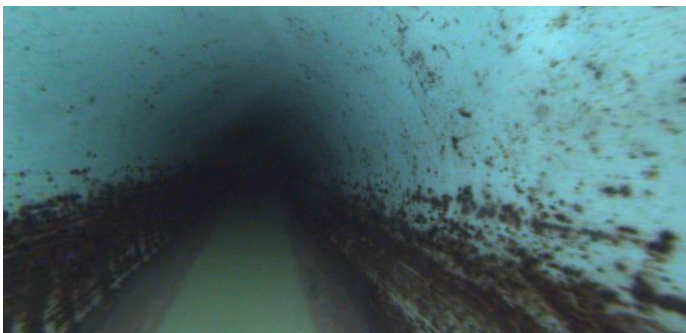
Code: **MWL**
Description: **Water Level**

Distance (ft): **182.5**
Structural Grade: **0**
O&M Grade: **0**
Clock Start/From:
Clock To:
1st Value:
2nd Value:
Value Percent: **5.000**
Continuous Index:
Within 8" of Joint: **NO**
Remarks:

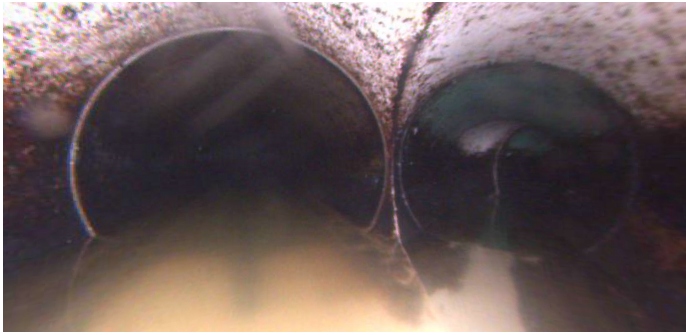
Code: **TFA**
Description: **Tap Factory Active**

Distance (ft): **188.9**
Structural Grade: **0**
O&M Grade: **0**
Clock Start/From: **3**
Clock To:
1st Value: **4.000**
2nd Value:
Value Percent:
Continuous Index:
Within 8" of Joint:
Remarks:

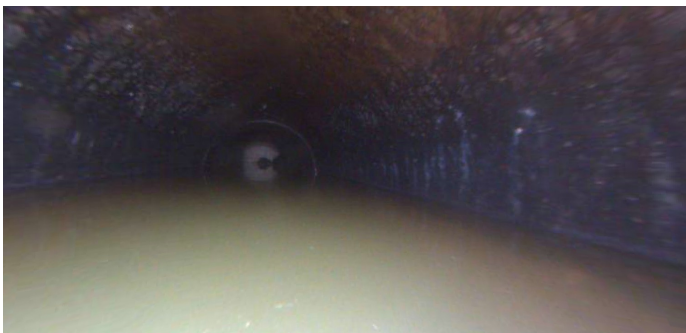
Code: **MWL**
Description: **Water Level**

Distance (ft): **200.3**
Structural Grade: **0**
O&M Grade: **0**
Clock Start/From:
Clock To:
1st Value:
2nd Value:
Value Percent: **40.000**
Continuous Index:
Within 8" of Joint: **NO**
Remarks:

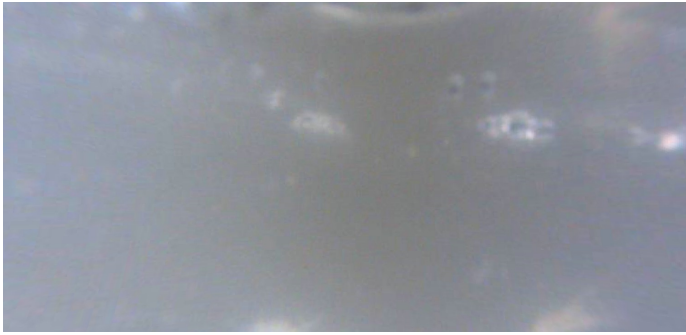
Code: **MWL**
Description: **Water Level**

Distance (ft): **204.7**
Structural Grade: **0**
O&M Grade: **0**
Clock Start/From:
Clock To:
1st Value:
2nd Value:
Value Percent: **100.000**
Continuous Index:
Within 8" of Joint: **NO**
Remarks:

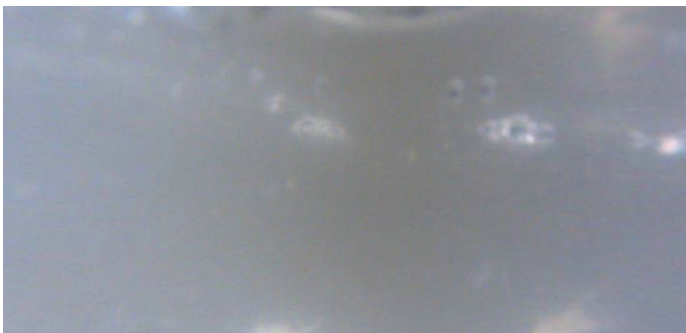
Code: **MCU**
Description: **Camera Underwater**

Distance (ft): **204.7**
Structural Grade: **0**
O&M Grade: **4**
Clock Start/From:
Clock To:
1st Value:
2nd Value:
Value Percent:
Continuous Index:
Within 8" of Joint: **NO**
Remarks:

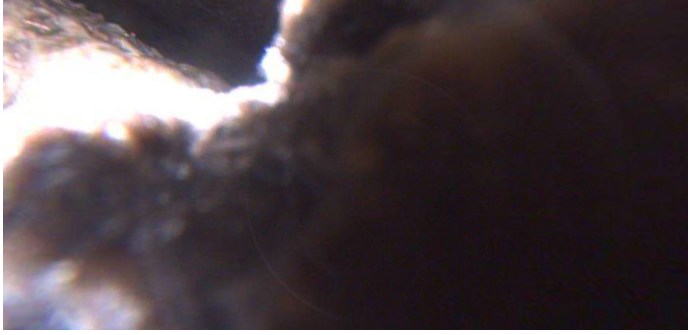
Code:	AMH
Description:	Manhole
Distance (ft):	205.7
Structural Grade:	0
O&M Grade:	0
Clock Start/From:	
Clock To:	
1st Value:	
2nd Value:	
Value Percent:	
Continuous Index:	
Within 8" of Joint:	NO
Remarks:	M-706-051
