Profile/Photo Observation Report

Date:	02/18/2022	Weather:		Coding:	PACP 7.0
Pipe Length (ft):	129.8	Owner:	City of Hobart	Pre Clean:	Heavy Cleaning
P.O.#:	YES502259	Surveyor:	S. Bucklin	PSR:	P-706-053-054
Customer:	City of Hobart	Clean Date:	02/14/2022	Shape:	C

Street:	Beacon Drive	Flow Control:	Not Controlled
City:	Hobart, IN	Year Renewed:	
Location:	Local rural streets with light traffic, t	Tape/Media #:	
Purpose:	Routine Assessment	Dia/Height:	8"
Use:	Sanitary Sewage Pipe	Material:	PVC
Drain Area:		Lining:	None
Category:	NA		
Comment:

Location Details:		Direction of Survey:	Upstream
US MH:	M-706-054	DS MH:	M-706-053
		Total Length Surveyed (ft):	129.8

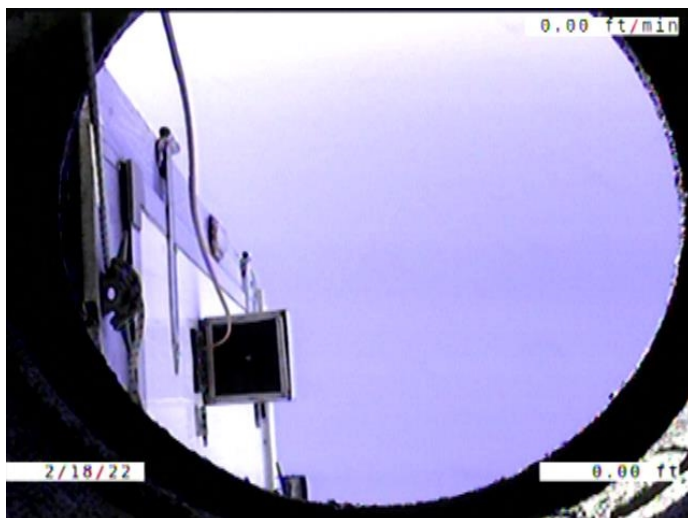
Code: **AMH**
Description: **Manhole**

Distance (ft): **.0**
Structural Grade: **0**
O&M Grade: **0**
Clock Start/From:
Clock To:
1st Value:
2nd Value:
Value Percent:
Continuous Index:
Within 8" of Joint: **NO**
Remarks: **M-706-053**

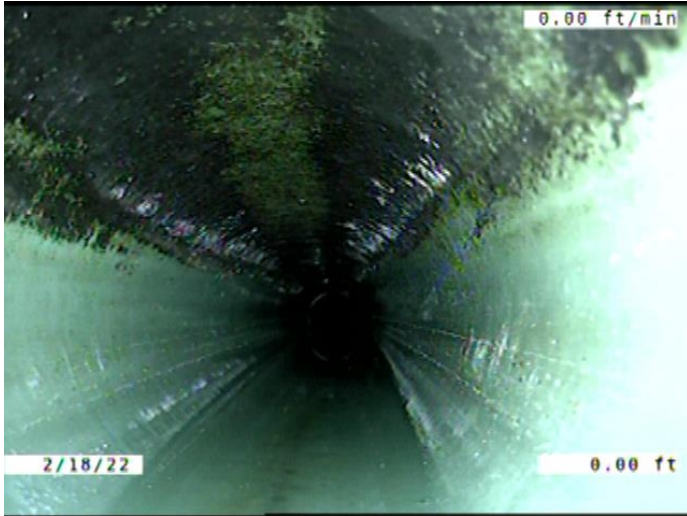
Code: **MWL**
Description: **Miscellaneous Water Level**

Distance (ft): **.0**
Structural Grade: **0**
O&M Grade: **0**
Clock Start/From:
Clock To:
1st Value:
2nd Value:
Value Percent: **10.000**
Continuous Index:
Within 8" of Joint: **NO**
Remarks:

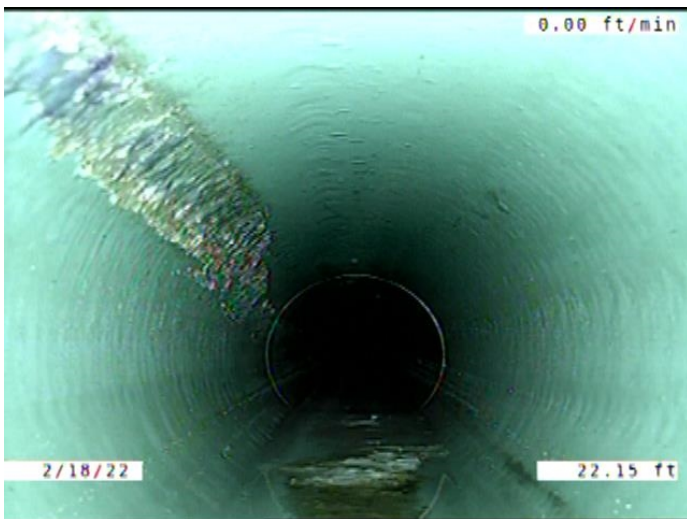
Code: **MWLS**
Description: **Miscellaneous Water Level Sag**

Distance (ft): **22.1**
Structural Grade: **2**
O&M Grade: **0**
Clock Start/From:
Clock To:
1st Value:
2nd Value:
Value Percent: **5.000**
Continuous Index: **S01**
Within 8" of Joint: **NO**
Remarks:

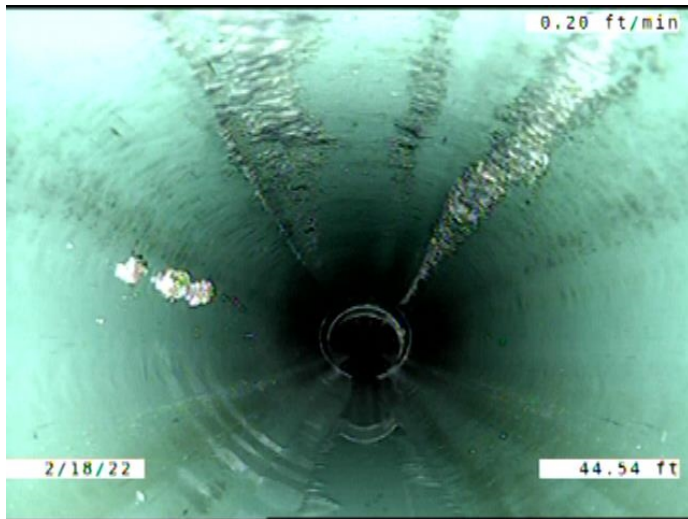
Code: **MWLS**
Description: **Miscellaneous Water Level Sag**

Distance (ft): **44.5**
Structural Grade: **2**
O&M Grade: **0**
Clock Start/From:
Clock To:
1st Value:
2nd Value:
Value Percent: **5.000**
Continuous Index: **F01**
Within 8" of Joint: **NO**
Remarks:

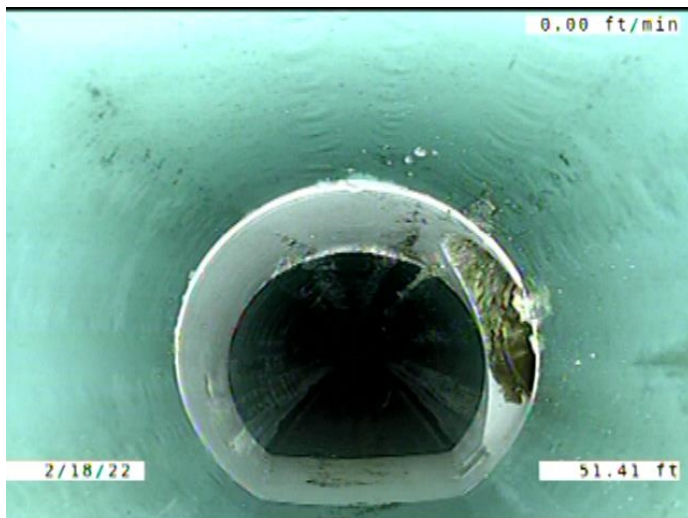
Code: **MWLS**
Description: **Miscellaneous Water Level Sag**

Distance (ft): **51.4**
Structural Grade: **2**
O&M Grade: **0**
Clock Start/From:
Clock To:
1st Value:
2nd Value:
Value Percent: **5.000**
Continuous Index: **S02**
Within 8" of Joint: **NO**
Remarks:

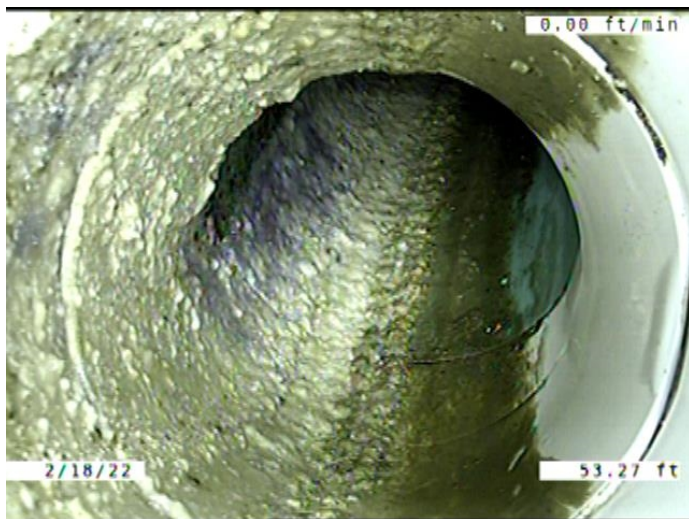
Code: **TF**
 Description: **Tap Factory**

Distance (ft): **53.3**
 Structural Grade: **0**
 O&M Grade: **0**
 Clock Start/From: **2**
 Clock To:
 1st Value: **4.000**
 2nd Value:
 Value Percent:
 Continuous Index:
 Within 8" of Joint: **YES**
 Remarks:

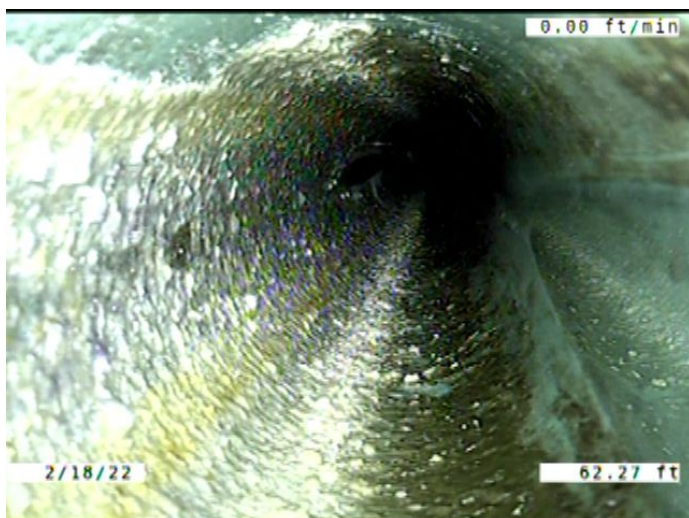
Code: **TB**
 Description: **Tap Break-in/Hammer**

Distance (ft): **62.3**
 Structural Grade: **0**
 O&M Grade: **0**
 Clock Start/From: **2**
 Clock To:
 1st Value: **4.000**
 2nd Value:
 Value Percent:
 Continuous Index:
 Within 8" of Joint: **NO**
 Remarks:

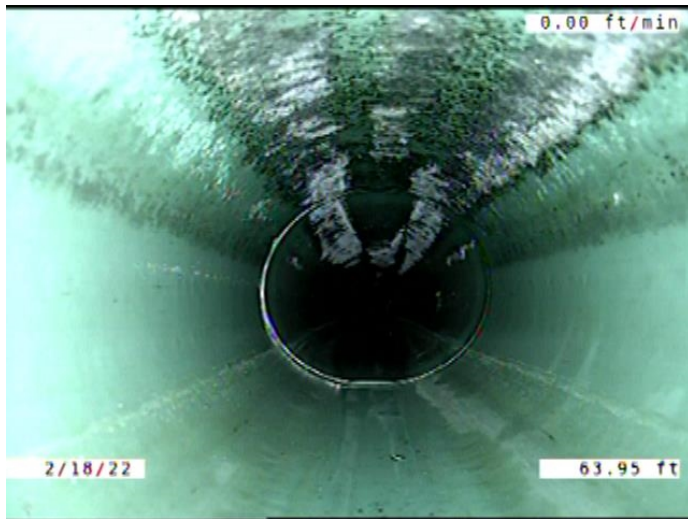
Code: **MWLS**
Description: **Miscellaneous Water Level Sag**

Distance (ft): **64.0**
Structural Grade: **2**
O&M Grade: **0**
Clock Start/From:
Clock To:
1st Value:
2nd Value:
Value Percent: **5.000**
Continuous Index: **F02**
Within 8" of Joint: **NO**
Remarks:

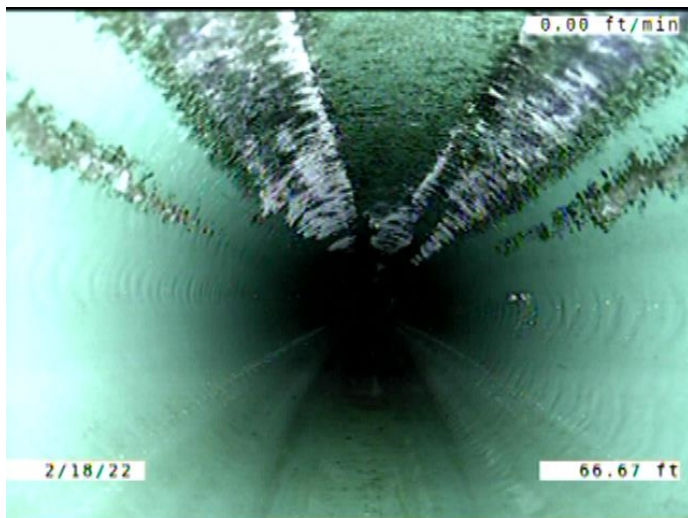
Code: **MWLS**
Description: **Miscellaneous Water Level Sag**

Distance (ft): **66.7**
Structural Grade: **2**
O&M Grade: **0**
Clock Start/From:
Clock To:
1st Value:
2nd Value:
Value Percent: **5.000**
Continuous Index: **S03**
Within 8" of Joint: **NO**
Remarks:

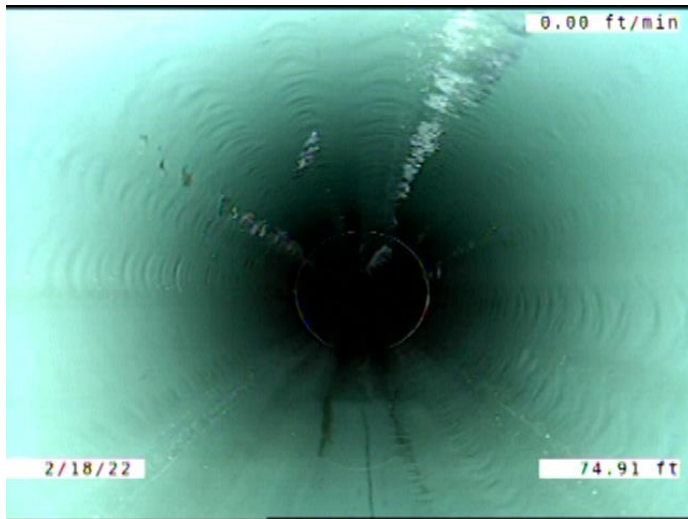
Code: **MWLS**
 Description: **Miscellaneous Water Level Sag**

Distance (ft): **74.9**
 Structural Grade: **2**
 O&M Grade: **0**
 Clock Start/From:
 Clock To:
 1st Value:
 2nd Value:
 Value Percent: **5.000**
 Continuous Index: **F03**
 Within 8" of Joint: **NO**
 Remarks:

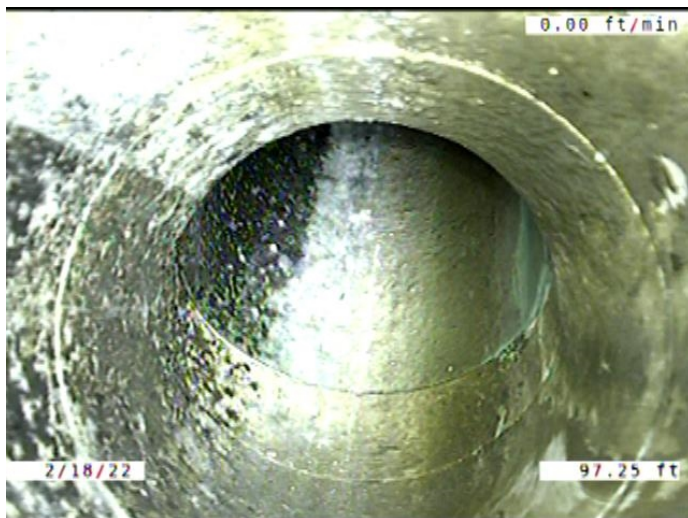
Code: **TF**
 Description: **Tap Factory**

Distance (ft): **97.2**
 Structural Grade: **0**
 O&M Grade: **0**
 Clock Start/From: **2**
 Clock To:
 1st Value: **4.000**
 2nd Value:
 Value Percent:
 Continuous Index:
 Within 8" of Joint: **YES**
 Remarks:

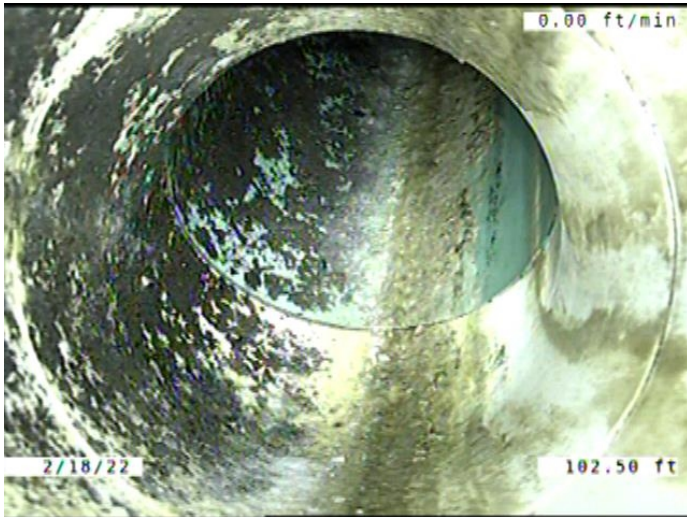
Code: **TF**
Description: **Tap Factory**

Distance (ft): **102.5**
Structural Grade: **0**
O&M Grade: **0**
Clock Start/From: **2**
Clock To:
1st Value: **4.000**
2nd Value:
Value Percent:
Continuous Index:
Within 8" of Joint: **YES**
Remarks:

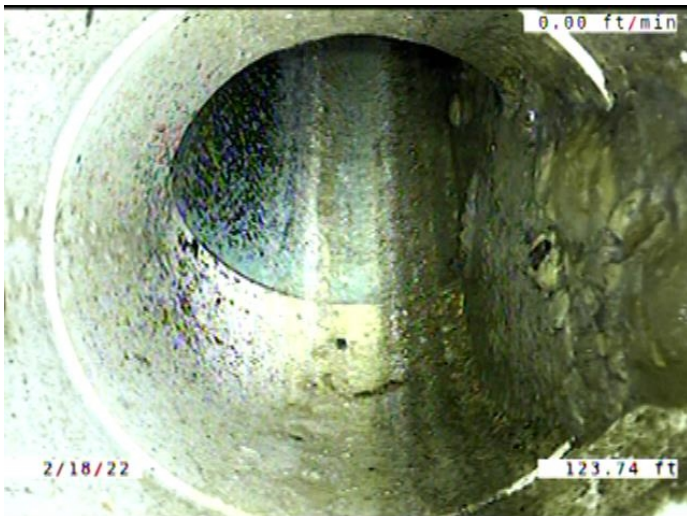
Code: **TF**
Description: **Tap Factory**

Distance (ft): **123.7**
Structural Grade: **0**
O&M Grade: **0**
Clock Start/From: **2**
Clock To:
1st Value: **4.000**
2nd Value:
Value Percent:
Continuous Index:
Within 8" of Joint: **YES**
Remarks:

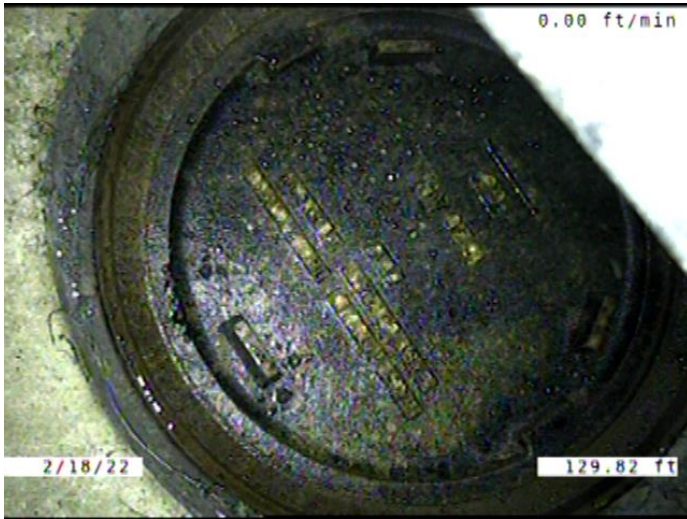
Code:	AMH
Description:	Manhole
Distance (ft):	129.8
Structural Grade:	0
O&M Grade:	0
Clock Start/From:	
Clock To:	
1st Value:	
2nd Value:	
Value Percent:	
Continuous Index:	
Within 8" of Joint:	NO
Remarks:	M-706-054
