Profile/Photo Observation Report

Street:	FLEMING ST & BEACON DR	Flow Control:	Not Controlled
City:	Hobart, IN	Year Renewed:	
Location:	Light Highway	Tape/Media #:	
Purpose:	Maintenance Related	Dia/Height:	8"
Use:	Sanitary	Material:	PVC
Drain Area:	NA	Lining:	Cured in Place
Category:	NA		
Comment:

Location Details:		Direction of Survey:	Downstream
US MH:	M-706-055	DS MH:	M-706-056
		Total Length Surveyed (ft):	251.7

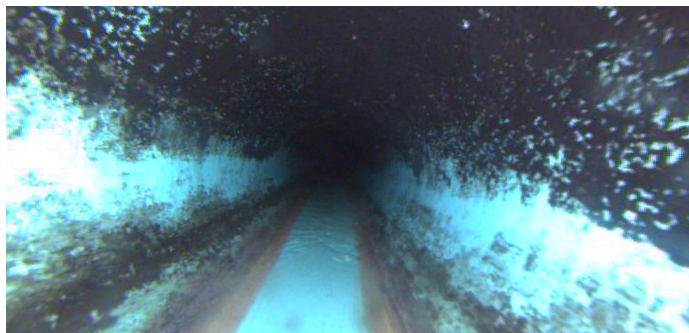
Code: **AMH**
Description: **Manhole**

Distance (ft): **.0**
Structural Grade: **0**
O&M Grade: **0**
Clock Start/From:
Clock To:
1st Value:
2nd Value:
Value Percent:
Continuous Index:
Within 8" of Joint: **NO**
Remarks: **M-706-055**

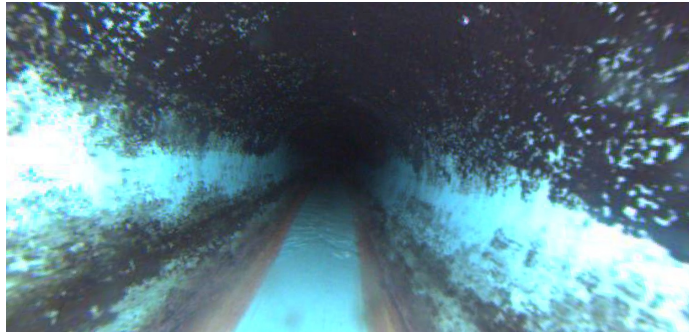
Code: **MWL**
Description: **Water Level**

Distance (ft): **.0**
Structural Grade: **0**
O&M Grade: **0**
Clock Start/From:
Clock To:
1st Value:
2nd Value:
Value Percent: **5.000**
Continuous Index:
Within 8" of Joint: **NO**
Remarks:

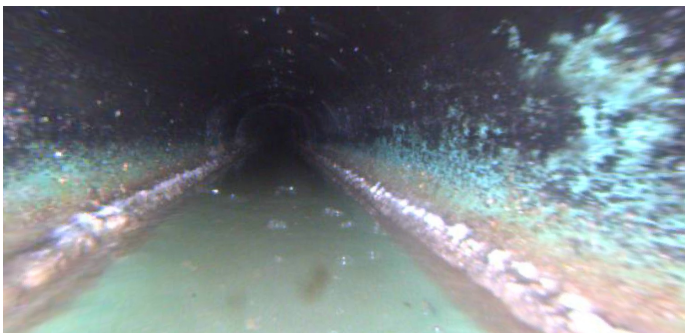
Code: **DAGS**
Description: **Deposits Attached Grease**

Distance (ft): **23.8**
Structural Grade: **0**
O&M Grade: **2**
Clock Start/From: **7**
Clock To: **5**
1st Value:
2nd Value:
Value Percent: **5.000**
Continuous Index: **S01**
Within 8" of Joint: **NO**
Remarks:

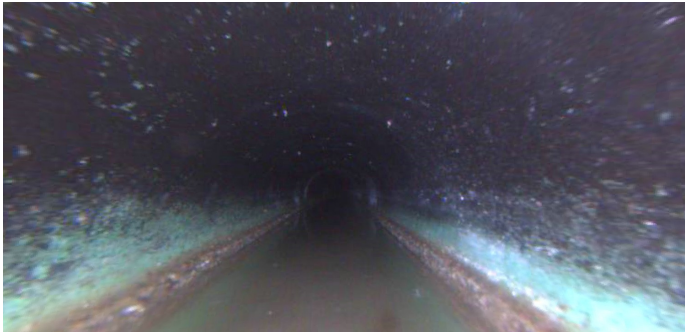
Code: **MWL**
Description: **Water Level**

Distance (ft): **36.0**
Structural Grade: **0**
O&M Grade: **0**
Clock Start/From:
Clock To:
1st Value:
2nd Value:
Value Percent: **10.000**
Continuous Index:
Within 8" of Joint: **NO**
Remarks:

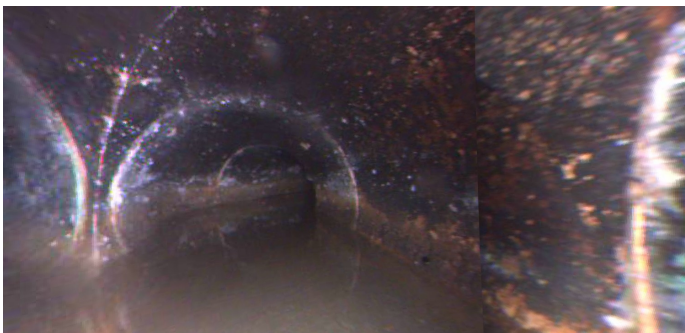
Code: **TFA**
Description: **Tap Factory Active**

Distance (ft): **50.7**
Structural Grade: **0**
O&M Grade: **0**
Clock Start/From: **9**
Clock To:
1st Value: **4.000**
2nd Value:
Value Percent:
Continuous Index:
Within 8" of Joint:
Remarks:

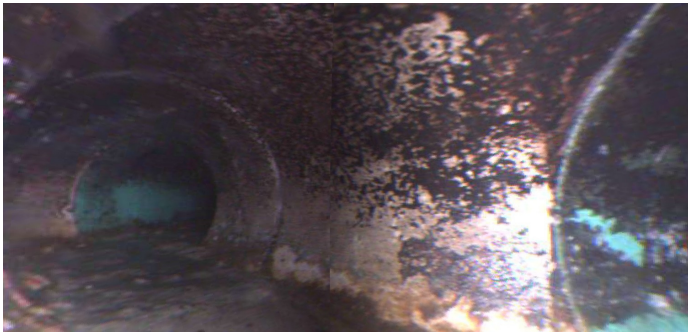
Code: **TFA**
Description: **Tap Factory Active**

Distance (ft): **89.4**
Structural Grade: **0**
O&M Grade: **0**
Clock Start/From: **9**
Clock To:
1st Value: **4.000**
2nd Value:
Value Percent:
Continuous Index:
Within 8" of Joint:
Remarks:

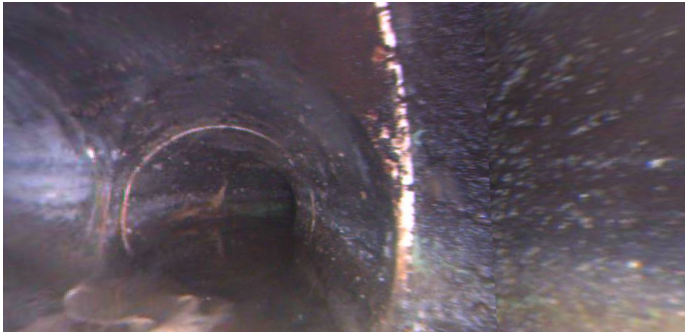
Code: **TFA**
Description: **Tap Factory Active**

Distance (ft): **131.6**
Structural Grade: **0**
O&M Grade: **0**
Clock Start/From: **9**
Clock To:
1st Value: **4.000**
2nd Value:
Value Percent:
Continuous Index:
Within 8" of Joint:
Remarks:

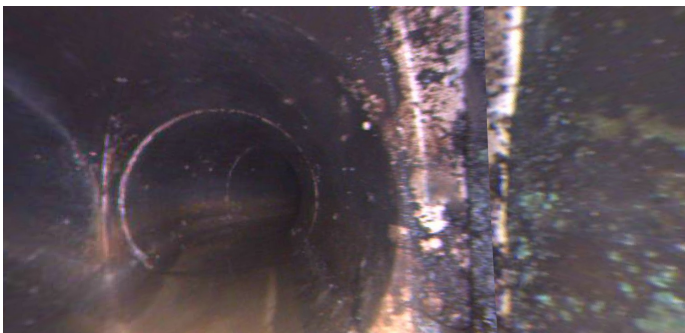
Code: **TFA**
Description: **Tap Factory Active**

Distance (ft): **133.4**
Structural Grade: **0**
O&M Grade: **0**
Clock Start/From: **9**
Clock To:
1st Value: **4.000**
2nd Value:
Value Percent:
Continuous Index:
Within 8" of Joint:
Remarks:

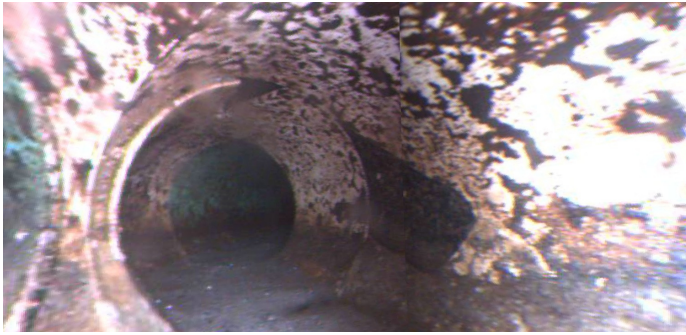
Code: **TFA**
Description: **Tap Factory Active**

Distance (ft): **168.3**
Structural Grade: **0**
O&M Grade: **0**
Clock Start/From: **9**
Clock To:
1st Value: **4.000**
2nd Value:
Value Percent:
Continuous Index:
Within 8" of Joint:
Remarks:

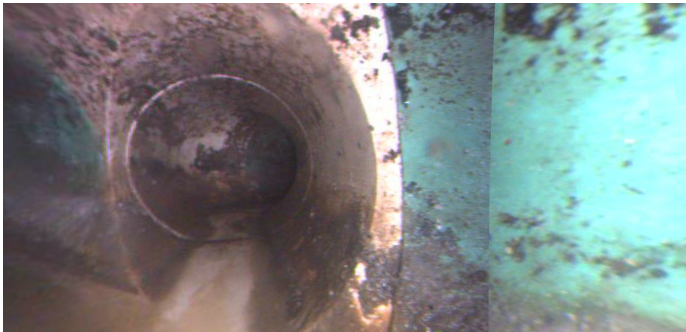
Code: **TFA**
Description: **Tap Factory Active**

Distance (ft): **170.6**
Structural Grade: **0**
O&M Grade: **0**
Clock Start/From: **9**
Clock To:
1st Value: **4.000**
2nd Value:
Value Percent:
Continuous Index:
Within 8" of Joint:
Remarks:

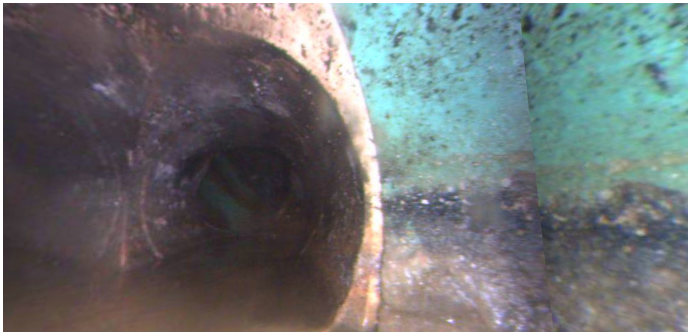
Code: **TFA**
Description: **Tap Factory Active**

Distance (ft): **208.3**
Structural Grade: **0**
O&M Grade: **0**
Clock Start/From: **9**
Clock To:
1st Value: **4.000**
2nd Value:
Value Percent:
Continuous Index:
Within 8" of Joint:
Remarks:

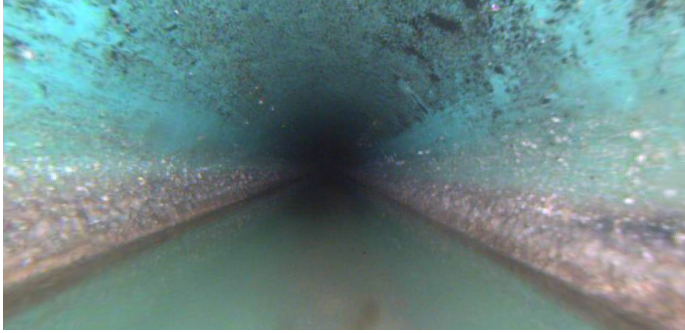
Code: **MWL**
Description: **Water Level**

Distance (ft): **208.3**
Structural Grade: **0**
O&M Grade: **0**
Clock Start/From:
Clock To:
1st Value:
2nd Value:
Value Percent: **20.000**
Continuous Index:
Within 8" of Joint: **NO**
Remarks:

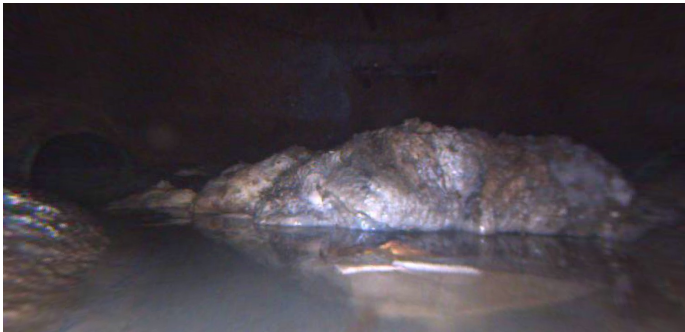
Code: **DAGS**
Description: **Deposits Attached Grease**

Distance (ft): **251.1**
Structural Grade: **0**
O&M Grade: **2**
Clock Start/From: **7**
Clock To: **5**
1st Value:
2nd Value:
Value Percent: **5.000**
Continuous Index: **F01**
Within 8" of Joint: **NO**
Remarks:

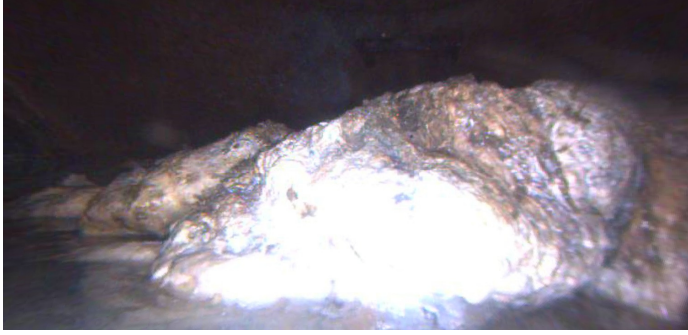
Code:	AMH
Description:	Manhole
Distance (ft):	251.7
Structural Grade:	0
O&M Grade:	0
Clock Start/From:	
Clock To:	
1st Value:	
2nd Value:	
Value Percent:	
Continuous Index:	
Within 8" of Joint:	NO
Remarks:	M-706-056
