Profile/Photo Observation Report

Date:	04/14/2018	Weather:		Coding:	PACP 6.0
Pipe Length (ft):	261.3	Owner:	NA	Pre Clean:	Not Known
P.O.#:		Surveyor:	Jen Costello	PSR:	P-706-055-056
Customer:		Clean Date:	01/01/1900	Shape:	C

Location Details:		Direction of Survey:	Downstream
US MH:	M-706-055	DS MH:	M-706-056
		Total Length Surveyed (ft):	251.7

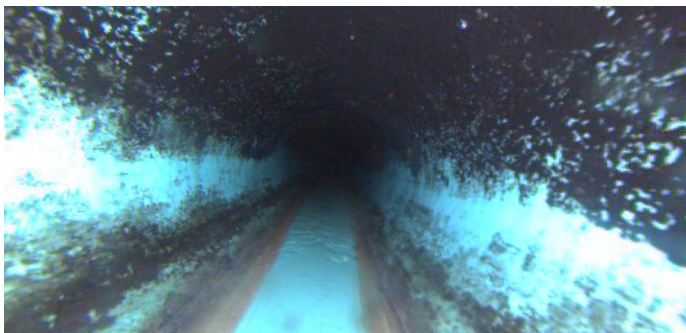
Code: **AMH**
Description: **Manhole**

Distance (ft): **.0**
Structural Grade: **0**
O&M Grade: **0**
Clock Start/From:
Clock To:
1st Value:
2nd Value:
Value Percent:
Continuous Index:
Within 8" of Joint: **NO**
Remarks: **M-706-055**

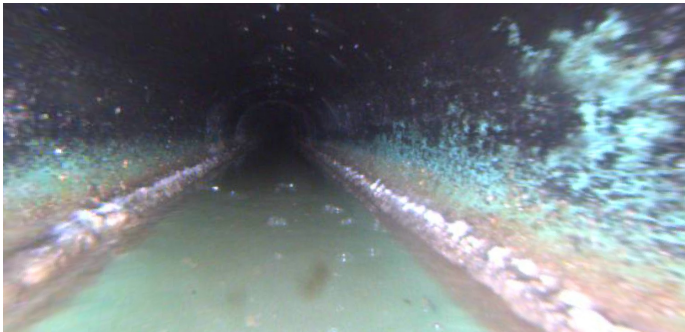
Code: **DAGS**
Description: **Deposits Attached Grease**

Distance (ft): **23.8**
Structural Grade: **0**
O&M Grade: **2**
Clock Start/From: **7**
Clock To: **5**
1st Value:
2nd Value:
Value Percent: **5.000**
Continuous Index: **S01**
Within 8" of Joint: **NO**
Remarks:

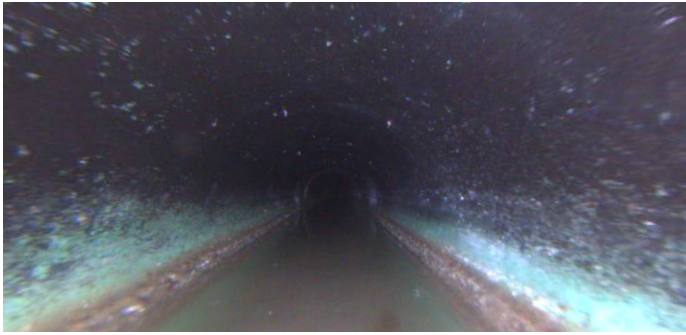
Code: **MWL**
Description: **Water Level**

Distance (ft): **36.0**
Structural Grade: **0**
O&M Grade: **0**
Clock Start/From:
Clock To:
1st Value:
2nd Value:
Value Percent: **10.000**
Continuous Index:
Within 8" of Joint: **NO**
Remarks:

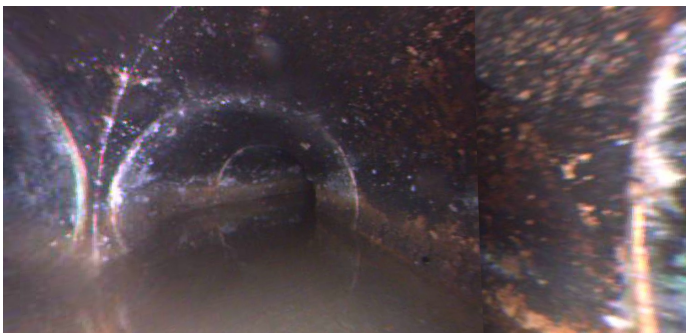
Code: **TFA**
Description: **Tap Factory Active**

Distance (ft): **50.7**
Structural Grade: **0**
O&M Grade: **0**
Clock Start/From: **9**
Clock To:
1st Value: **4.000**
2nd Value:
Value Percent:
Continuous Index:
Within 8" of Joint:
Remarks:

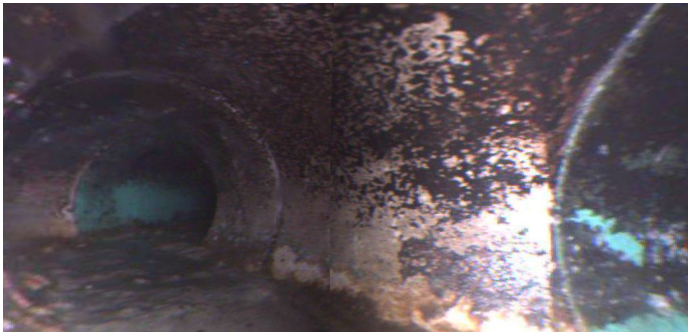
Code: **TFA**
Description: **Tap Factory Active**

Distance (ft): **89.4**
Structural Grade: **0**
O&M Grade: **0**
Clock Start/From: **9**
Clock To:
1st Value: **4.000**
2nd Value:
Value Percent:
Continuous Index:
Within 8" of Joint:
Remarks:

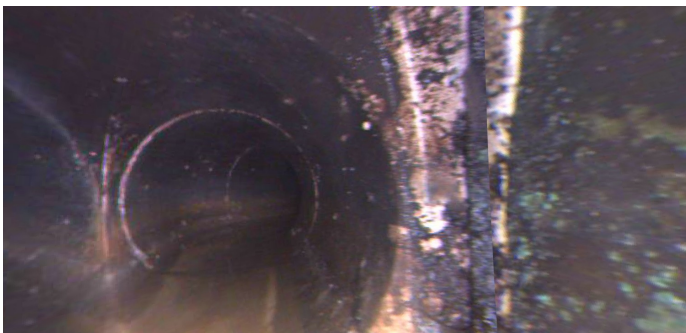
Code: **TFA**
Description: **Tap Factory Active**

Distance (ft): **133.4**
Structural Grade: **0**
O&M Grade: **0**
Clock Start/From: **9**
Clock To:
1st Value: **4.000**
2nd Value:
Value Percent:
Continuous Index:
Within 8" of Joint:
Remarks:

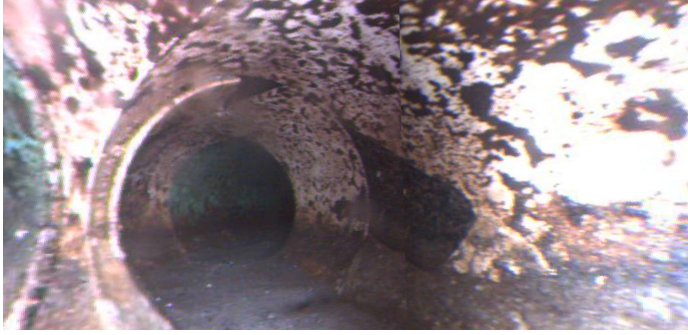
Code: **TFA**
Description: **Tap Factory Active**

Distance (ft): **168.3**
Structural Grade: **0**
O&M Grade: **0**
Clock Start/From: **9**
Clock To:
1st Value: **4.000**
2nd Value:
Value Percent:
Continuous Index:
Within 8" of Joint:
Remarks:

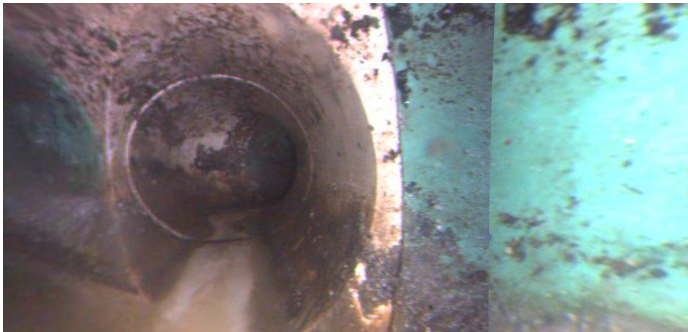
Code: **TFA**
Description: **Tap Factory Active**

Distance (ft): **170.6**
Structural Grade: **0**
O&M Grade: **0**
Clock Start/From: **9**
Clock To:
1st Value: **4.000**
2nd Value:
Value Percent:
Continuous Index:
Within 8" of Joint:
Remarks:

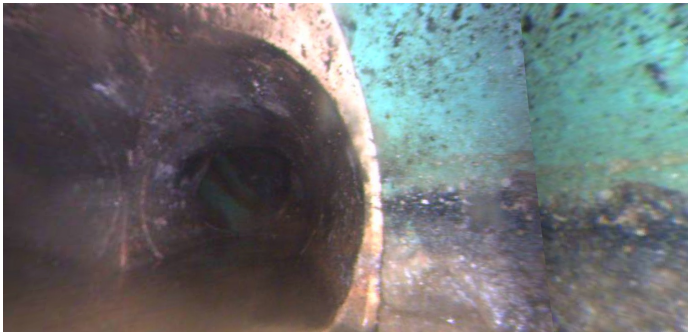
Code: **TFA**
Description: **Tap Factory Active**

Distance (ft): **208.3**
Structural Grade: **0**
O&M Grade: **0**
Clock Start/From: **9**
Clock To:
1st Value: **4.000**
2nd Value:
Value Percent:
Continuous Index:
Within 8" of Joint:
Remarks:

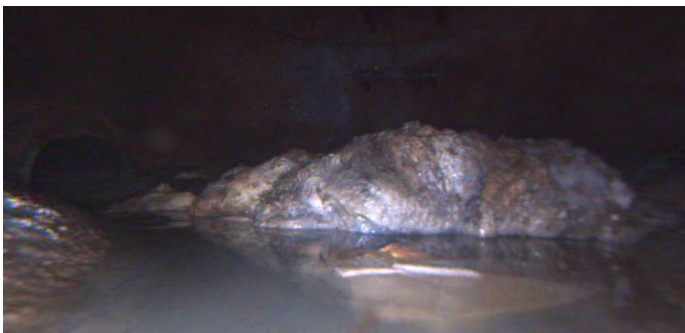
Code: **DAGS**
Description: **Deposits Attached Grease**

Distance (ft): **251.1**
Structural Grade: **0**
O&M Grade: **2**
Clock Start/From: **7**
Clock To: **5**
1st Value:
2nd Value:
Value Percent: **5.000**
Continuous Index: **F01**
Within 8" of Joint: **NO**
Remarks:

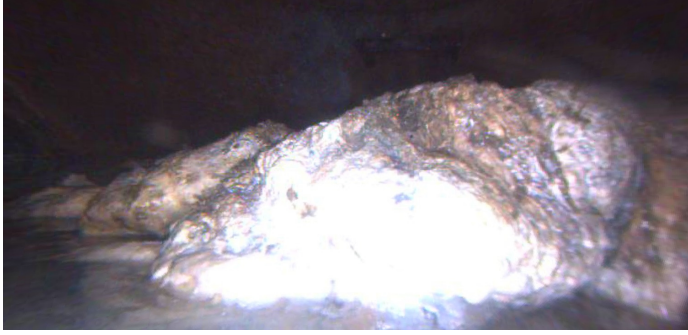
Code:	AMH
Description:	Manhole
Distance (ft):	251.7
Structural Grade:	0
O&M Grade:	0
Clock Start/From:	
Clock To:	
1st Value:	
2nd Value:	
Value Percent:	
Continuous Index:	
Within 8" of Joint:	NO
Remarks:	M-706-056
