Profile/Photo Observation Report

Street:	BEACON DR	Flow Control:	Not Controlled
City:	Hobart, IN	Year Renewed:	
Location:	Light Highway	Tape/Media #:	
Purpose:	Maintenance Related	Dia/Height:	8"
Use:	Sanitary	Material:	PVC
Drain Area:	NA	Lining:	Cured in Place
Category:	NA		
Comment:	mh confirmed.

Location Details:		Direction of Survey:	Downstream
US MH:	M-706-056	DS MH:	M-706-057
		Total Length Surveyed (ft):	79.9

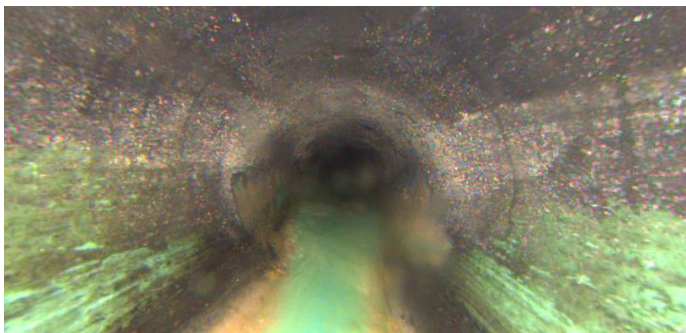
Code: **AMH**
Description: **Manhole**

Distance (ft): **.0**
Structural Grade: **0**
O&M Grade: **0**
Clock Start/From:
Clock To:
1st Value:
2nd Value:
Value Percent:
Continuous Index:
Within 8" of Joint: **NO**
Remarks: **M-706-056**

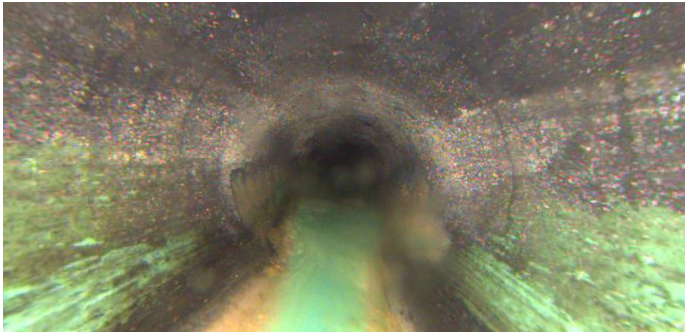
Code:	MWL
Description:	Water Level

Distance (ft):	.0
Structural Grade:	0
O&M Grade:	0
Clock Start/From:	
Clock To:	
1st Value:	
2nd Value:	
Value Percent:	5.000
Continuous Index:	
Within 8" of Joint:	NO
Remarks:

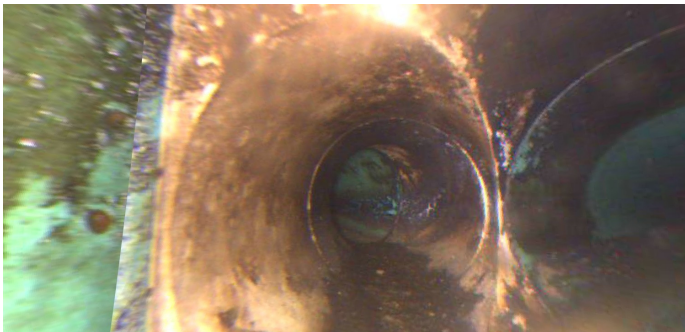
Code:	TF
Description:	Tap Factory

Distance (ft):	38.6
Structural Grade:	0
O&M Grade:	0
Clock Start/From:	3
Clock To:	
1st Value:	4.000
2nd Value:	
Value Percent:	
Continuous Index:	
Within 8" of Joint:	
Remarks:

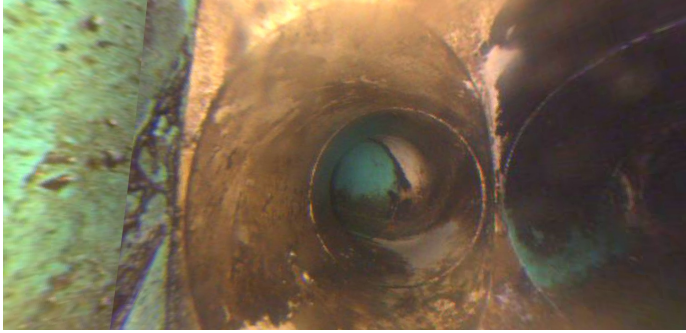
Code: **TF**
Description: **Tap Factory**

Distance (ft): **40.4**
Structural Grade: **0**
O&M Grade: **0**
Clock Start/From: **3**
Clock To:
1st Value: **4.000**
2nd Value:
Value Percent:
Continuous Index:
Within 8" of Joint:
Remarks:

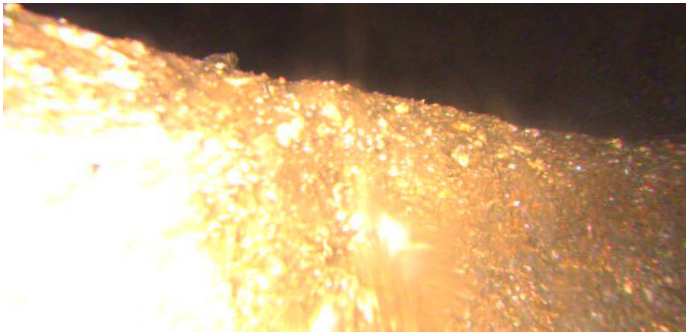
Code: **AMH**
Description: **Manhole**

Distance (ft): **79.9**
Structural Grade: **0**
O&M Grade: **0**
Clock Start/From:
Clock To:
1st Value:
2nd Value:
Value Percent:
Continuous Index:
Within 8" of Joint: **NO**
Remarks: **M-706-057**
