## Profile/Photo Observation Report

Street:	<b>Capitol</b>	Flow Control:	<b>Not Controlled</b>
City:	<b>Hobart, IN</b>	Year Renewed:	
Location:	<b>Light Highway</b>	Tape/Media #:	
Purpose:	<b>Maintenance Related</b>	Dia/Height:	<b>8"</b>
Use:	<b>Sanitary</b>	Material:	<b>PVC</b>
Drain Area:	<b>NA</b>	Lining:	<b>Cured in Place</b>
Category:	<b>NA</b>		
Comment:	<b>mh confirmed.</b>

Location Details:		Direction of Survey:	<b>Downstream</b>
US MH:	<b>M-706-056</b>	DS MH:	<b>M-706-057</b>
		Total Length Surveyed (ft):	<b>79.9</b>

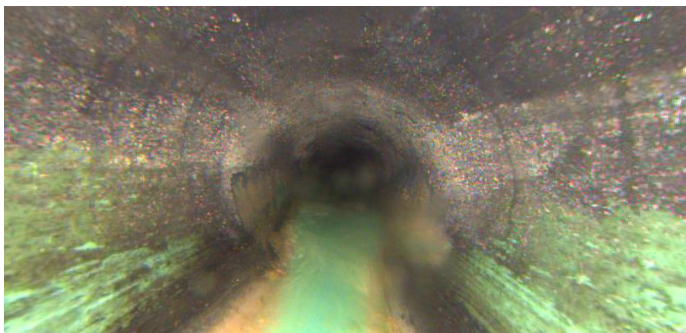
Code: **AMH**  
Description: **Manhole**

Distance (ft): **.0**  
Structural Grade: **0**  
O&M Grade: **0**  
Clock Start/From:  
Clock To:  
1st Value:  
2nd Value:  
Value Percent:  
Continuous Index:  
Within 8" of Joint: **NO**  
Remarks: **M-706-056**

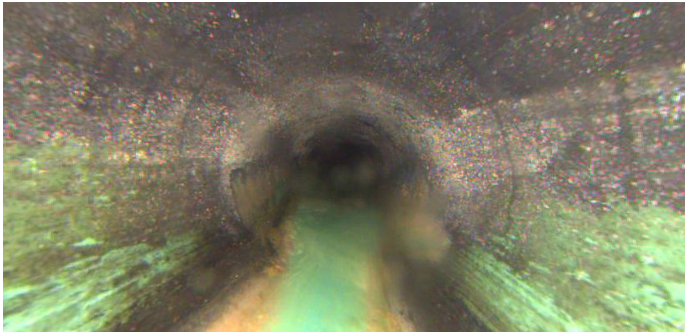
Code:	<b>MWL</b>
Description:	<b>Water Level</b>

Distance (ft):	<b>.0</b>
Structural Grade:	<b>0</b>
O&M Grade:	<b>0</b>
Clock Start/From:	
Clock To:	
1st Value:	
2nd Value:	
Value Percent:	<b>5.000</b>
Continuous Index:	
Within 8" of Joint:	<b>NO</b>
Remarks:

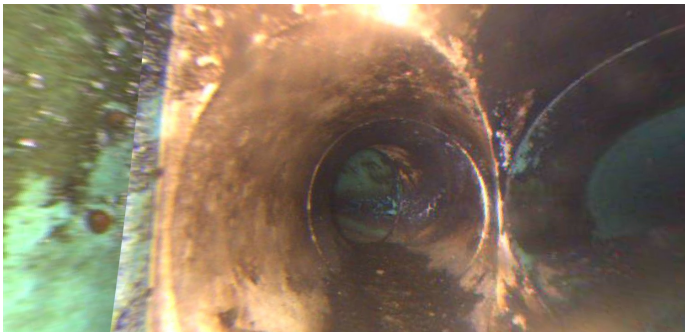
Code:	<b>TF</b>
Description:	<b>Tap Factory</b>

Distance (ft):	<b>38.6</b>
Structural Grade:	<b>0</b>
O&M Grade:	<b>0</b>
Clock Start/From:	<b>3</b>
Clock To:	
1st Value:	<b>4.000</b>
2nd Value:	
Value Percent:	
Continuous Index:	
Within 8" of Joint:	
Remarks:

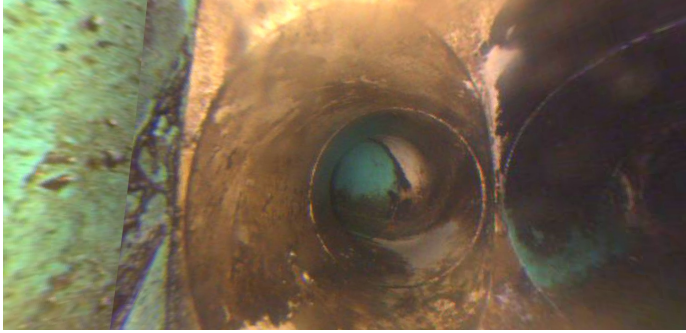
Code: **TF**  
Description: **Tap Factory**

Distance (ft): **40.4**  
Structural Grade: **0**  
O&M Grade: **0**  
Clock Start/From: **3**  
Clock To:  
1st Value: **4.000**  
2nd Value:  
Value Percent:  
Continuous Index:  
Within 8" of Joint:  
Remarks:

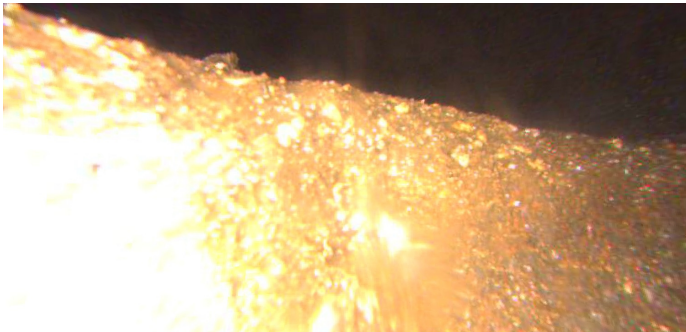
Code: **AMH**  
Description: **Manhole**

Distance (ft): **79.9**  
Structural Grade: **0**  
O&M Grade: **0**  
Clock Start/From:  
Clock To:  
1st Value:  
2nd Value:  
Value Percent:  
Continuous Index:  
Within 8" of Joint: **NO**  
Remarks: **M-706-057**
