Profile/Photo Observation Report

Street:	BEACON DR	Flow Control:	Not Controlled
City:	Hobart, IN	Year Renewed:	
Location:	Light Highway	Tape/Media #:	
Purpose:	Maintenance Related	Dia/Height:	10"
Use:	Sanitary	Material:	PVC
Drain Area:	NA	Lining:	Cured in Place
Category:	NA		
Comment:

Location Details:		Direction of Survey:	Downstream
US MH:	M-706-057	DS MH:	M-606-027
		Total Length Surveyed (ft):	274.3

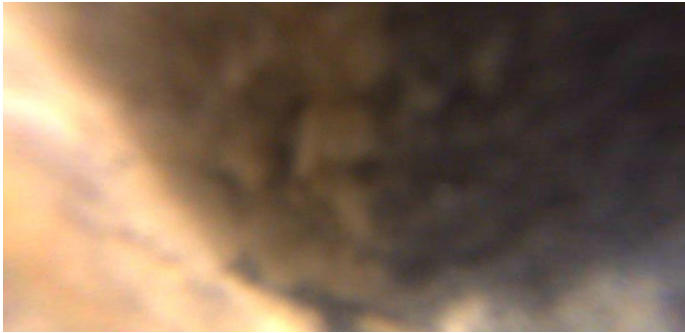
Code:	MWL
Description:	Water Level

Distance (ft):	.0
Structural Grade:	0
O&M Grade:	0
Clock Start/From:	
Clock To:	
1st Value:	
2nd Value:	
Value Percent:	5.000
Continuous Index:	
Within 8" of Joint:	NO
Remarks:

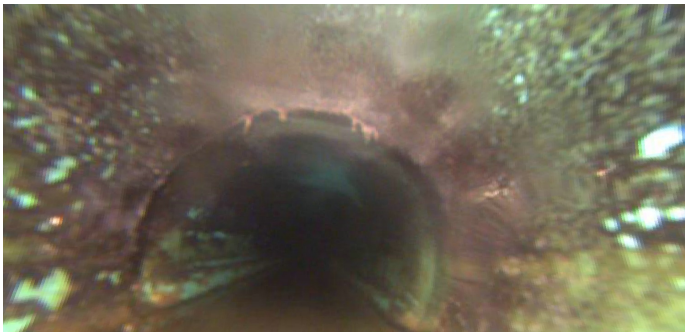
Code:	RFJ
Description:	Roots Fine Joint

Distance (ft):	88.9
Structural Grade:	0
O&M Grade:	1
Clock Start/From:	11
Clock To:	1
1st Value:	
2nd Value:	
Value Percent:	
Continuous Index:	
Within 8" of Joint:	YES
Remarks:

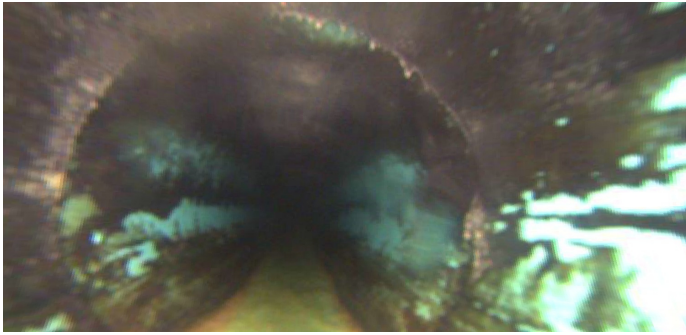
Code: **RFJ**
Description: **Roots Fine Joint**

Distance (ft): **115.5**
Structural Grade: **0**
O&M Grade: **1**
Clock Start/From: **9**
Clock To: **4**
1st Value:
2nd Value:
Value Percent:
Continuous Index:
Within 8" of Joint: **YES**
Remarks:

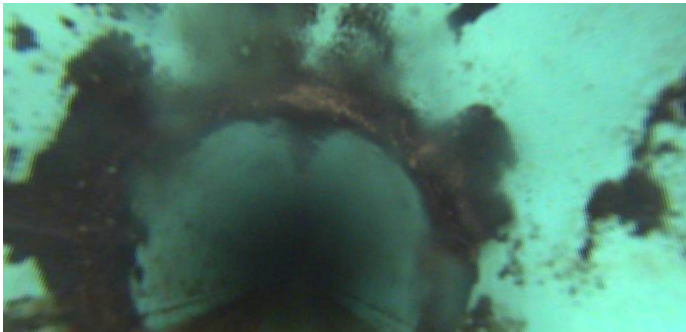
Code: **RFJ**
Description: **Roots Fine Joint**

Distance (ft): **128.6**
Structural Grade: **0**
O&M Grade: **1**
Clock Start/From: **12**
Clock To: **1**
1st Value:
2nd Value:
Value Percent:
Continuous Index:
Within 8" of Joint: **YES**
Remarks:

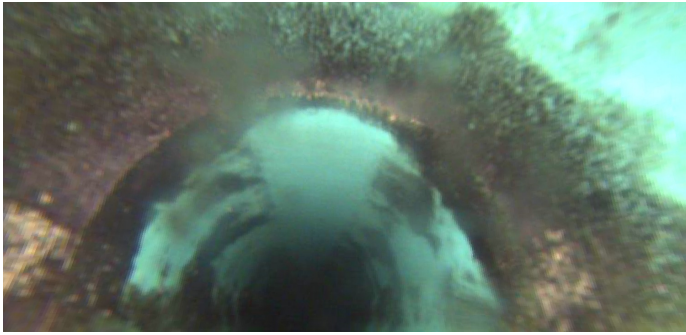
Code: **RFJ**
Description: **Roots Fine Joint**

Distance (ft): **233.5**
Structural Grade: **0**
O&M Grade: **1**
Clock Start/From: **12**
Clock To: **1**
1st Value:
2nd Value:
Value Percent:
Continuous Index:
Within 8" of Joint: **YES**
Remarks:

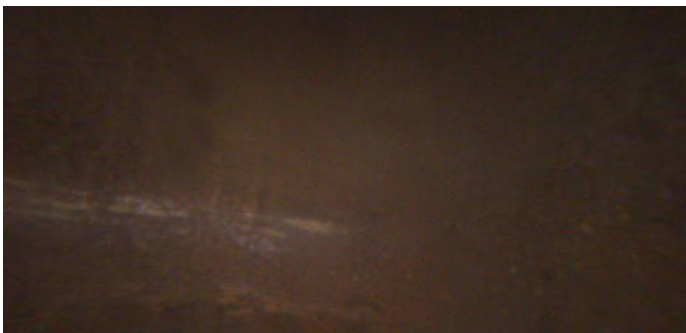
Code: **AMH**
Description: **Manhole**

Distance (ft): **274.3**
Structural Grade: **0**
O&M Grade: **0**
Clock Start/From:
Clock To:
1st Value:
2nd Value:
Value Percent:
Continuous Index:
Within 8" of Joint: **NO**
Remarks: **M-606-027**
