Profile/Photo Observation Report

Street:	DEBIE LN & PENNY CT	Flow Control:	Not Controlled
City:	Hobart, IN	Year Renewed:	
Location:	Light Highway	Tape/Media #:	
Purpose:	Maintenance Related	Dia/Height:	8"
Use:	Sanitary	Material:	PVC
Drain Area:	NA	Lining:	Cured in Place
Category:	NA		
Comment:	mh confirmed.

Location Details:		Direction of Survey:	Upstream
US MH:	M-706-060	DS MH:	M-706-061
		Total Length Surveyed (ft):	95.3

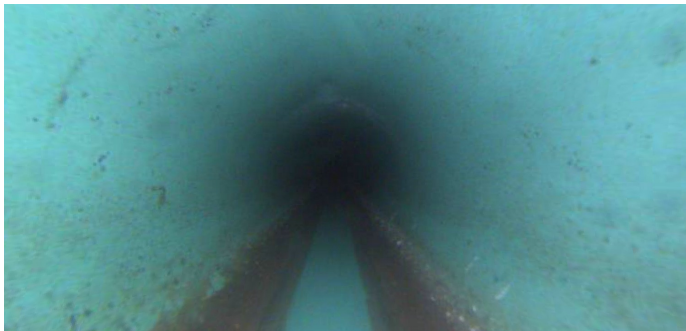
Position	Code	Observation	Video (sec)	Grade
.0	AMH	Manhole	10	NA
.0	MWL	Water Level	21	NA
36.7	TF	Tap Factory	106	NA
38.9	TF	Tap Factory	122	NA
57.0	TFA	Tap Factory Active	170	NA
59.4	TFA	Tap Factory Active	186	NA
81.5	TFA	Tap Factory Active	242	NA
84.2	TF	Tap Factory	259	NA
95.3	AMH	Manhole	293	NA

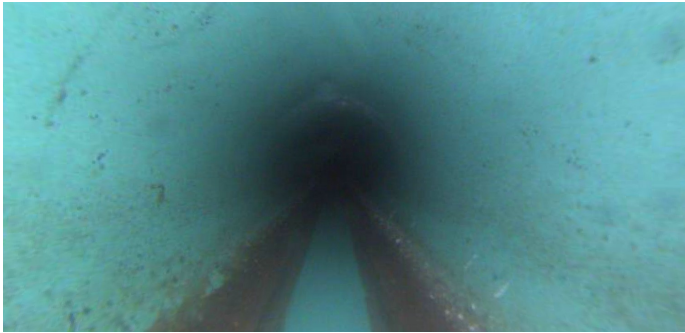
Code:	MWL
Description:	Water Level

Distance (ft):	.0
Structural Grade:	0
O&M Grade:	0
Clock Start/From:	
Clock To:	
1st Value:	
2nd Value:	
Value Percent:	5.000
Continuous Index:	
Within 8" of Joint:	NO
Remarks:

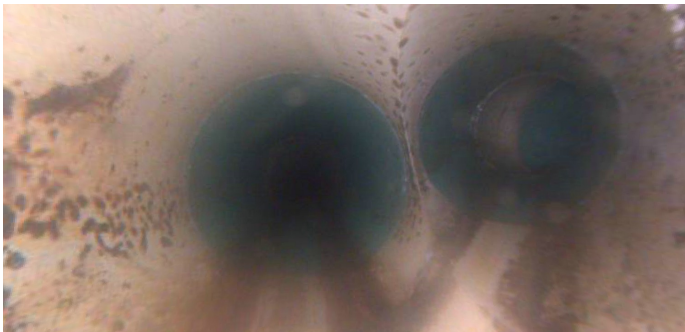
Code:	TF
Description:	Tap Factory

Distance (ft):	36.7
Structural Grade:	0
O&M Grade:	0
Clock Start/From:	3
Clock To:	
1st Value:	4.000
2nd Value:	
Value Percent:	
Continuous Index:	
Within 8" of Joint:	
Remarks:

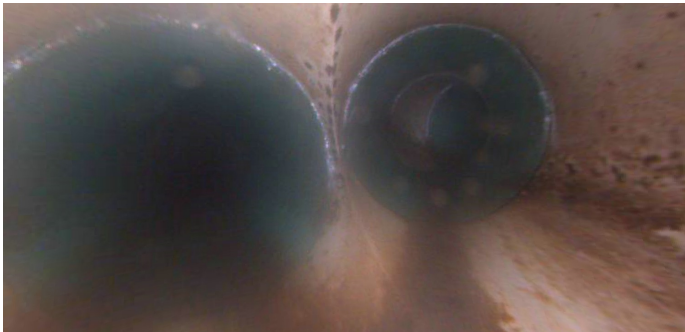
Code: **TFA**
Description: **Tap Factory Active**

Distance (ft): **57.0**
Structural Grade: **0**
O&M Grade: **0**
Clock Start/From: **3**
Clock To:
1st Value: **4.000**
2nd Value:
Value Percent:
Continuous Index:
Within 8" of Joint:
Remarks:

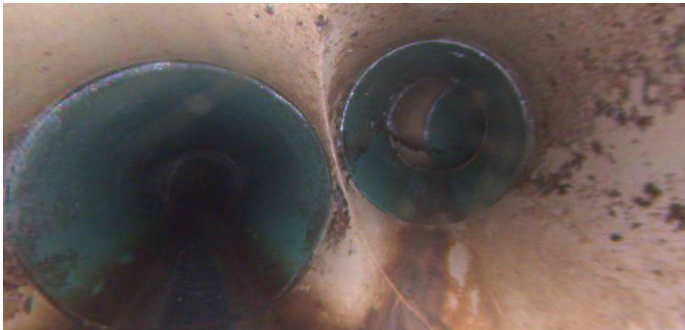
Code: **TFA**
Description: **Tap Factory Active**

Distance (ft): **81.5**
Structural Grade: **0**
O&M Grade: **0**
Clock Start/From: **3**
Clock To:
1st Value: **4.000**
2nd Value:
Value Percent:
Continuous Index:
Within 8" of Joint:
Remarks:

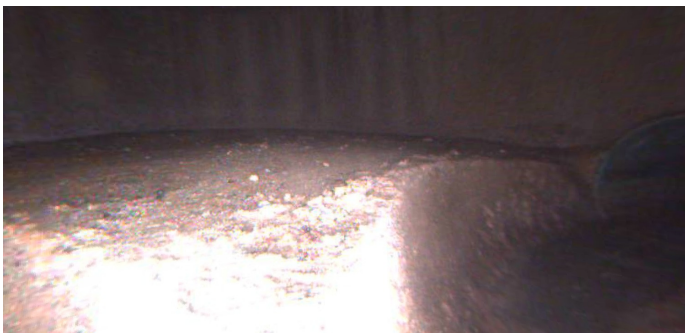
Code: **AMH**
Description: **Manhole**

Distance (ft): **95.3**
Structural Grade: **0**
O&M Grade: **0**
Clock Start/From:
Clock To:
1st Value:
2nd Value:
Value Percent:
Continuous Index:
Within 8" of Joint: **NO**
Remarks: **M-706-060**
