## Profile/Photo Observation Report

Street:	<b>Capitol</b>	Flow Control:	<b>Not Controlled</b>
City:	<b>Hobart, IN</b>	Year Renewed:	
Location:	<b>Light Highway</b>	Tape/Media #:	
Purpose:	<b>Maintenance Related</b>	Dia/Height:	<b>8"</b>
Use:	<b>Sanitary</b>	Material:	<b>PVC</b>
Drain Area:	<b>NA</b>	Lining:	<b>Cured in Place</b>
Category:	<b>NA</b>		
Comment:	<b>mh confirmed.</b>

Location Details:		Direction of Survey:	<b>Upstream</b>
US MH:	<b>M-706-060</b>	DS MH:	<b>M-706-061</b>
		Total Length Surveyed (ft):	<b>95.3</b>

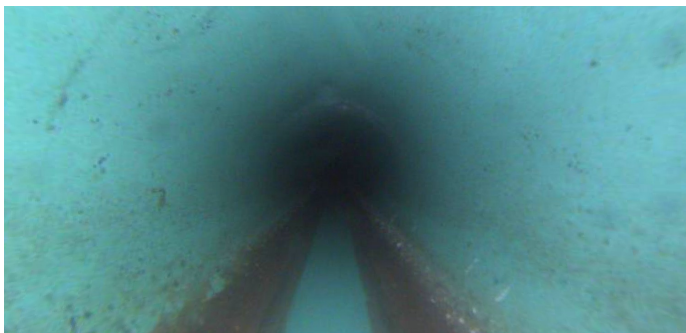
Code: **AMH**  
Description: **Manhole**

Distance (ft): **.0**  
Structural Grade: **0**  
O&M Grade: **0**  
Clock Start/From:  
Clock To:  
1st Value:  
2nd Value:  
Value Percent:  
Continuous Index:  
Within 8" of Joint: **NO**  
Remarks: **M-706-061**

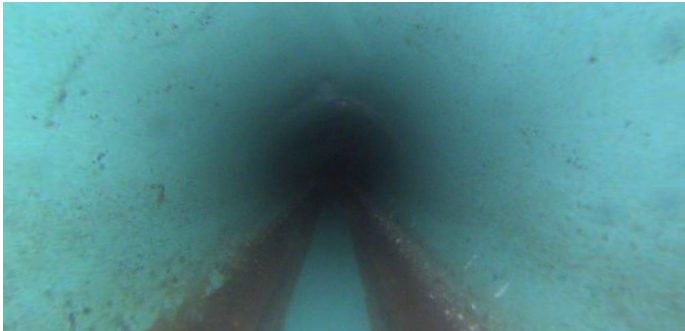
Code:	<b>MWL</b>
Description:	<b>Water Level</b>

Distance (ft):	<b>.0</b>
Structural Grade:	<b>0</b>
O&M Grade:	<b>0</b>
Clock Start/From:	
Clock To:	
1st Value:	
2nd Value:	
Value Percent:	<b>5.000</b>
Continuous Index:	
Within 8" of Joint:	<b>NO</b>
Remarks:

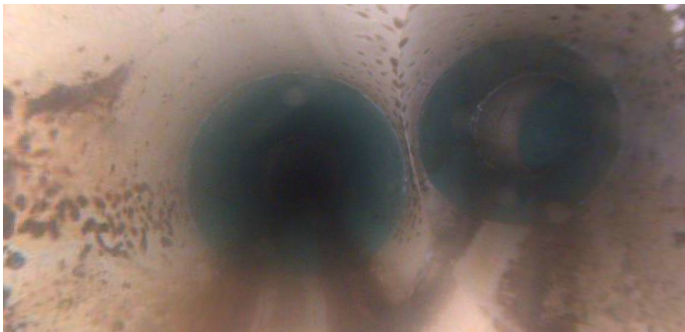
Code:	<b>TF</b>
Description:	<b>Tap Factory</b>

Distance (ft):	<b>36.7</b>
Structural Grade:	<b>0</b>
O&M Grade:	<b>0</b>
Clock Start/From:	<b>3</b>
Clock To:	
1st Value:	<b>4.000</b>
2nd Value:	
Value Percent:	
Continuous Index:	
Within 8" of Joint:	
Remarks:

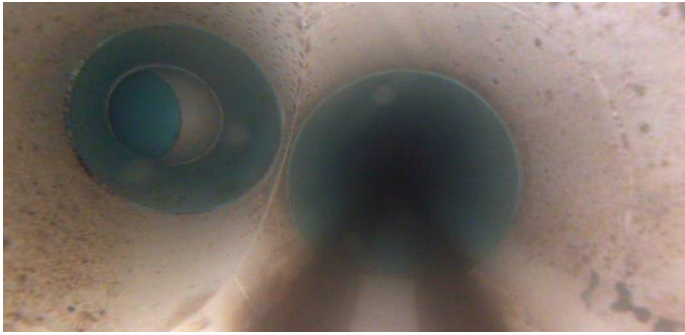
Code: **TF**  
Description: **Tap Factory**

Distance (ft): **38.9**  
Structural Grade: **0**  
O&M Grade: **0**  
Clock Start/From: **9**  
Clock To:  
1st Value: **4.000**  
2nd Value:  
Value Percent:  
Continuous Index:  
Within 8" of Joint:  
Remarks:

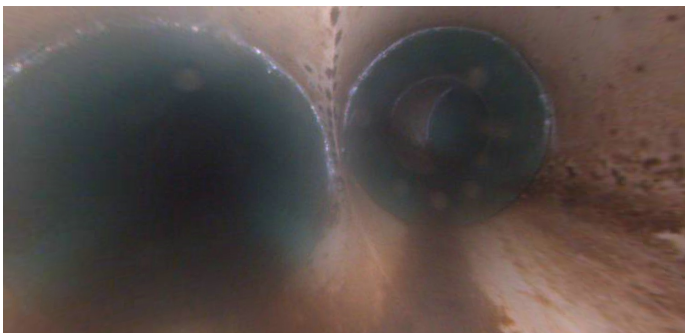
Code: **TFA**  
Description: **Tap Factory Active**

Distance (ft): **57.0**  
Structural Grade: **0**  
O&M Grade: **0**  
Clock Start/From: **3**  
Clock To:  
1st Value: **4.000**  
2nd Value:  
Value Percent:  
Continuous Index:  
Within 8" of Joint:  
Remarks:

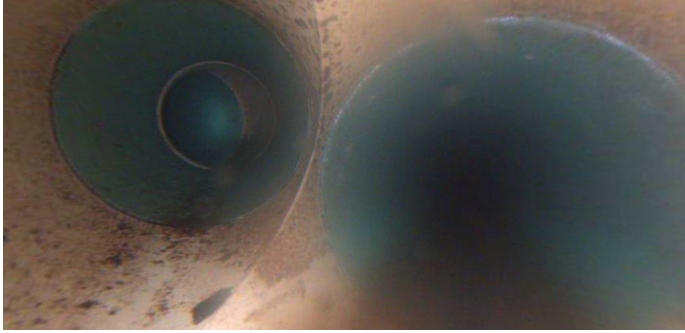
Code: **TFA**  
Description: **Tap Factory Active**

Distance (ft): **59.4**  
Structural Grade: **0**  
O&M Grade: **0**  
Clock Start/From: **9**  
Clock To:  
1st Value: **4.000**  
2nd Value:  
Value Percent:  
Continuous Index:  
Within 8" of Joint:  
Remarks:

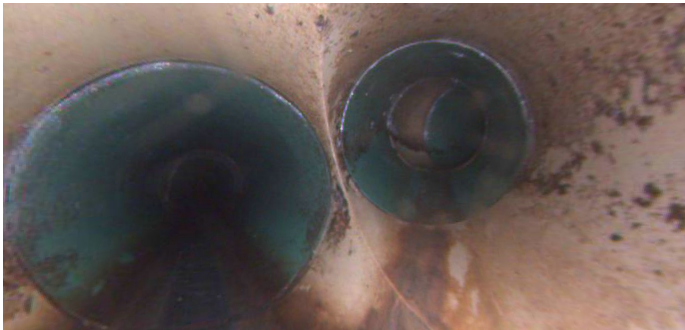
Code: **TFA**  
Description: **Tap Factory Active**

Distance (ft): **81.5**  
Structural Grade: **0**  
O&M Grade: **0**  
Clock Start/From: **3**  
Clock To:  
1st Value: **4.000**  
2nd Value:  
Value Percent:  
Continuous Index:  
Within 8" of Joint:  
Remarks:

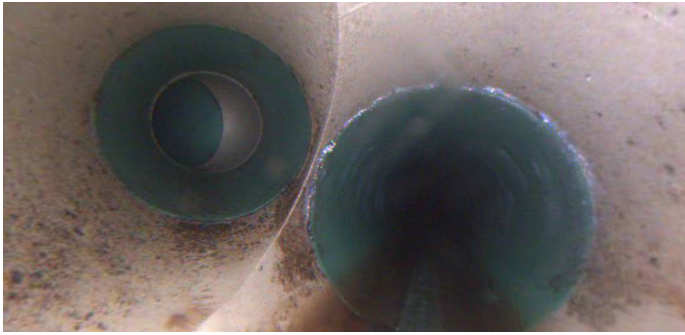
Code: **TF**  
Description: **Tap Factory**

Distance (ft): **84.2**  
Structural Grade: **0**  
O&M Grade: **0**  
Clock Start/From: **9**  
Clock To:  
1st Value: **4.000**  
2nd Value:  
Value Percent:  
Continuous Index:  
Within 8" of Joint:  
Remarks:

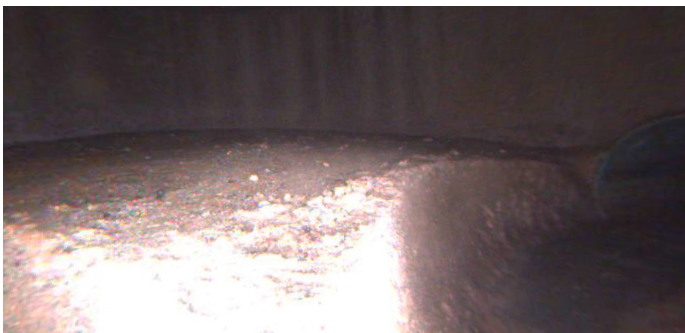
Code: **AMH**  
Description: **Manhole**

Distance (ft): **95.3**  
Structural Grade: **0**  
O&M Grade: **0**  
Clock Start/From:  
Clock To:  
1st Value:  
2nd Value:  
Value Percent:  
Continuous Index:  
Within 8" of Joint: **NO**  
Remarks: **M-706-060**
