Profile/Photo Observation Report

Street:	DEBIE LN & PENNY CT	Flow Control:	Not Controlled
City:	Hobart, IN	Year Renewed:	
Location:	Light Highway	Tape/Media #:	
Purpose:	Maintenance Related	Dia/Height:	8"
Use:	Sanitary	Material:	PVC
Drain Area:	NA	Lining:	Cured in Place
Category:	NA		
Comment:

Location Details:		Direction of Survey:	Downstream
US MH:	M-706-061	DS MH:	M-706-059
		Total Length Surveyed (ft):	349.3

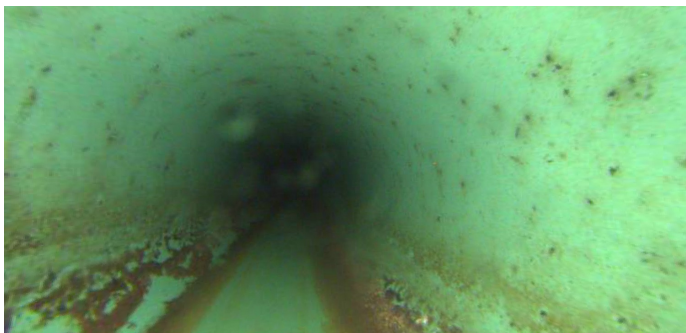
Code: **AMH**
Description: **Manhole**

Distance (ft): **.0**
Structural Grade: **0**
O&M Grade: **0**
Clock Start/From:
Clock To:
1st Value:
2nd Value:
Value Percent:
Continuous Index:
Within 8" of Joint: **NO**
Remarks: **M-706-061**

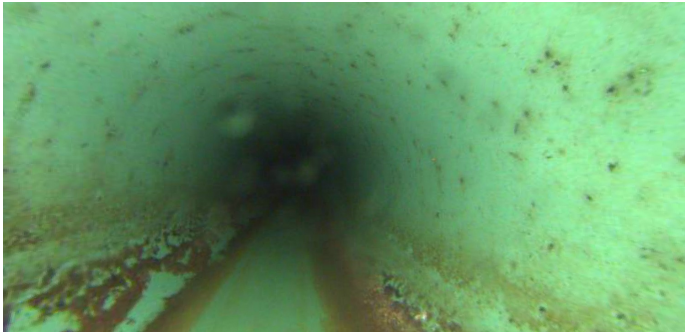
Code:	MWL
Description:	Water Level

Distance (ft):	.0
Structural Grade:	0
O&M Grade:	0
Clock Start/From:	
Clock To:	
1st Value:	
2nd Value:	
Value Percent:	5.000
Continuous Index:	
Within 8" of Joint:	NO
Remarks:

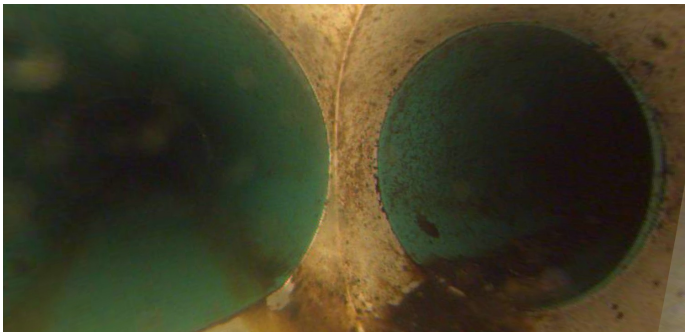
Code:	TFA
Description:	Tap Factory Active

Distance (ft):	38.8
Structural Grade:	0
O&M Grade:	0
Clock Start/From:	3
Clock To:	
1st Value:	4.000
2nd Value:	
Value Percent:	
Continuous Index:	
Within 8" of Joint:	
Remarks:

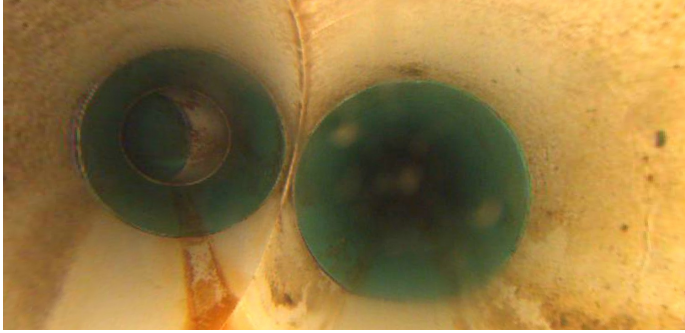
Code: **TF**
Description: **Tap Factory**

Distance (ft): **153.7**
Structural Grade: **0**
O&M Grade: **0**
Clock Start/From: **9**
Clock To:
1st Value: **4.000**
2nd Value:
Value Percent:
Continuous Index:
Within 8" of Joint:
Remarks:

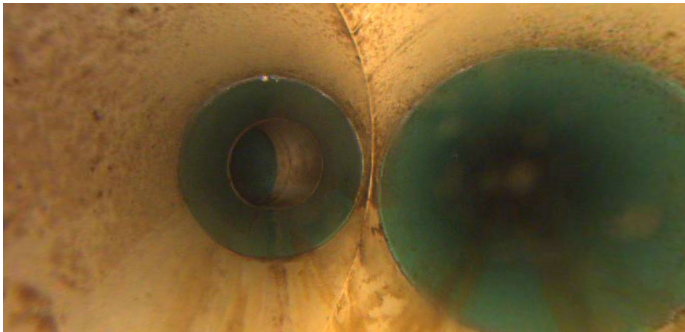
Code: **TF**
Description: **Tap Factory**

Distance (ft): **179.6**
Structural Grade: **0**
O&M Grade: **0**
Clock Start/From: **9**
Clock To:
1st Value: **4.000**
2nd Value:
Value Percent:
Continuous Index:
Within 8" of Joint:
Remarks:

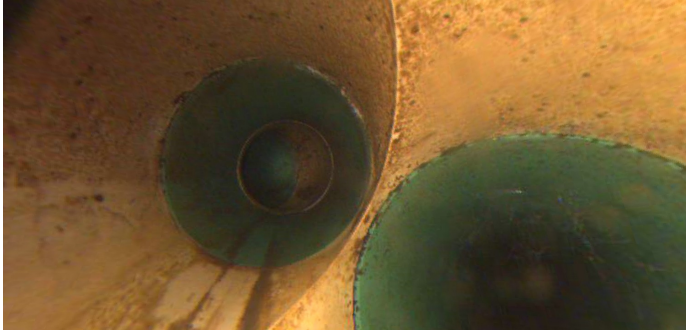
Code: **TF**
Description: **Tap Factory**

Distance (ft): **202.6**
Structural Grade: **0**
O&M Grade: **0**
Clock Start/From: **10**
Clock To:
1st Value: **4.000**
2nd Value:
Value Percent:
Continuous Index:
Within 8" of Joint:
Remarks:

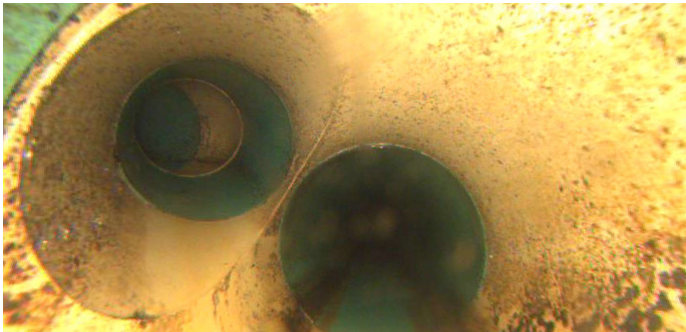
Code: **TFA**
Description: **Tap Factory Active**

Distance (ft): **224.0**
Structural Grade: **0**
O&M Grade: **0**
Clock Start/From: **10**
Clock To:
1st Value: **4.000**
2nd Value:
Value Percent:
Continuous Index:
Within 8" of Joint:
Remarks:

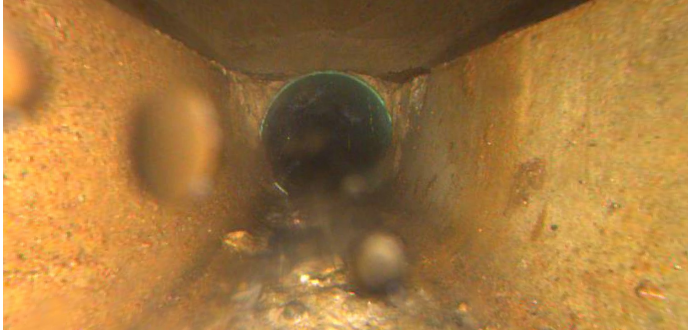
Code:	AMH
Description:	Manhole
Distance (ft):	349.3
Structural Grade:	0
O&M Grade:	0
Clock Start/From:	
Clock To:	
1st Value:	
2nd Value:	
Value Percent:	
Continuous Index:	
Within 8" of Joint:	NO
Remarks:	M-706-059
