Profile/Photo Observation Report

Street:	DEBIE LN	Flow Control:	Not Controlled
City:	Hobart, IN	Year Renewed:	
Location:	Yard	Tape/Media #:	
Purpose:	Routine Assessment	Dia/Height:	8"
Use:	Sanitary	Material:	PVC
Drain Area:	NA	Lining:	
Category:	NA		
Comment:	Flow direction is marked wrong.

Location Details:		Direction of Survey:	Upstream
US MH:	M-706-062	DS MH:	M-706-061
		Total Length Surveyed (ft):	157.3

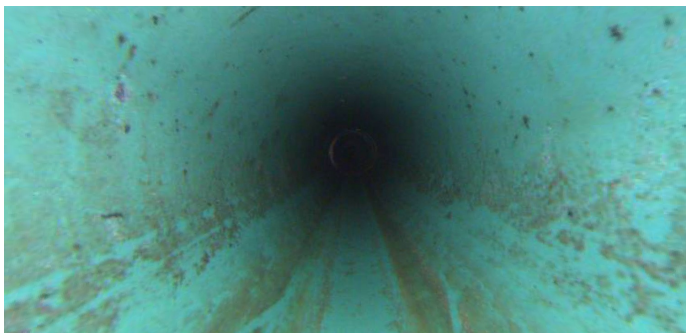
Code: **AMH**
Description: **Manhole**

Distance (ft): **.0**
Structural Grade: **0**
O&M Grade: **0**
Clock Start/From:
Clock To:
1st Value:
2nd Value:
Value Percent:
Continuous Index:
Within 8" of Joint: **NO**
Remarks: **M-706-061**

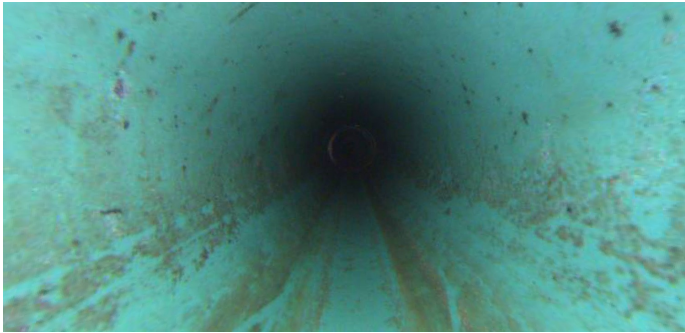
Code:	MWL
Description:	Water Level

Distance (ft):	.0
Structural Grade:	0
O&M Grade:	0
Clock Start/From:	
Clock To:	
1st Value:	
2nd Value:	
Value Percent:	5.000
Continuous Index:	
Within 8" of Joint:	NO
Remarks:

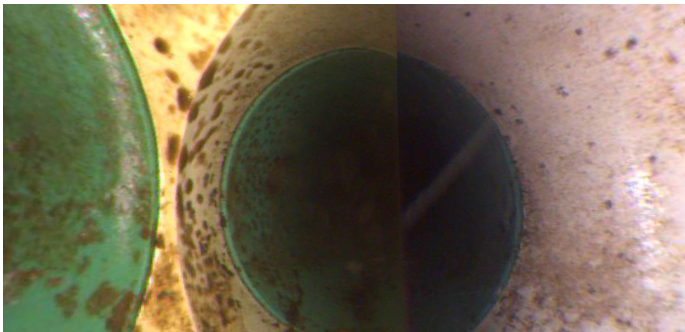
Code:	TF
Description:	Tap Factory

Distance (ft):	4.9
Structural Grade:	0
O&M Grade:	0
Clock Start/From:	9
Clock To:	
1st Value:	4.000
2nd Value:	
Value Percent:	
Continuous Index:	
Within 8" of Joint:	
Remarks:

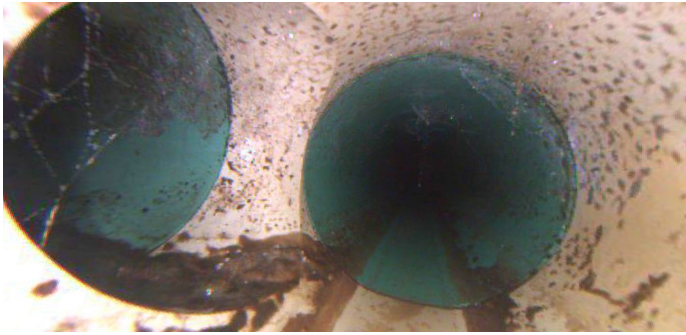
Code: **TF**
Description: **Tap Factory**

Distance (ft): **24.0**
Structural Grade: **0**
O&M Grade: **0**
Clock Start/From: **9**
Clock To:
1st Value: **4.000**
2nd Value:
Value Percent:
Continuous Index:
Within 8" of Joint:
Remarks:

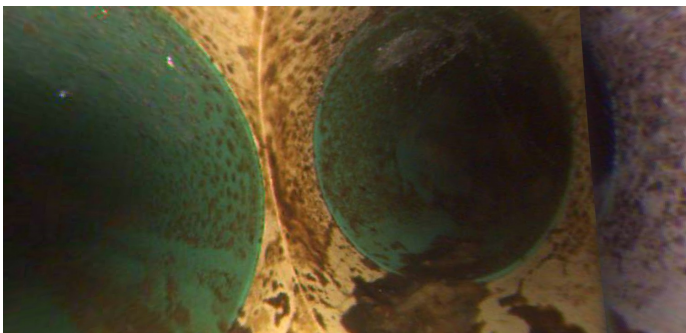
Code: **TF**
Description: **Tap Factory**

Distance (ft): **49.8**
Structural Grade: **0**
O&M Grade: **0**
Clock Start/From: **9**
Clock To:
1st Value: **4.000**
2nd Value:
Value Percent:
Continuous Index:
Within 8" of Joint:
Remarks:

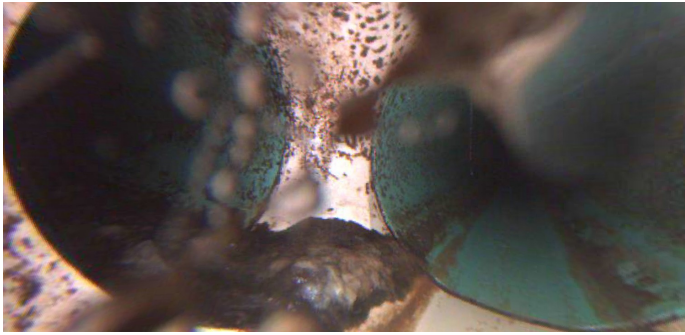
Code: **TF**
Description: **Tap Factory**

Distance (ft): **74.4**
Structural Grade: **0**
O&M Grade: **0**
Clock Start/From: **9**
Clock To:
1st Value: **4.000**
2nd Value:
Value Percent:
Continuous Index:
Within 8" of Joint:
Remarks:

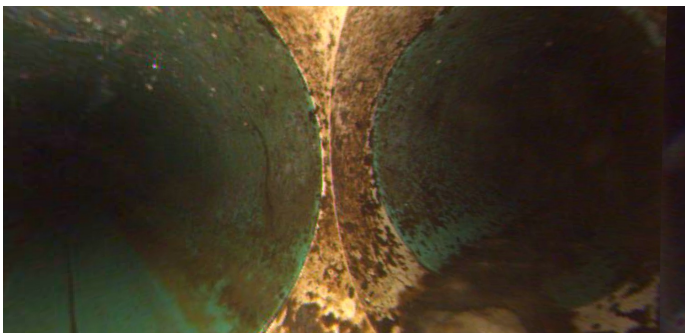
Code: **TF**
Description: **Tap Factory**

Distance (ft): **95.0**
Structural Grade: **0**
O&M Grade: **0**
Clock Start/From: **9**
Clock To:
1st Value: **4.000**
2nd Value:
Value Percent:
Continuous Index:
Within 8" of Joint:
Remarks:

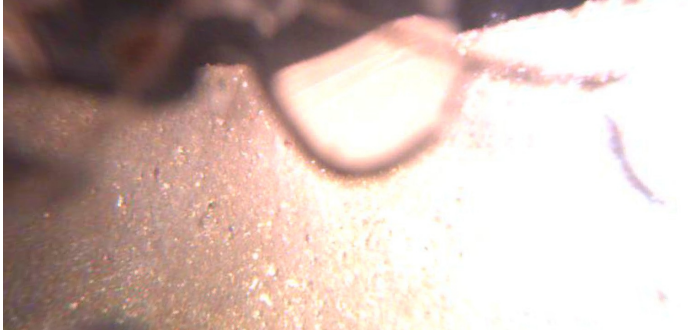
Code:	AMH
Description:	Manhole
Distance (ft):	157.3
Structural Grade:	0
O&M Grade:	0
Clock Start/From:	
Clock To:	
1st Value:	
2nd Value:	
Value Percent:	
Continuous Index:	
Within 8" of Joint:	NO
Remarks:	M-706-062
