## Profile/Photo Observation Report

Street:	<b>FOXCROFT STREET</b>	Flow Control:	<b>Not Controlled</b>
City:	<b>Hobart, IN</b>	Year Renewed:	
Location:	<b>Yard</b>	Tape/Media #:	
Purpose:	<b>Routine Assessment</b>	Dia/Height:	<b>8"</b>
Use:	<b>Sanitary</b>	Material:	<b>PVC</b>
Drain Area:	<b>NA</b>	Lining:	
Category:	<b>NA</b>		
Comment:	<b>Flow direction is marked wrong.</b>

Location Details:		Direction of Survey:	<b>Upstream</b>
US MH:	<b>M-706-062</b>	DS MH:	<b>M-706-061</b>
		Total Length Surveyed (ft):	<b>157.3</b>

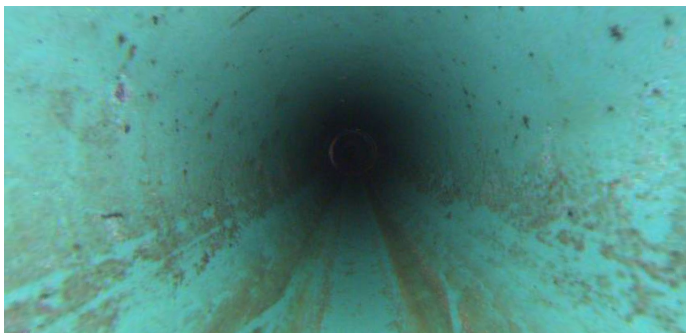
Code: **AMH**  
Description: **Manhole**

Distance (ft): **.0**  
Structural Grade: **0**  
O&M Grade: **0**  
Clock Start/From:  
Clock To:  
1st Value:  
2nd Value:  
Value Percent:  
Continuous Index:  
Within 8" of Joint: **NO**  
Remarks: **M-706-061**

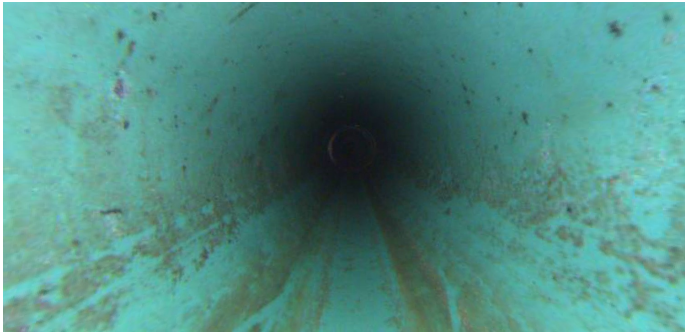
Code:	<b>MWL</b>
Description:	<b>Water Level</b>

Distance (ft):	<b>.0</b>
Structural Grade:	<b>0</b>
O&M Grade:	<b>0</b>
Clock Start/From:	
Clock To:	
1st Value:	
2nd Value:	
Value Percent:	<b>5.000</b>
Continuous Index:	
Within 8" of Joint:	<b>NO</b>
Remarks:

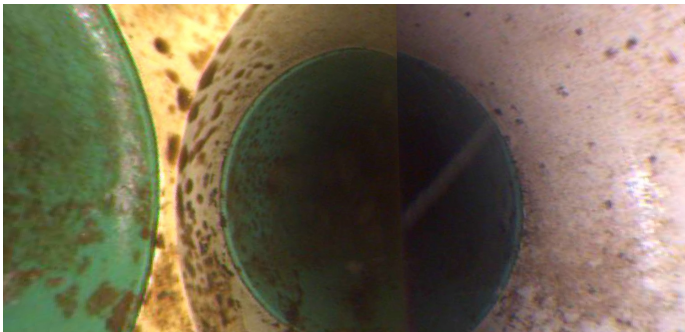
Code:	<b>TF</b>
Description:	<b>Tap Factory</b>

Distance (ft):	<b>4.9</b>
Structural Grade:	<b>0</b>
O&M Grade:	<b>0</b>
Clock Start/From:	<b>9</b>
Clock To:	
1st Value:	<b>4.000</b>
2nd Value:	
Value Percent:	
Continuous Index:	
Within 8" of Joint:	
Remarks:

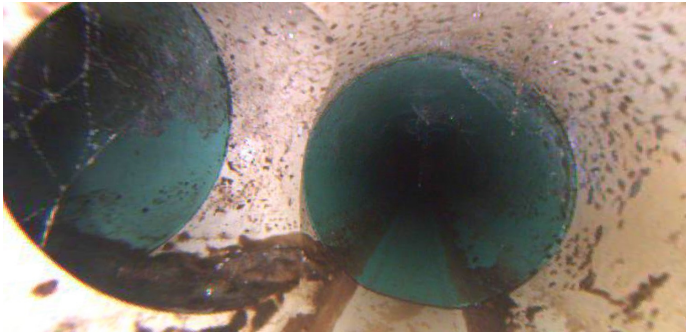
Code: **TF**  
Description: **Tap Factory**

Distance (ft): **24.0**  
Structural Grade: **0**  
O&M Grade: **0**  
Clock Start/From: **9**  
Clock To:  
1st Value: **4.000**  
2nd Value:  
Value Percent:  
Continuous Index:  
Within 8" of Joint:  
Remarks:

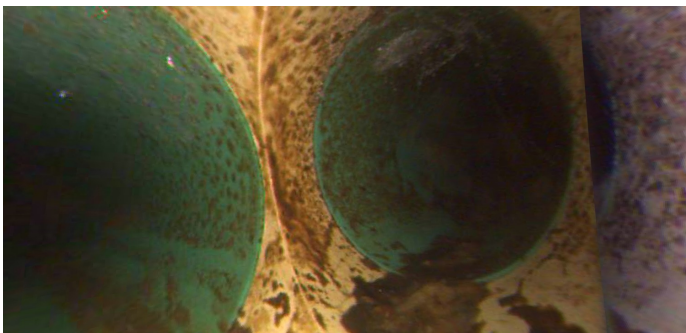
Code: **TF**  
Description: **Tap Factory**

Distance (ft): **49.8**  
Structural Grade: **0**  
O&M Grade: **0**  
Clock Start/From: **9**  
Clock To:  
1st Value: **4.000**  
2nd Value:  
Value Percent:  
Continuous Index:  
Within 8" of Joint:  
Remarks:

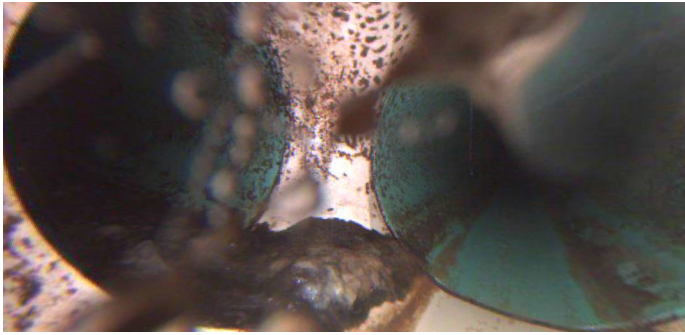
Code: **TF**  
Description: **Tap Factory**

Distance (ft): **74.4**  
Structural Grade: **0**  
O&M Grade: **0**  
Clock Start/From: **9**  
Clock To:  
1st Value: **4.000**  
2nd Value:  
Value Percent:  
Continuous Index:  
Within 8" of Joint:  
Remarks:

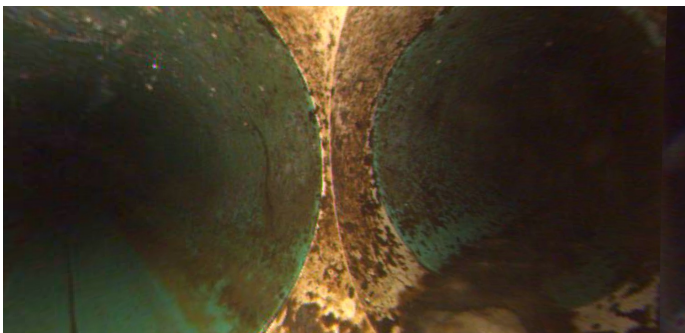
Code: **TF**  
Description: **Tap Factory**

Distance (ft): **95.0**  
Structural Grade: **0**  
O&M Grade: **0**  
Clock Start/From: **9**  
Clock To:  
1st Value: **4.000**  
2nd Value:  
Value Percent:  
Continuous Index:  
Within 8" of Joint:  
Remarks:

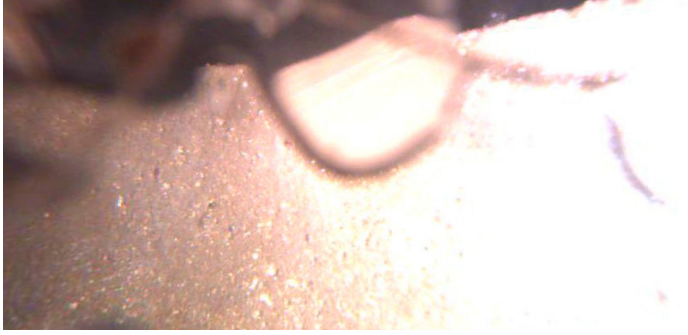
Code:	AMH
Description:	Manhole
Distance (ft):	157.3
Structural Grade:	0
O&M Grade:	0
Clock Start/From:	
Clock To:	
1st Value:	
2nd Value:	
Value Percent:	
Continuous Index:	
Within 8" of Joint:	NO
Remarks:	M-706-062
