## Profile/Photo Observation Report

Street:	<b>S LAKE PARK AVE &amp; DEBIE LN</b>	Flow Control:	<b>Not Controlled</b>
City:	<b>Hobart, IN</b>	Year Renewed:	
Location:	<b>Yard</b>	Tape/Media #:	
Purpose:	<b>Routine Assessment</b>	Dia/Height:	<b>8"</b>
Use:	<b>Sanitary</b>	Material:	<b>PVC</b>
Drain Area:	<b>NA</b>	Lining:	
Category:	<b>NA</b>		
Comment:	<b>Flow direction is marked wrong.</b>		
Location Details:		Direction of Survey:	<b>Downstream</b>
US MH:	<b>M-706-063</b>	DS MH:	<b>M-706-062</b>
		Total Length Surveyed (ft):	<b>74.8</b>

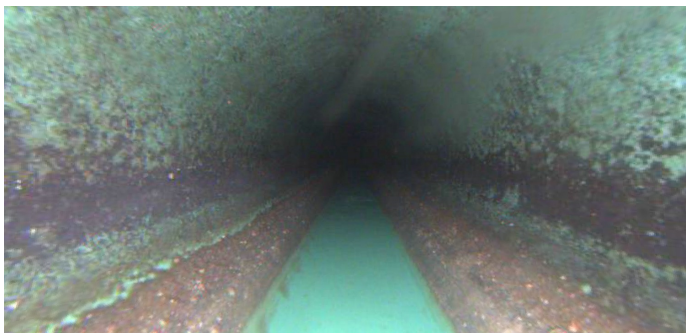
Code: **AMH**  
Description: **Manhole**

Distance (ft): **.0**  
Structural Grade: **0**  
O&M Grade: **0**  
Clock Start/From:  
Clock To:  
1st Value:  
2nd Value:  
Value Percent:  
Continuous Index:  
Within 8" of Joint: **NO**  
Remarks: **M-706-063**

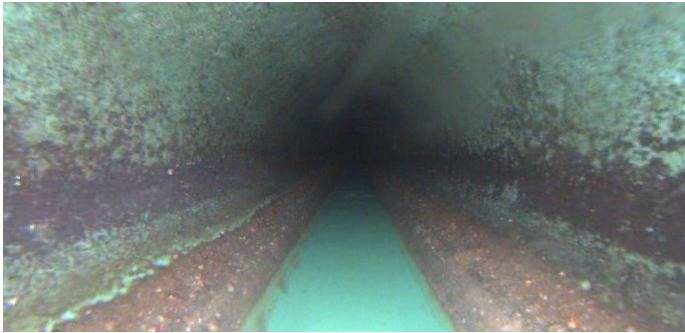
Code:	<b>MWL</b>
Description:	<b>Water Level</b>

Distance (ft):	<b>.0</b>
Structural Grade:	<b>0</b>
O&M Grade:	<b>0</b>
Clock Start/From:	
Clock To:	
1st Value:	
2nd Value:	
Value Percent:	<b>5.000</b>
Continuous Index:	
Within 8" of Joint:	<b>NO</b>
Remarks:

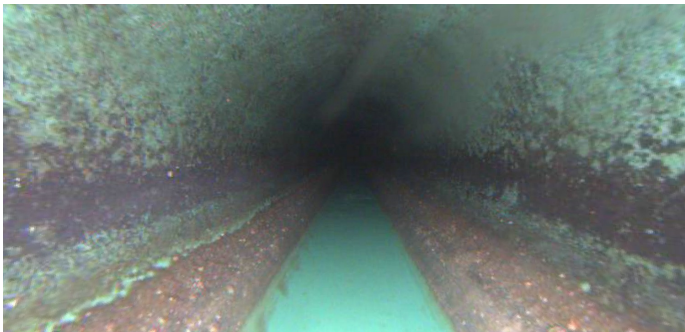
Code:	<b>DAGS</b>
Description:	<b>Deposits Attached Grease</b>

Distance (ft):	<b>.0</b>
Structural Grade:	<b>0</b>
O&M Grade:	<b>2</b>
Clock Start/From:	<b>5</b>
Clock To:	<b>7</b>
1st Value:	
2nd Value:	
Value Percent:	<b>5.000</b>
Continuous Index:	<b>S01</b>
Within 8" of Joint:	<b>NO</b>
Remarks:

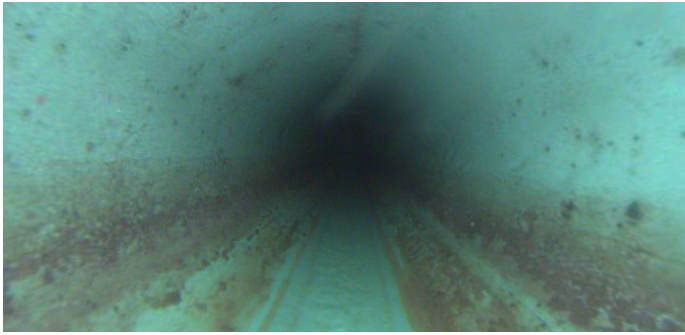
Code: **DAGS**  
Description: **Deposits Attached Grease**

Distance (ft): **15.9**  
Structural Grade: **0**  
O&M Grade: **2**  
Clock Start/From: **5**  
Clock To: **7**  
1st Value:  
2nd Value:  
Value Percent: **5.000**  
Continuous Index: **F01**  
Within 8" of Joint: **NO**  
Remarks:

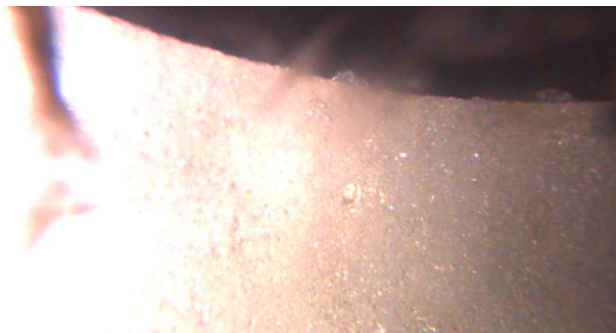
Code: **AMH**  
Description: **Manhole**

Distance (ft): **74.8**  
Structural Grade: **0**  
O&M Grade: **0**  
Clock Start/From:  
Clock To:  
1st Value:  
2nd Value:  
Value Percent:  
Continuous Index:  
Within 8" of Joint: **NO**  
Remarks: **M-706-062**
