## Profile/Photo Observation Report

Street:	<b>Middle School Lot</b>	Flow Control:	
City:	<b>Hobart, IN</b>	Year Renewed:	
Location:	<b>Parking Lot</b>	Tape/Media #:	<b>930</b>
Purpose:	<b>Routine Assessment</b>	Dia/Height:	<b>8"</b>
Use:	<b>Sanitary</b>	Material:	<b>VCP</b>
Drain Area:		Lining:	
Category:	<b>NA</b>		
Comment:

Location Details:		Direction of Survey:	<b>Upstream</b>
US MH:	<b>M-706-65</b>	DS MH:	<b>M-706-64</b>
		Total Length Surveyed (ft):	<b>6.4</b>

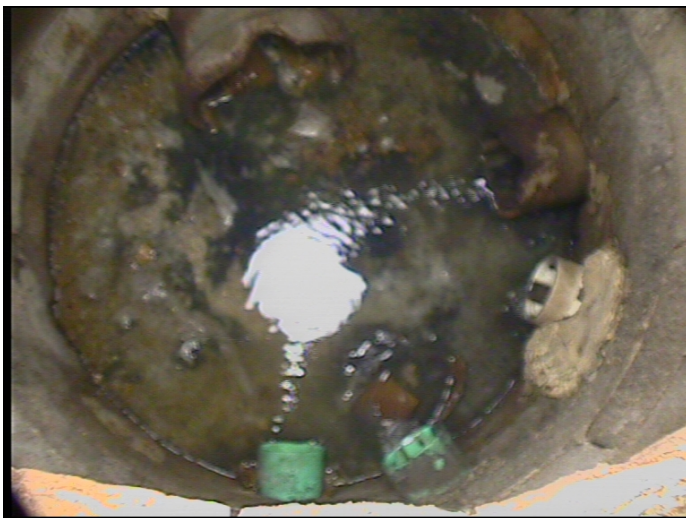
Code:	AMH
Description:	Manhole
Distance (ft):	.0
Structural Grade:	0
O&M Grade:	0
Clock Start/From:	
Clock To:	
1st Value:	
2nd Value:	
Value Percent:	
Continuous Index:	
Within 8" of Joint:	NO
Remarks:	M-706-64

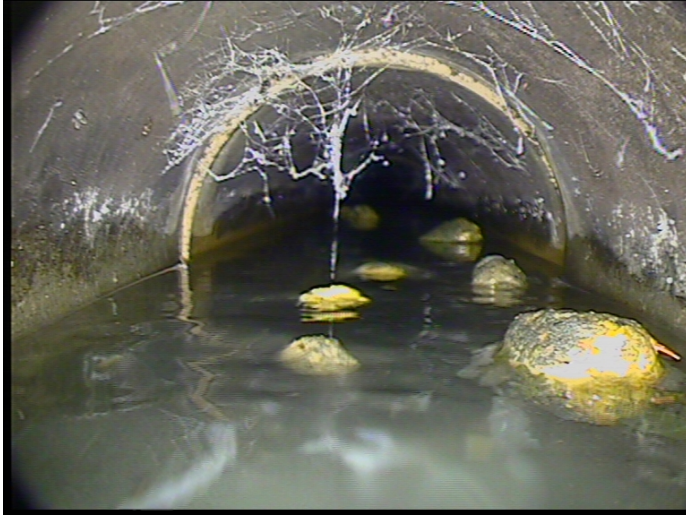
Code: **MWL**  
Description: **Water Level**

Distance (ft): **.0**  
Structural Grade: **0**  
O&M Grade: **0**  
Clock Start/From:  
Clock To:  
1st Value:  
2nd Value:  
Value Percent: **15.000**  
Continuous Index:  
Within 8" of Joint: **NO**  
Remarks:

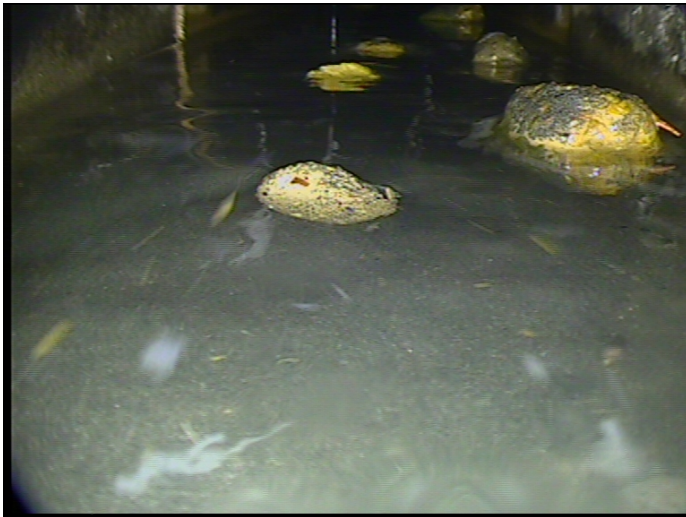
Code: **DSF**  
Description: **Deposits Settled Fine**

Distance (ft): **.0**  
Structural Grade: **0**  
O&M Grade: **3**  
Clock Start/From: **4**  
Clock To: **8**  
1st Value:  
2nd Value:  
Value Percent: **15.000**  
Continuous Index: **S01**  
Within 8" of Joint: **YES**  
Remarks:
