Profile/Photo Observation Report

Date:	03/29/2018	Weather:		Coding:	PACP 6.0
Pipe Length (ft):	315.0	Owner:	NA	Pre Clean:	Not Known
P.O.#:		Surveyor:	Mark Ruby	PSR:	P-708-004-003
Customer:		Clean Date:	01/01/1900	Shape:	C

Street:	LINCOLN ST	Flow Control:	Not Controlled
City:	Hobart, IN	Year Renewed:	
Location:	Light Highway	Tape/Media #:	
Purpose:	Maintenance Related	Dia/Height:	8"
Use:	Sanitary	Material:	PVC
Drain Area:	NA	Lining:	
Category:	NA		
Comment:

Location Details:		Direction of Survey:	Upstream
US MH:	M-707-003	DS MH:	M-708-004
		Total Length Surveyed (ft):	338.5

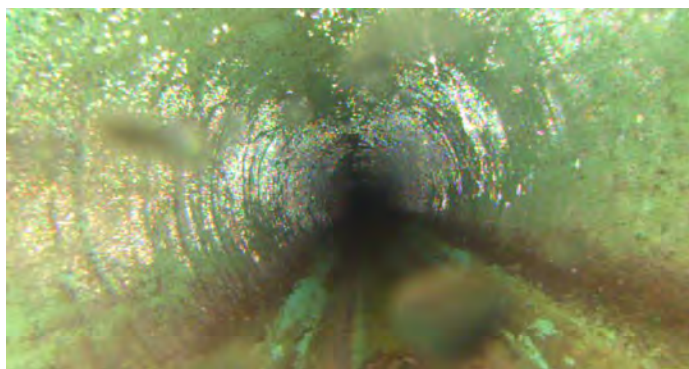
Code: **AMH**
Description: **Manhole**

Distance (ft): **.0**
Structural Grade: **0**
O&M Grade: **0**
Clock Start/From:
Clock To:
1st Value:
2nd Value:
Value Percent:
Continuous Index:
Within 8" of Joint: **NO**
Remarks: **M-708-004**

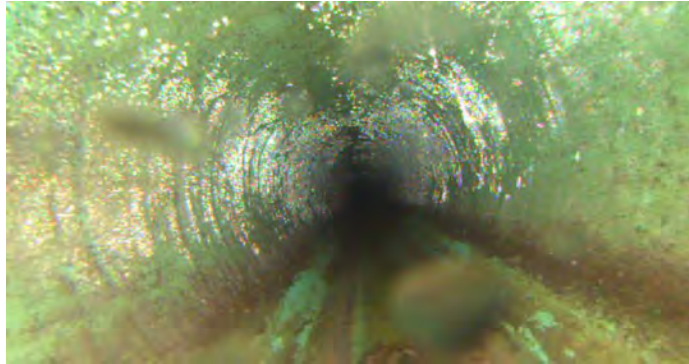
Code: **MWL**
Description: **Water Level**

Distance (ft): **.0**
Structural Grade: **0**
O&M Grade: **0**
Clock Start/From:
Clock To:
1st Value:
2nd Value:
Value Percent: **10.000**
Continuous Index:
Within 8" of Joint: **NO**
Remarks:

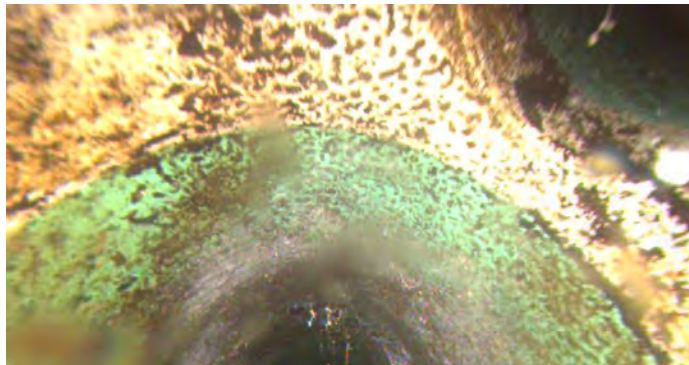
Code: **TF**
Description: **Tap Factory**

Distance (ft): **9.1**
Structural Grade: **0**
O&M Grade: **0**
Clock Start/From: **2**
Clock To:
1st Value: **4.000**
2nd Value:
Value Percent:
Continuous Index:
Within 8" of Joint:
Remarks:

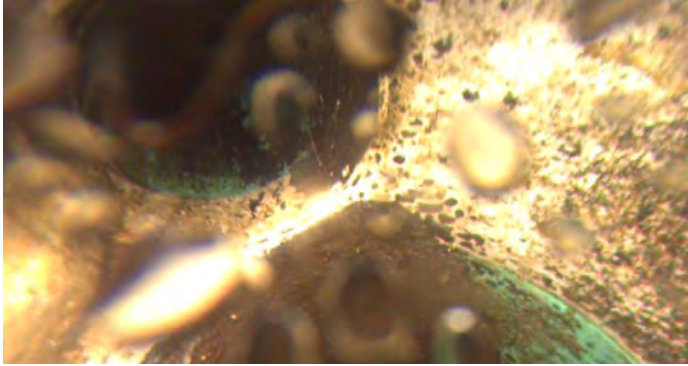
Code: **TF**
Description: **Tap Factory**

Distance (ft): **79.9**
Structural Grade: **0**
O&M Grade: **0**
Clock Start/From: **10**
Clock To:
1st Value: **4.000**
2nd Value:
Value Percent:
Continuous Index:
Within 8" of Joint:
Remarks:

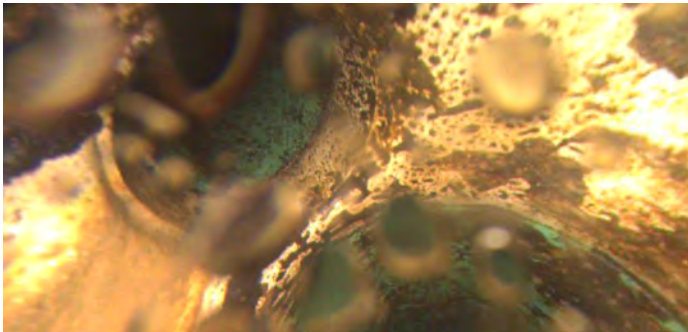
Code: **TF**
Description: **Tap Factory**

Distance (ft): **113.3**
Structural Grade: **0**
O&M Grade: **0**
Clock Start/From: **11**
Clock To:
1st Value: **4.000**
2nd Value:
Value Percent:
Continuous Index:
Within 8" of Joint:
Remarks:

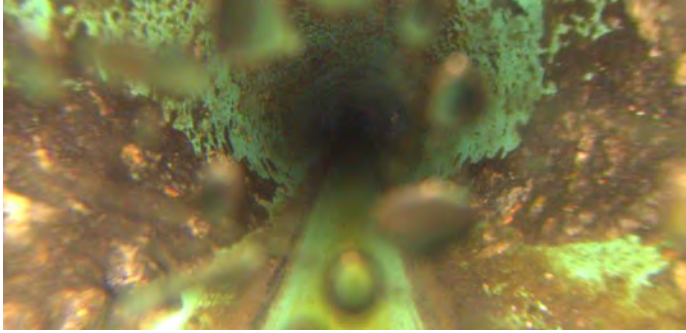
Code: **DAGS**
Description: **Deposits Attached Grease**

Distance (ft): **113.8**
Structural Grade: **0**
O&M Grade: **2**
Clock Start/From: **8**
Clock To: **4**
1st Value:
2nd Value:
Value Percent: **5.000**
Continuous Index:
Within 8" of Joint: **NO**
Remarks:

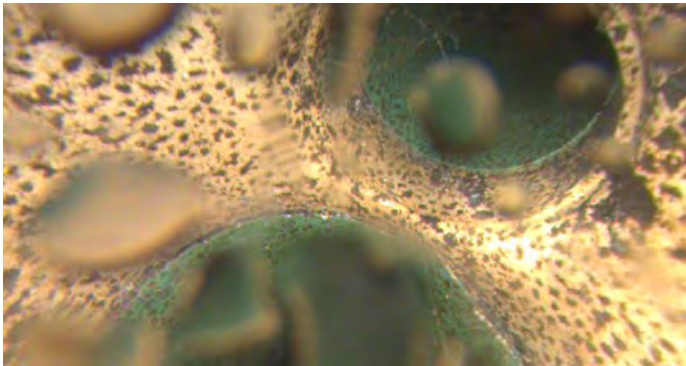
Code: **TF**
Description: **Tap Factory**

Distance (ft): **119.6**
Structural Grade: **0**
O&M Grade: **0**
Clock Start/From: **2**
Clock To:
1st Value: **4.000**
2nd Value:
Value Percent:
Continuous Index:
Within 8" of Joint:
Remarks:

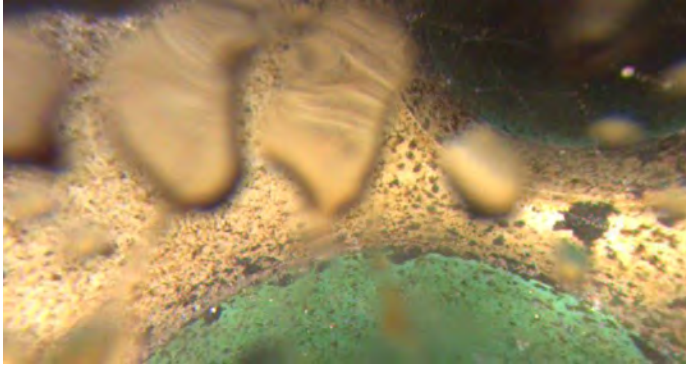
Code: **TF**
Description: **Tap Factory**

Distance (ft): **147.4**
Structural Grade: **0**
O&M Grade: **0**
Clock Start/From: **2**
Clock To:
1st Value: **4.000**
2nd Value:
Value Percent:
Continuous Index:
Within 8" of Joint:
Remarks:

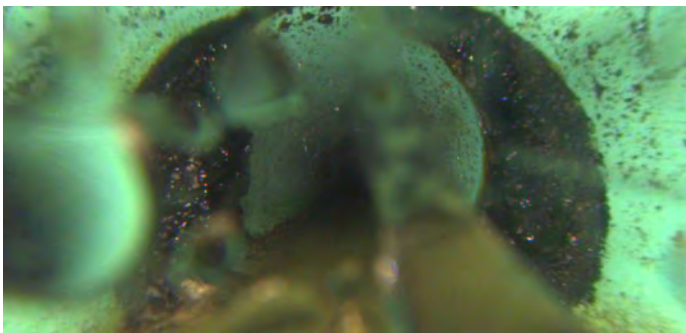
Code: **DAE**
Description: **Deposits Attached Encrustation**

Distance (ft): **173.8**
Structural Grade: **0**
O&M Grade: **3**
Clock Start/From: **8**
Clock To: **4**
1st Value:
2nd Value:
Value Percent: **20.000**
Continuous Index:
Within 8" of Joint: **NO**
Remarks:

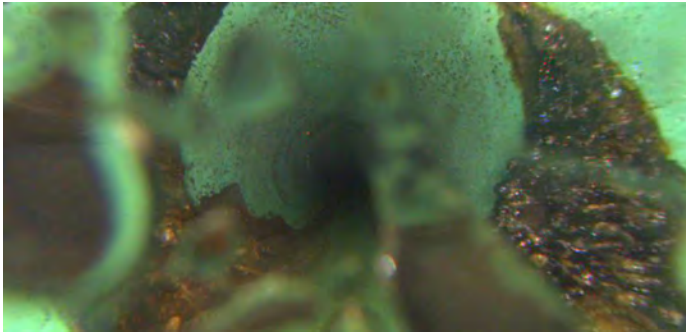
Code: **DAE**
Description: **Deposits Attached Encrustation**

Distance (ft): **214.3**
Structural Grade: **0**
O&M Grade: **2**
Clock Start/From: **8**
Clock To: **4**
1st Value:
2nd Value:
Value Percent: **10.000**
Continuous Index:
Within 8" of Joint: **YES**
Remarks:

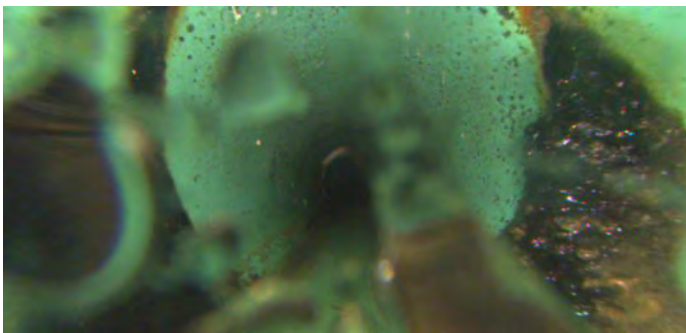
Code: **DAE**
Description: **Deposits Attached Encrustation**

Distance (ft): **241.3**
Structural Grade: **0**
O&M Grade: **2**
Clock Start/From: **8**
Clock To: **4**
1st Value:
2nd Value:
Value Percent: **10.000**
Continuous Index:
Within 8" of Joint: **YES**
Remarks:

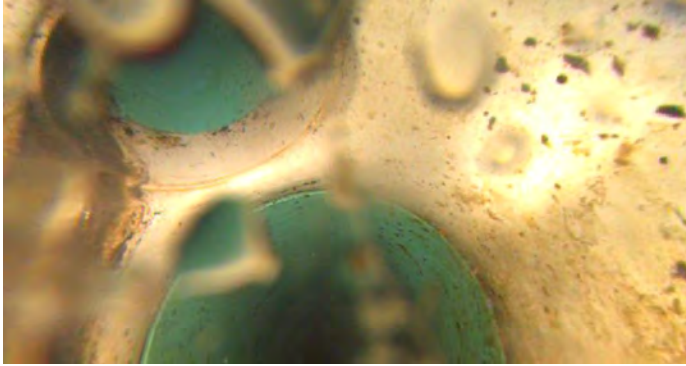
Code: **TF**
Description: **Tap Factory**

Distance (ft): **244.7**
Structural Grade: **0**
O&M Grade: **0**
Clock Start/From: **10**
Clock To:
1st Value: **4.000**
2nd Value:
Value Percent:
Continuous Index:
Within 8" of Joint:
Remarks:

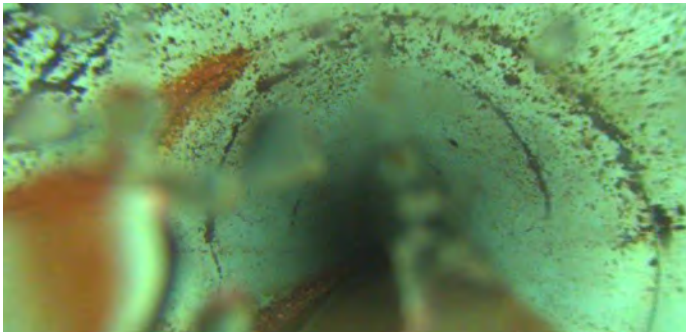
Code: **IW**
Description: **Infil Weeper**

Distance (ft): **282.3**
Structural Grade: **0**
O&M Grade: **2**
Clock Start/From: **8**
Clock To: **12**
1st Value:
2nd Value:
Value Percent:
Continuous Index:
Within 8" of Joint: **YES**
Remarks:

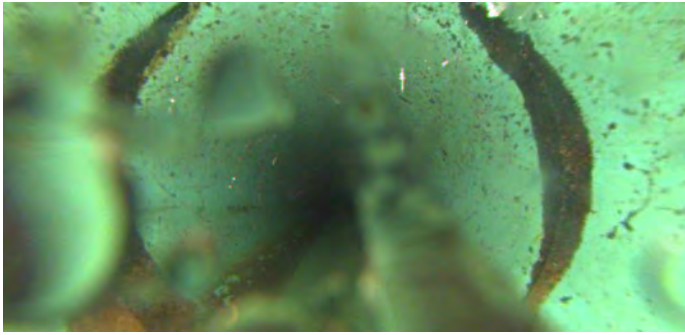
Code: **IW**
Description: **Infil Weeper**

Distance (ft): **295.7**
Structural Grade: **0**
O&M Grade: **2**
Clock Start/From: **8**
Clock To: **4**
1st Value:
2nd Value:
Value Percent:
Continuous Index:
Within 8" of Joint:
Remarks:

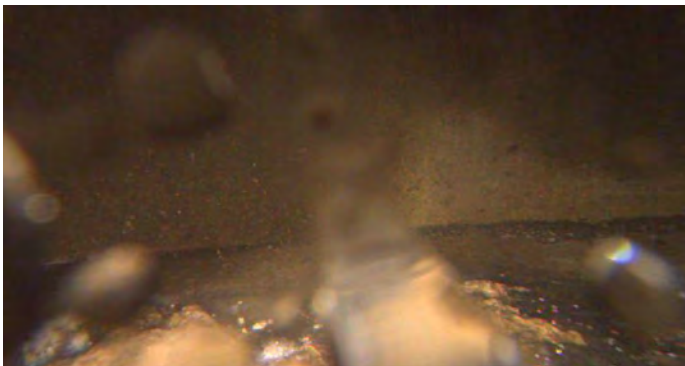
Code: **AMH**
Description: **Manhole**

Distance (ft): **338.5**
Structural Grade: **0**
O&M Grade: **0**
Clock Start/From:
Clock To:
1st Value:
2nd Value:
Value Percent:
Continuous Index:
Within 8" of Joint: **NO**
Remarks: **M-707-003**
