Profile/Photo Observation Report

Date:	03/29/2018	Weather:		Coding:	PACP 6.0
Pipe Length (ft):	315.0	Owner:	NA	Pre Clean:	Not Known
P.O.#:		Surveyor:	Mark Ruby	PSR:	P-708-004-003
Customer:		Clean Date:	01/01/1900	Shape:	C

Street:	Lincoln	Flow Control:	Not Controlled
City:	Hobart, IN	Year Renewed:	
Location:	Light Highway	Tape/Media #:	
Purpose:	Maintenance Related	Dia/Height:	8"
Use:	Sanitary	Material:	PVC
Drain Area:	NA	Lining:	
Category:	NA		
Comment:

Location Details:		Direction of Survey:	Upstream
US MH:	M-707-003	DS MH:	M-708-004
		Total Length Surveyed (ft):	338.5

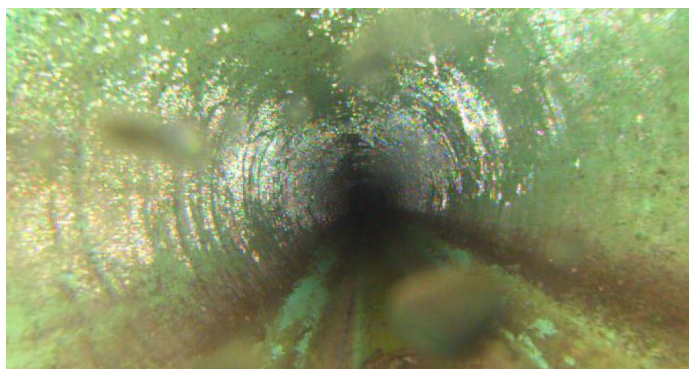
Code: **AMH**
 Description: **Manhole**

Distance (ft): **.0**
 Structural Grade: **0**
 O&M Grade: **0**
 Clock Start/From:
 Clock To:
 1st Value:
 2nd Value:
 Value Percent:
 Continuous Index:
 Within 8" of Joint: **NO**
 Remarks: **M-708-004**

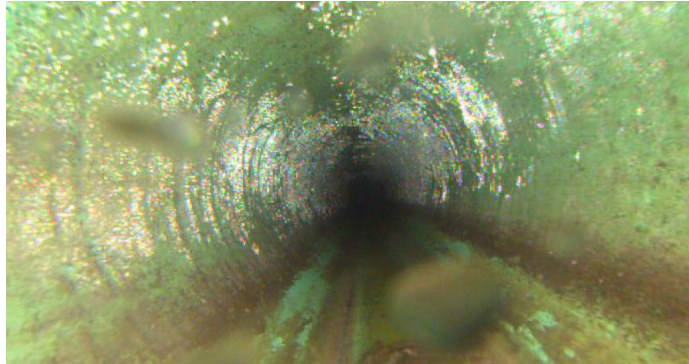
Code: **MWL**
Description: **Water Level**

Distance (ft): **.0**
Structural Grade: **0**
O&M Grade: **0**
Clock Start/From:
Clock To:
1st Value:
2nd Value:
Value Percent: **10.000**
Continuous Index:
Within 8" of Joint: **NO**
Remarks:

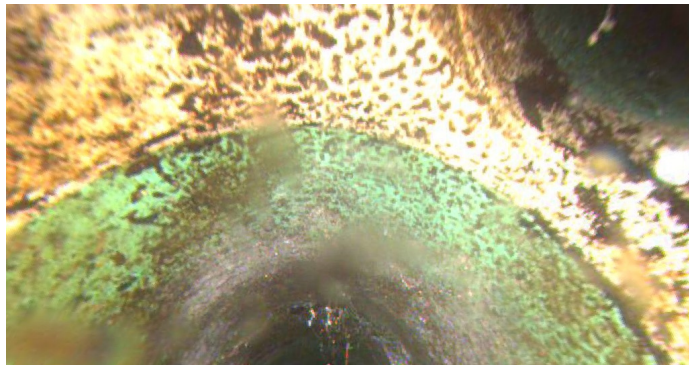
Code: **TF**
Description: **Tap Factory**

Distance (ft): **9.1**
Structural Grade: **0**
O&M Grade: **0**
Clock Start/From: **2**
Clock To:
1st Value: **4.000**
2nd Value:
Value Percent:
Continuous Index:
Within 8" of Joint:
Remarks:

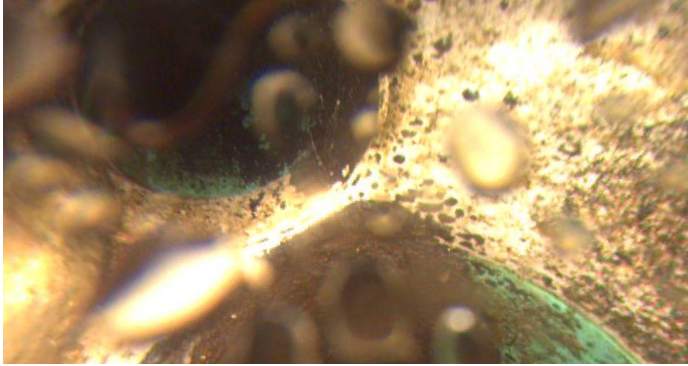
Code: **TF**
Description: **Tap Factory**

Distance (ft): **79.9**
Structural Grade: **0**
O&M Grade: **0**
Clock Start/From: **10**
Clock To:
1st Value: **4.000**
2nd Value:
Value Percent:
Continuous Index:
Within 8" of Joint:
Remarks:

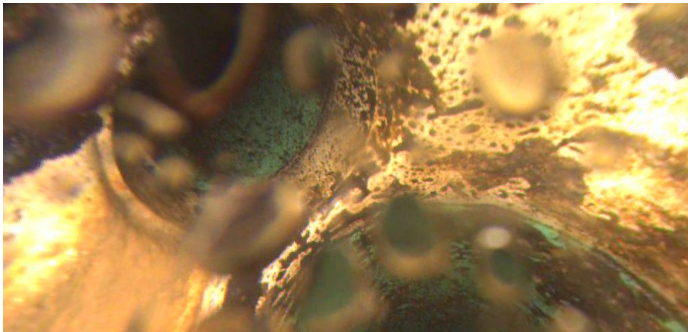
Code: **TF**
Description: **Tap Factory**

Distance (ft): **113.3**
Structural Grade: **0**
O&M Grade: **0**
Clock Start/From: **11**
Clock To:
1st Value: **4.000**
2nd Value:
Value Percent:
Continuous Index:
Within 8" of Joint:
Remarks:

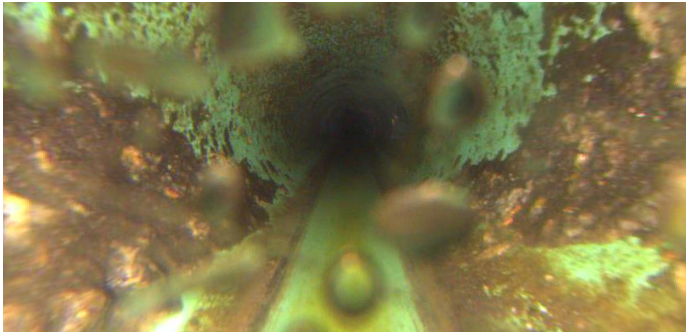
Code: **DAGS**
Description: **Deposits Attached Grease**

Distance (ft): **113.8**
Structural Grade: **0**
O&M Grade: **2**
Clock Start/From: **8**
Clock To: **4**
1st Value:
2nd Value:
Value Percent: **5.000**
Continuous Index:
Within 8" of Joint: **NO**
Remarks:

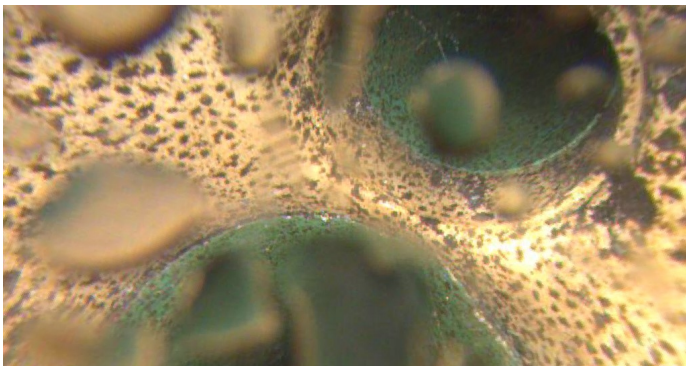
Code: **TF**
Description: **Tap Factory**

Distance (ft): **119.6**
Structural Grade: **0**
O&M Grade: **0**
Clock Start/From: **2**
Clock To:
1st Value: **4.000**
2nd Value:
Value Percent:
Continuous Index:
Within 8" of Joint:
Remarks:

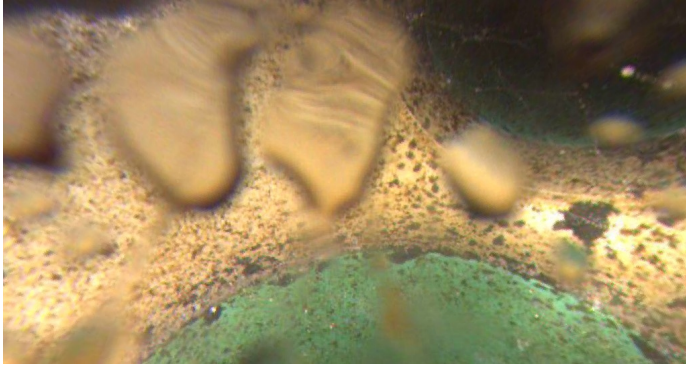
Code: **TF**
Description: **Tap Factory**

Distance (ft): **147.4**
Structural Grade: **0**
O&M Grade: **0**
Clock Start/From: **2**
Clock To:
1st Value: **4.000**
2nd Value:
Value Percent:
Continuous Index:
Within 8" of Joint:
Remarks:

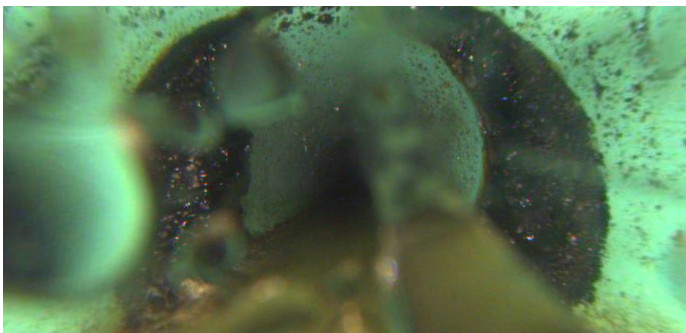
Code: **DAE**
Description: **Deposits Attached Encrustation**

Distance (ft): **173.8**
Structural Grade: **0**
O&M Grade: **3**
Clock Start/From: **8**
Clock To: **4**
1st Value:
2nd Value:
Value Percent: **20.000**
Continuous Index:
Within 8" of Joint: **NO**
Remarks:

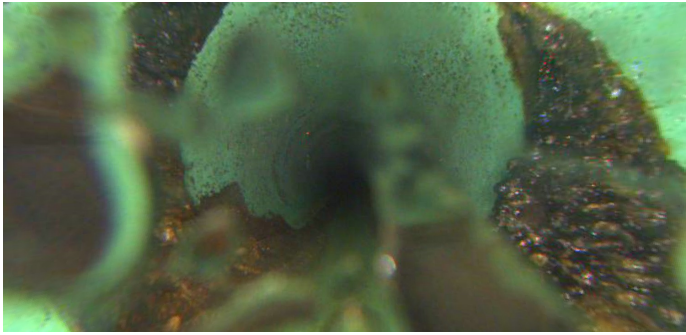
Code: **DAE**
Description: **Deposits Attached Encrustation**

Distance (ft): **214.3**
Structural Grade: **0**
O&M Grade: **2**
Clock Start/From: **8**
Clock To: **4**
1st Value:
2nd Value:
Value Percent: **10.000**
Continuous Index:
Within 8" of Joint: **YES**
Remarks:

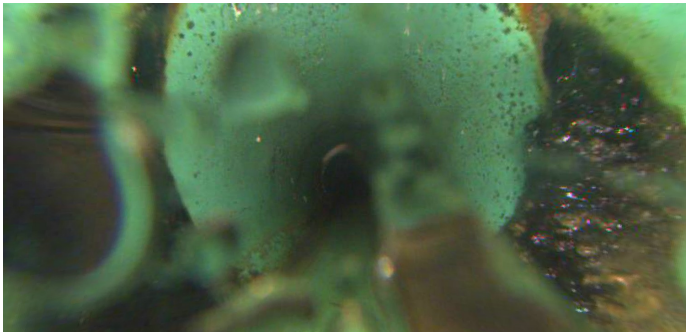
Code: **DAE**
Description: **Deposits Attached Encrustation**

Distance (ft): **241.3**
Structural Grade: **0**
O&M Grade: **2**
Clock Start/From: **8**
Clock To: **4**
1st Value:
2nd Value:
Value Percent: **10.000**
Continuous Index:
Within 8" of Joint: **YES**
Remarks:

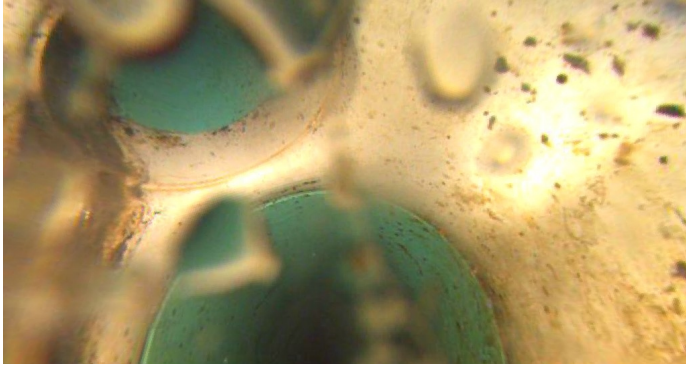
Code: **TF**
Description: **Tap Factory**

Distance (ft): **244.7**
Structural Grade: **0**
O&M Grade: **0**
Clock Start/From: **10**
Clock To:
1st Value: **4.000**
2nd Value:
Value Percent:
Continuous Index:
Within 8" of Joint:
Remarks:

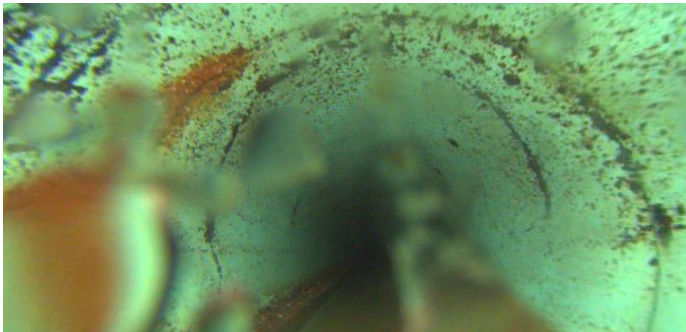
Code: **IW**
Description: **Infil Weeper**

Distance (ft): **282.3**
Structural Grade: **0**
O&M Grade: **2**
Clock Start/From: **8**
Clock To: **12**
1st Value:
2nd Value:
Value Percent:
Continuous Index:
Within 8" of Joint: **YES**
Remarks:

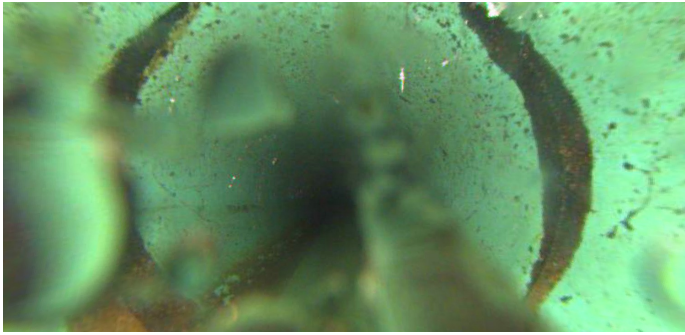
Code: **IW**
Description: **Infil Weeper**

Distance (ft): **295.7**
Structural Grade: **0**
O&M Grade: **2**
Clock Start/From: **8**
Clock To: **4**
1st Value:
2nd Value:
Value Percent:
Continuous Index:
Within 8" of Joint:
Remarks:

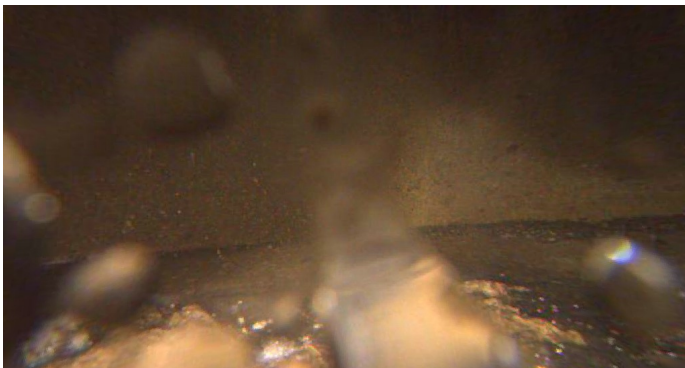
Code: **AMH**
Description: **Manhole**

Distance (ft): **338.5**
Structural Grade: **0**
O&M Grade: **0**
Clock Start/From:
Clock To:
1st Value:
2nd Value:
Value Percent:
Continuous Index:
Within 8" of Joint: **NO**
Remarks: **M-707-003**
