## Profile/Photo Observation Report

Street:	<b>GARFIELD ST</b>	Flow Control:	<b>Not Controlled</b>
City:	<b>Hobart, IN</b>	Year Renewed:	
Location:	<b>Light Highway</b>	Tape/Media #:	
Purpose:	<b>Maintenance Related</b>	Dia/Height:	<b>10"</b>
Use:	<b>Sanitary</b>	Material:	<b>PVC</b>
Drain Area:	<b>NA</b>	Lining:	<b>Cured in Place</b>
Category:	<b>NA</b>		
Comment:	<b>Flow direction wrong.</b>

Location Details:		Direction of Survey:	<b>Upstream</b>
US MH:	<b>M-707-004</b>	DS MH:	<b>M-707-002</b>
		Total Length Surveyed (ft):	<b>284.4</b>

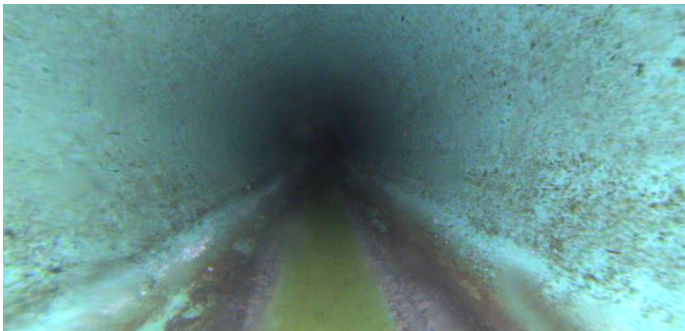
Code: **AMH**  
Description: **Manhole**

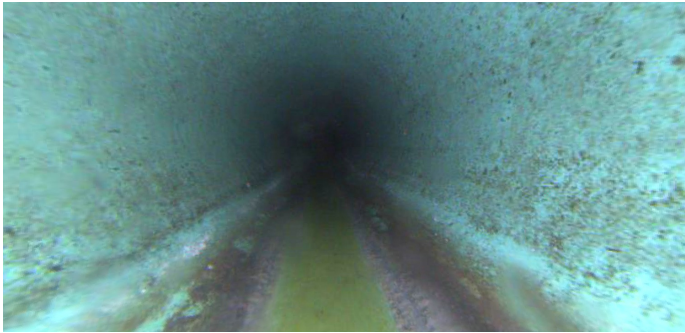
Code:	<b>MWL</b>
Description:	<b>Water Level</b>

Distance (ft):	<b>.0</b>
Structural Grade:	<b>0</b>
O&M Grade:	<b>0</b>
Clock Start/From:	
Clock To:	
1st Value:	
2nd Value:	
Value Percent:	<b>5.000</b>
Continuous Index:	
Within 8" of Joint:	<b>NO</b>
Remarks:

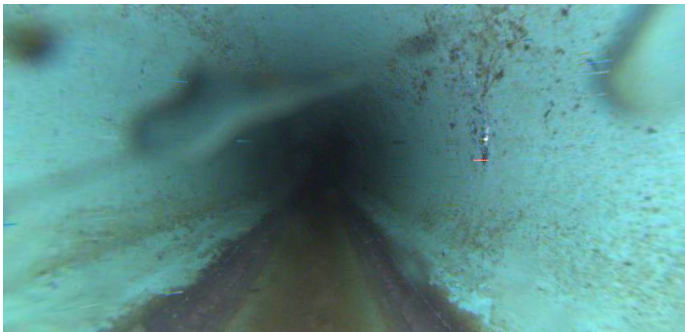
Code:	<b>MGO</b>
Description:	<b>General Observation</b>

Distance (ft):	<b>32.8</b>
Structural Grade:	<b>0</b>
O&M Grade:	<b>0</b>
Clock Start/From:	
Clock To:	
1st Value:	
2nd Value:	
Value Percent:	
Continuous Index:	
Within 8" of Joint:	<b>NO</b>
Remarks:	<b>rear camera</b>

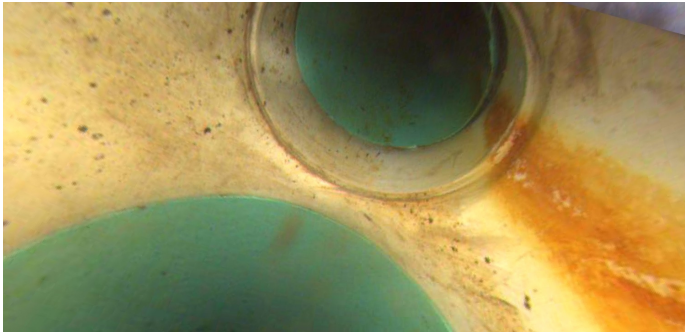
Code: **TF**  
Description: **Tap Factory**

Distance (ft): **79.3**  
Structural Grade: **0**  
O&M Grade: **0**  
Clock Start/From: **11**  
Clock To:  
1st Value: **4.000**  
2nd Value:  
Value Percent:  
Continuous Index:  
Within 8" of Joint:  
Remarks:

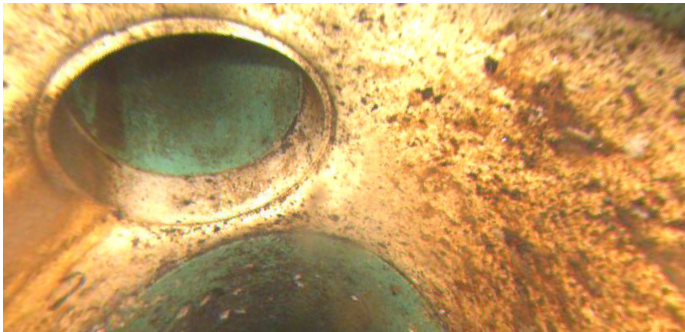
Code: **TF**  
Description: **Tap Factory**

Distance (ft): **160.3**  
Structural Grade: **0**  
O&M Grade: **0**  
Clock Start/From: **1**  
Clock To:  
1st Value: **4.000**  
2nd Value:  
Value Percent:  
Continuous Index:  
Within 8" of Joint:  
Remarks:

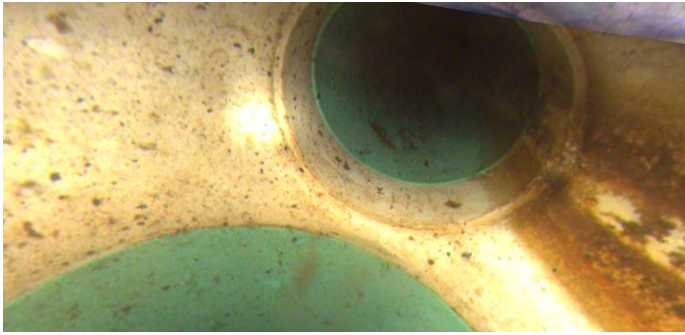
Code: **TF**  
Description: **Tap Factory**

Distance (ft): **180.3**  
Structural Grade: **0**  
O&M Grade: **0**  
Clock Start/From: **11**  
Clock To:  
1st Value: **4.000**  
2nd Value:  
Value Percent:  
Continuous Index:  
Within 8" of Joint:  
Remarks:

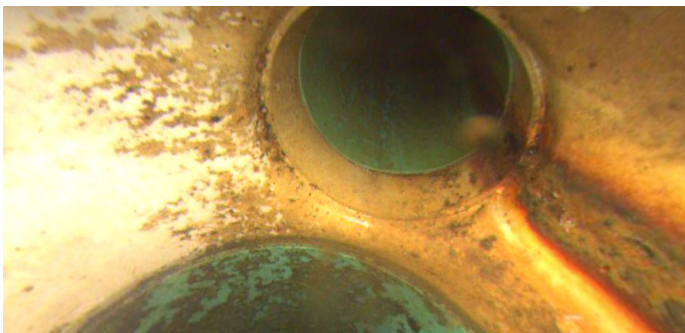
Code: **TFA**  
Description: **Tap Factory Active**

Distance (ft): **222.0**  
Structural Grade: **0**  
O&M Grade: **0**  
Clock Start/From: **1**  
Clock To:  
1st Value: **4.000**  
2nd Value:  
Value Percent:  
Continuous Index:  
Within 8" of Joint:  
Remarks:

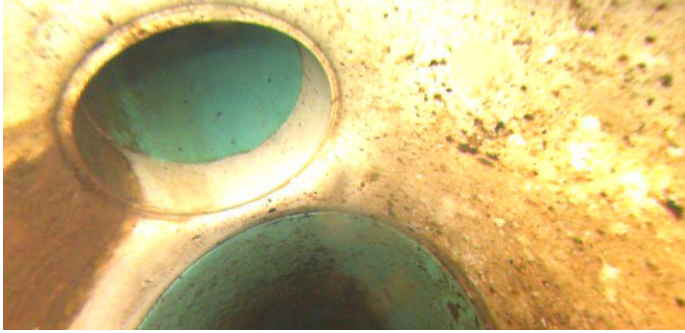
Code: **TF**  
Description: **Tap Factory**

Distance (ft): **253.7**  
Structural Grade: **0**  
O&M Grade: **0**  
Clock Start/From: **1**  
Clock To:  
1st Value: **4.000**  
2nd Value:  
Value Percent:  
Continuous Index:  
Within 8" of Joint:  
Remarks:

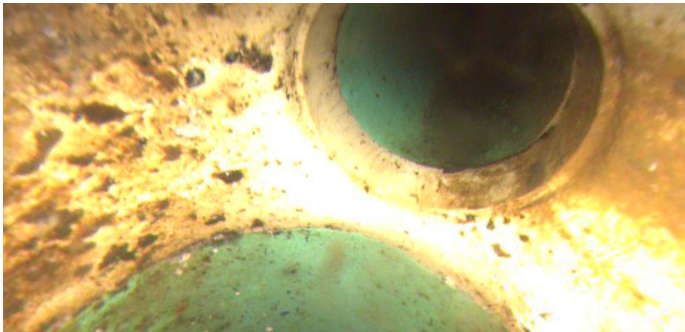
Code: **TF**  
Description: **Tap Factory**

Distance (ft): **264.7**  
Structural Grade: **0**  
O&M Grade: **0**  
Clock Start/From: **11**  
Clock To:  
1st Value: **4.000**  
2nd Value:  
Value Percent:  
Continuous Index:  
Within 8" of Joint:  
Remarks:

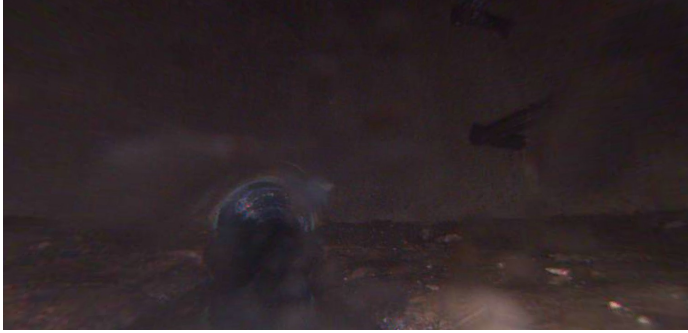
Code:	AMH
Description:	Manhole
Distance (ft):	284.4
Structural Grade:	0
O&M Grade:	0
Clock Start/From:	
Clock To:	
1st Value:	
2nd Value:	
Value Percent:	
Continuous Index:	
Within 8" of Joint:	NO
Remarks:	M-707-004
