Profile/Photo Observation Report

Date:	04/07/2018	Weather:		Coding:	PACP 6.0
Pipe Length (ft):	399.5	Owner:	NA	Pre Clean:	Not Known
P.O.#:		Surveyor:	Jen Costello	PSR:	P-707-007-006
Customer:		Clean Date:	01/01/1900	Shape:	C

Street:	E 13TH ST & GARFIELD ST	Flow Control:	Not Controlled
City:	Hobart, IN	Year Renewed:	
Location:	Light Highway	Tape/Media #:	
Purpose:	Maintenance Related	Dia/Height:	8"
Use:	Sanitary	Material:	PVC
Drain Area:	NA	Lining:	Cured in Place
Category:	NA		
Comment:	Flow direction wrong.

Location Details:		Direction of Survey:	Upstream
US MH:	M-707-006	DS MH:	M-707-007
		Total Length Surveyed (ft):	399.5

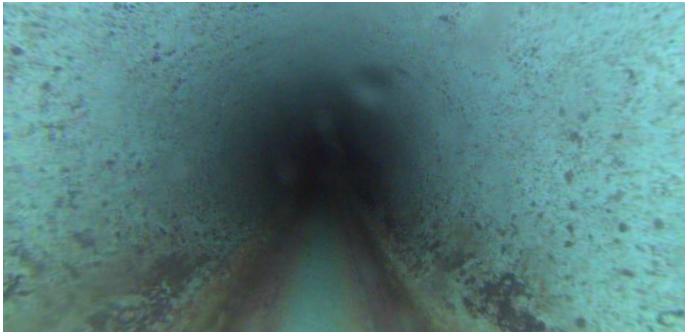
Code:	MWL
Description:	Water Level

Distance (ft):	.0
Structural Grade:	0
O&M Grade:	0
Clock Start/From:	
Clock To:	
1st Value:	
2nd Value:	
Value Percent:	5.000
Continuous Index:	
Within 8" of Joint:	NO
Remarks:

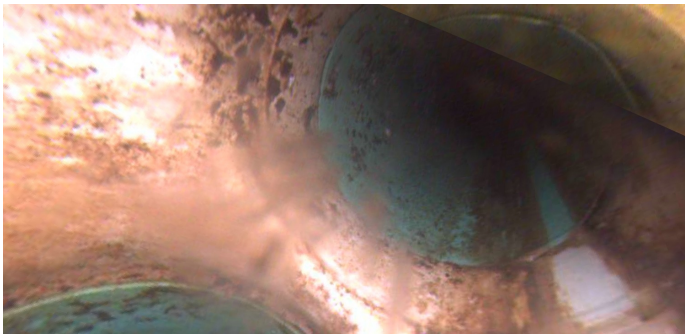
Code:	TF
Description:	Tap Factory

Distance (ft):	5.6
Structural Grade:	0
O&M Grade:	0
Clock Start/From:	1
Clock To:	
1st Value:	4.000
2nd Value:	
Value Percent:	
Continuous Index:	
Within 8" of Joint:	
Remarks:

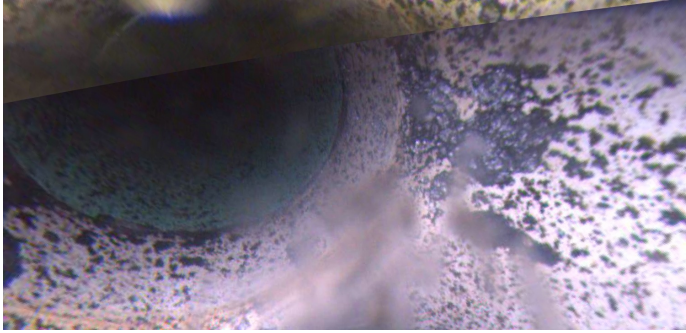
Code: **TF**
Description: **Tap Factory**

Distance (ft): **91.4**
Structural Grade: **0**
O&M Grade: **0**
Clock Start/From: **11**
Clock To:
1st Value: **4.000**
2nd Value:
Value Percent:
Continuous Index:
Within 8" of Joint:
Remarks:

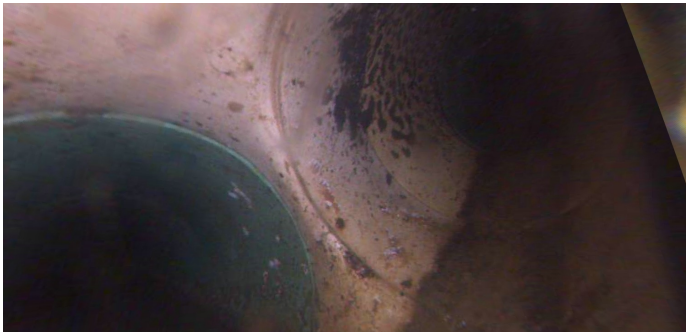
Code: **TFA**
Description: **Tap Factory Active**

Distance (ft): **159.9**
Structural Grade: **0**
O&M Grade: **0**
Clock Start/From: **2**
Clock To:
1st Value: **4.000**
2nd Value:
Value Percent:
Continuous Index:
Within 8" of Joint:
Remarks:

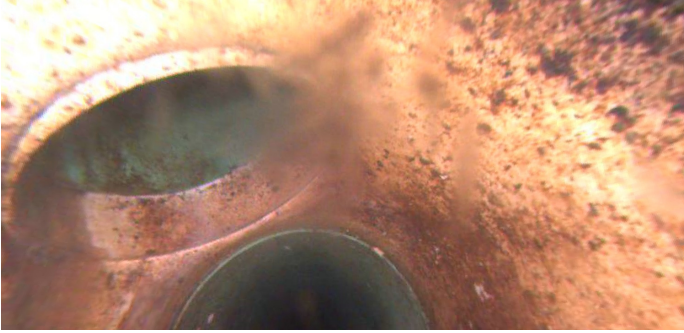
Code: **TF**
Description: **Tap Factory**

Distance (ft): **313.4**
Structural Grade: **0**
O&M Grade: **0**
Clock Start/From: **11**
Clock To:
1st Value: **4.000**
2nd Value:
Value Percent:
Continuous Index:
Within 8" of Joint:
Remarks:

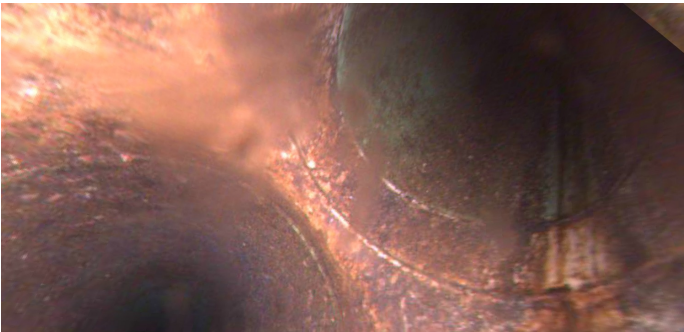
Code: **TF**
Description: **Tap Factory**

Distance (ft): **322.5**
Structural Grade: **0**
O&M Grade: **0**
Clock Start/From: **1**
Clock To:
1st Value: **4.000**
2nd Value:
Value Percent:
Continuous Index:
Within 8" of Joint:
Remarks:

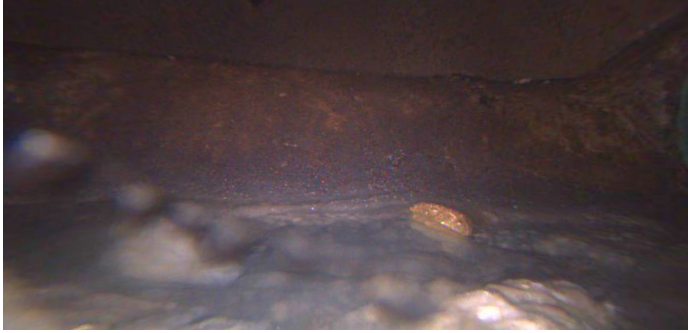
Code:	AMH
Description:	Manhole
Distance (ft):	399.5
Structural Grade:	0
O&M Grade:	0
Clock Start/From:	
Clock To:	
1st Value:	
2nd Value:	
Value Percent:	
Continuous Index:	
Within 8" of Joint:	NO
Remarks:	M-707-006
