Profile/Photo Observation Report

Street:	13th	Flow Control:	Not Controlled
City:	Hobart, IN	Year Renewed:	
Location:	Light Highway	Tape/Media #:	
Purpose:	Maintenance Related	Dia/Height:	8"
Use:	Sanitary	Material:	PVC
Drain Area:	NA	Lining:	Cured in Place
Category:	NA		
Comment:	Flow direction wrong.

Location Details:		Direction of Survey:	Upstream
US MH:	M-707-006	DS MH:	M-707-007
		Total Length Surveyed (ft):	399.5

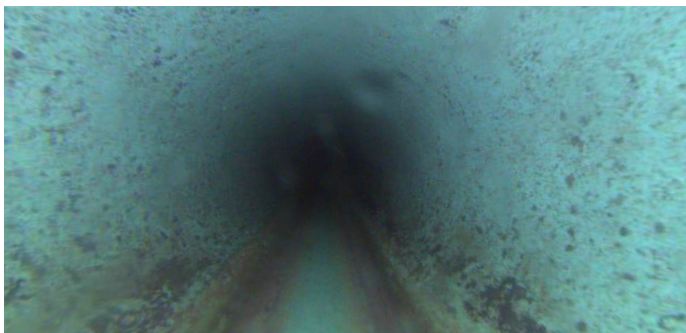
Code: **AMH**
Description: **Manhole**

Distance (ft): **.0**
Structural Grade: **0**
O&M Grade: **0**
Clock Start/From:
Clock To:
1st Value:
2nd Value:
Value Percent:
Continuous Index:
Within 8" of Joint: **NO**
Remarks: **M-707-007**

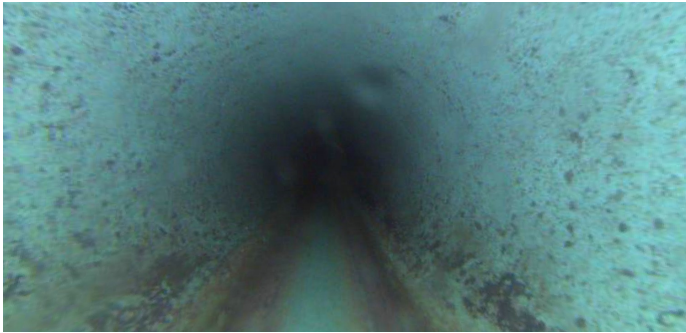
Code:	MWL
Description:	Water Level

Distance (ft):	.0
Structural Grade:	0
O&M Grade:	0
Clock Start/From:	
Clock To:	
1st Value:	
2nd Value:	
Value Percent:	5.000
Continuous Index:	
Within 8" of Joint:	NO
Remarks:

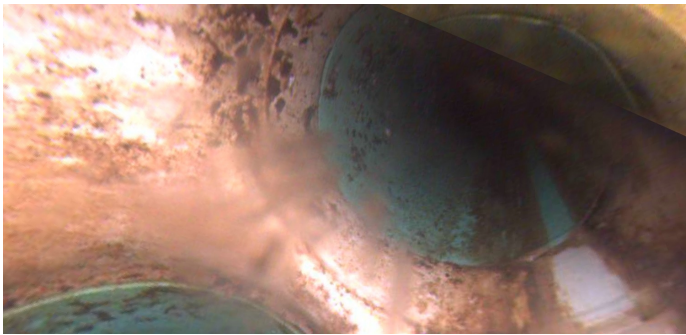
Code:	TF
Description:	Tap Factory

Distance (ft):	5.6
Structural Grade:	0
O&M Grade:	0
Clock Start/From:	1
Clock To:	
1st Value:	4.000
2nd Value:	
Value Percent:	
Continuous Index:	
Within 8" of Joint:	
Remarks:

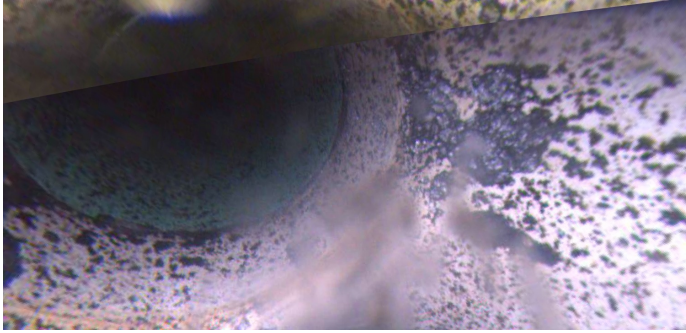
Code: **TF**
Description: **Tap Factory**

Distance (ft): **91.4**
Structural Grade: **0**
O&M Grade: **0**
Clock Start/From: **11**
Clock To:
1st Value: **4.000**
2nd Value:
Value Percent:
Continuous Index:
Within 8" of Joint:
Remarks:

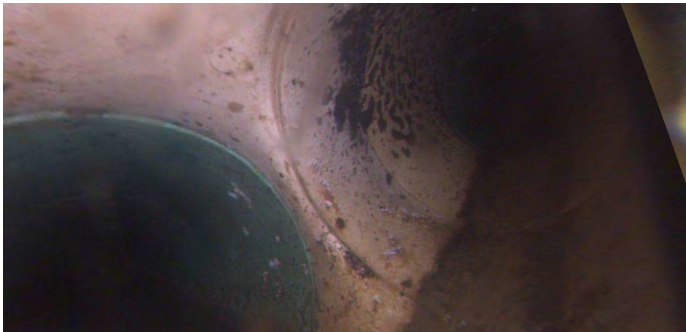
Code: **TFA**
Description: **Tap Factory Active**

Distance (ft): **159.9**
Structural Grade: **0**
O&M Grade: **0**
Clock Start/From: **2**
Clock To:
1st Value: **4.000**
2nd Value:
Value Percent:
Continuous Index:
Within 8" of Joint:
Remarks:

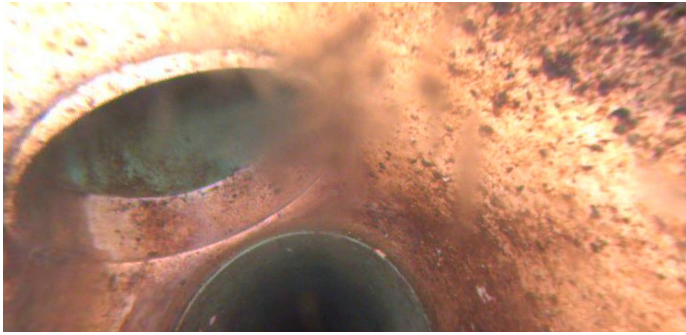
Code: **TF**
Description: **Tap Factory**

Distance (ft): **313.4**
Structural Grade: **0**
O&M Grade: **0**
Clock Start/From: **11**
Clock To:
1st Value: **4.000**
2nd Value:
Value Percent:
Continuous Index:
Within 8" of Joint:
Remarks:

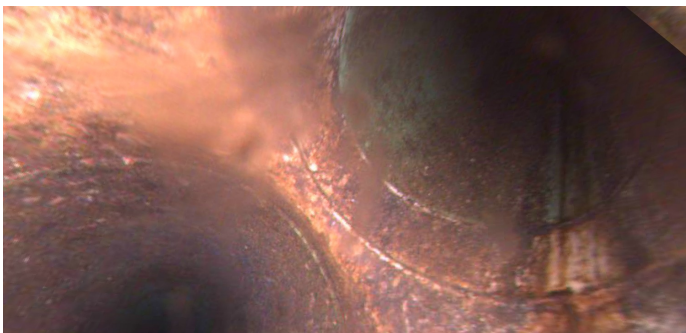
Code: **TF**
Description: **Tap Factory**

Distance (ft): **322.5**
Structural Grade: **0**
O&M Grade: **0**
Clock Start/From: **1**
Clock To:
1st Value: **4.000**
2nd Value:
Value Percent:
Continuous Index:
Within 8" of Joint:
Remarks:

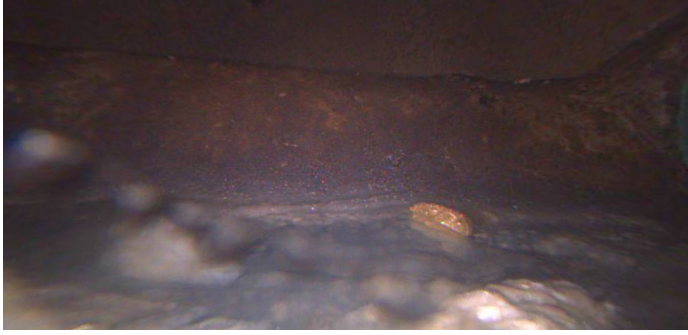
Code:	AMH
Description:	Manhole
Distance (ft):	399.5
Structural Grade:	0
O&M Grade:	0
Clock Start/From:	
Clock To:	
1st Value:	
2nd Value:	
Value Percent:	
Continuous Index:	
Within 8" of Joint:	NO
Remarks:	M-707-006
