Profile/Photo Observation Report

Street:	13th	Flow Control:	Not Controlled
City:	Hobart, IN	Year Renewed:	
Location:	Light Highway	Tape/Media #:	
Purpose:	Maintenance Related	Dia/Height:	8"
Use:	Sanitary	Material:	PVC
Drain Area:	NA	Lining:	Cured in Place
Category:	NA		
Comment:

Location Details:		Direction of Survey:	Upstream
US MH:	M-707-007	DS MH:	M-807-007
		Total Length Surveyed (ft):	339.5

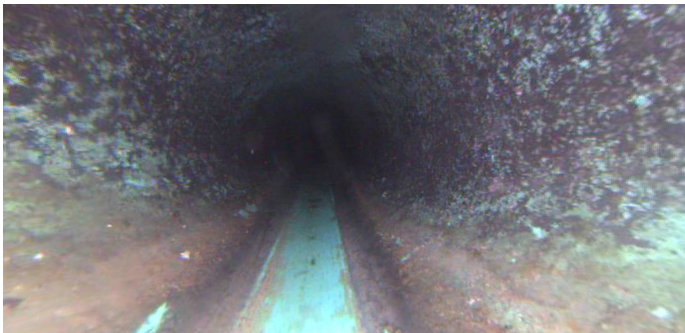
Code: **AMH**
Description: **Manhole**

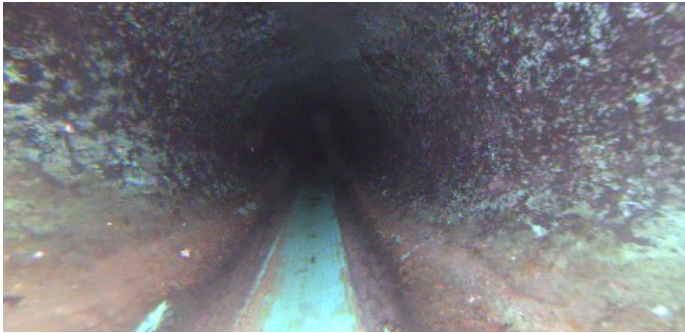
Code:	MWL
Description:	Water Level

Distance (ft):	.0
Structural Grade:	0
O&M Grade:	0
Clock Start/From:	
Clock To:	
1st Value:	
2nd Value:	
Value Percent:	5.000
Continuous Index:	
Within 8" of Joint:	NO
Remarks:

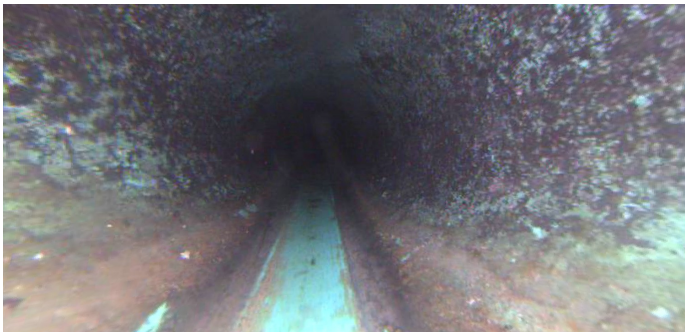
Code:	DAGS
Description:	Deposits Attached Grease

Distance (ft):	.0
Structural Grade:	0
O&M Grade:	2
Clock Start/From:	7
Clock To:	5
1st Value:	
2nd Value:	
Value Percent:	5.000
Continuous Index:	S01
Within 8" of Joint:	NO
Remarks:

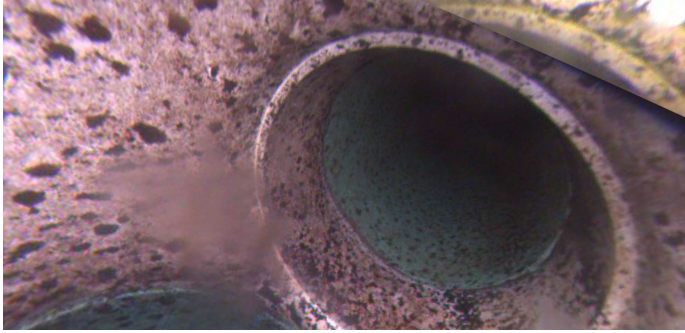
Code: **TF**
Description: **Tap Factory**

Distance (ft): **15.1**
Structural Grade: **0**
O&M Grade: **0**
Clock Start/From: **1**
Clock To:
1st Value: **4.000**
2nd Value:
Value Percent:
Continuous Index:
Within 8" of Joint:
Remarks:

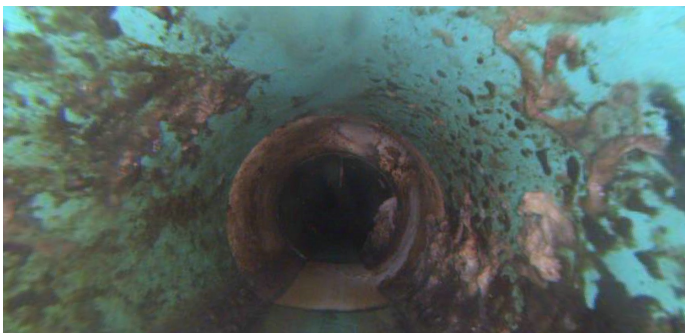
Code: **DAGS**
Description: **Deposits Attached Grease**

Distance (ft): **140.0**
Structural Grade: **0**
O&M Grade: **2**
Clock Start/From: **8**
Clock To: **4**
1st Value:
2nd Value:
Value Percent: **5.000**
Continuous Index:
Within 8" of Joint: **NO**
Remarks:

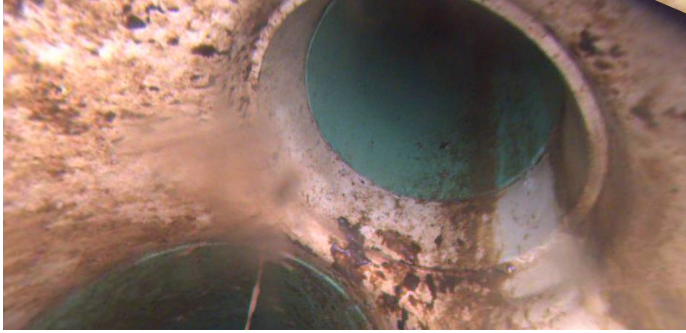
Code: **TF**
Description: **Tap Factory**

Distance (ft): **141.0**
Structural Grade: **0**
O&M Grade: **0**
Clock Start/From: **2**
Clock To:
1st Value: **4.000**
2nd Value:
Value Percent:
Continuous Index:
Within 8" of Joint:
Remarks:

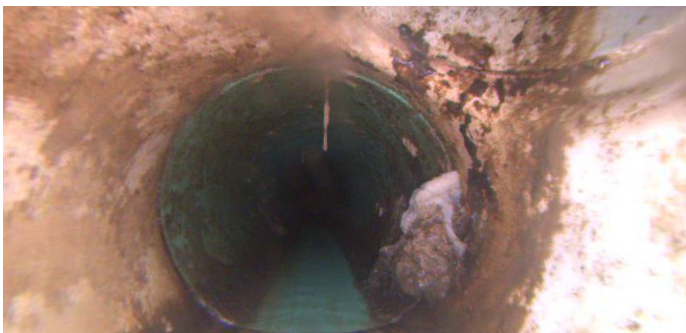
Code: **DAGS**
Description: **Deposits Attached Grease**

Distance (ft): **141.0**
Structural Grade: **0**
O&M Grade: **2**
Clock Start/From: **3**
Clock To: **4**
1st Value:
2nd Value:
Value Percent: **5.000**
Continuous Index:
Within 8" of Joint: **YES**
Remarks:

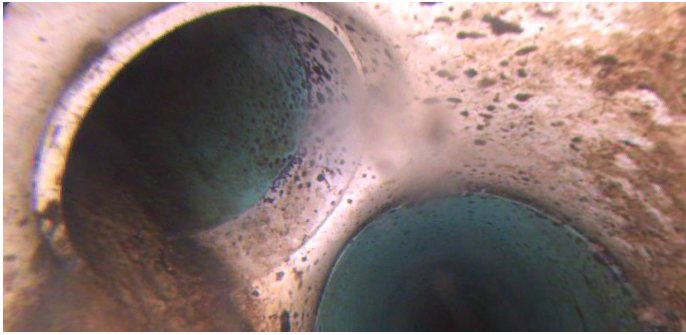
Code: **TF**
Description: **Tap Factory**

Distance (ft): **254.2**
Structural Grade: **0**
O&M Grade: **0**
Clock Start/From: **10**
Clock To:
1st Value: **4.000**
2nd Value:
Value Percent:
Continuous Index:
Within 8" of Joint:
Remarks:

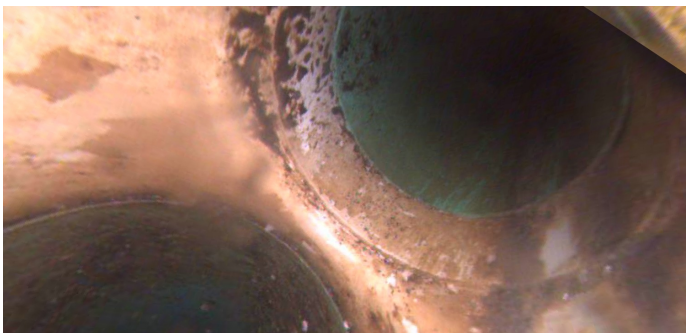
Code: **TF**
Description: **Tap Factory**

Distance (ft): **272.4**
Structural Grade: **0**
O&M Grade: **0**
Clock Start/From: **1**
Clock To:
1st Value: **4.000**
2nd Value:
Value Percent:
Continuous Index:
Within 8" of Joint:
Remarks:

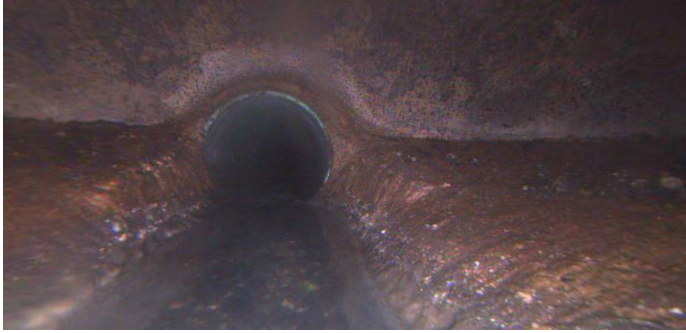
Code: **AMH**
Description: **Manhole**

Distance (ft): **339.5**
Structural Grade: **0**
O&M Grade: **0**
Clock Start/From:
Clock To:
1st Value:
2nd Value:
Value Percent:
Continuous Index:
Within 8" of Joint: **NO**
Remarks: **M-707-007**

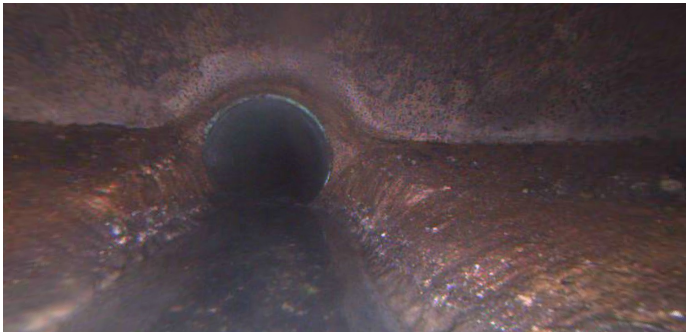
Code: **DAGS**
Description: **Deposits Attached Grease**

Distance (ft): **339.5**
Structural Grade: **0**
O&M Grade: **2**
Clock Start/From: **7**
Clock To: **5**
1st Value:
2nd Value:
Value Percent: **5.000**
Continuous Index: **F01**
Within 8" of Joint: **NO**
Remarks:
