Profile/Photo Observation Report

Street:	GARFIELD ST & E 12TH ST	Flow Control:	Not Controlled
City:	Hobart, IN	Year Renewed:	
Location:	Light Highway	Tape/Media #:	
Purpose:	Maintenance Related	Dia/Height:	10"
Use:	Sanitary	Material:	PVC
Drain Area:	NA	Lining:	Cured in Place
Category:	NA		
Comment:	flow incorrect.

Location Details:		Direction of Survey:	Upstream
US MH:	M-707-009	DS MH:	M-707-010
		Total Length Surveyed (ft):	378.1

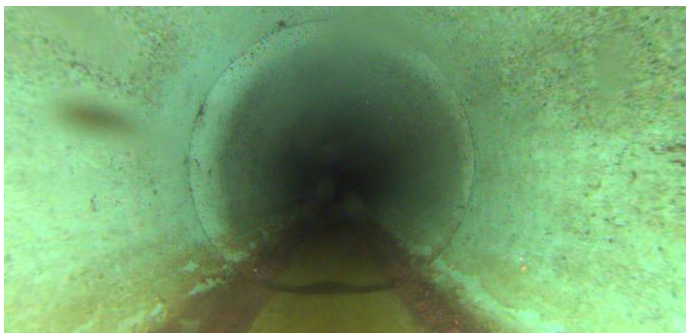
Code: **AMH**
Description: **Manhole**

Distance (ft): **.0**
Structural Grade: **0**
O&M Grade: **0**
Clock Start/From:
Clock To:
1st Value:
2nd Value:
Value Percent:
Continuous Index:
Within 8" of Joint: **NO**
Remarks: **M-707-010**

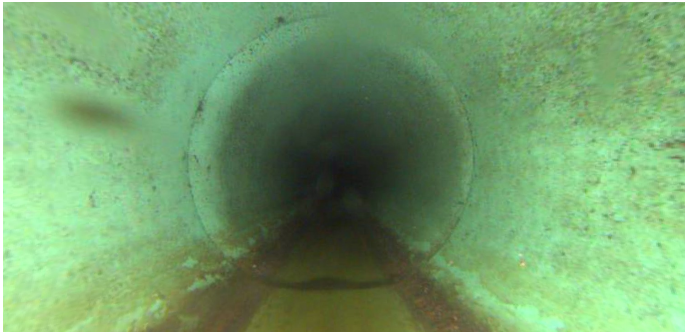
Code:	MWL
Description:	Water Level

Distance (ft):	.0
Structural Grade:	0
O&M Grade:	0
Clock Start/From:	
Clock To:	
1st Value:	
2nd Value:	
Value Percent:	5.000
Continuous Index:	
Within 8" of Joint:	NO
Remarks:

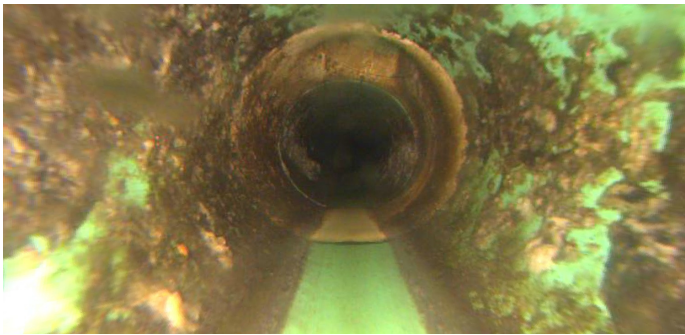
Code:	DAGS
Description:	Deposits Attached Grease

Distance (ft):	90.2
Structural Grade:	0
O&M Grade:	2
Clock Start/From:	8
Clock To:	4
1st Value:	
2nd Value:	
Value Percent:	5.000
Continuous Index:	
Within 8" of Joint:	NO
Remarks:

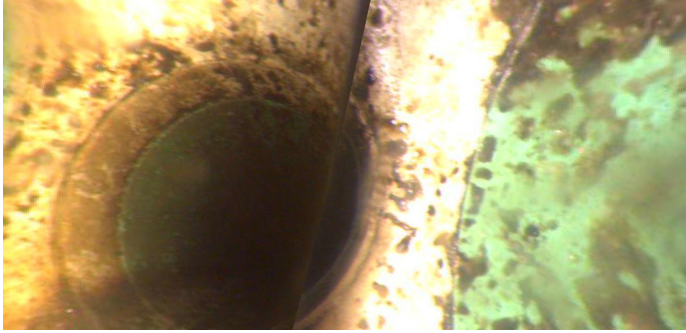
Code: **TF**
Description: **Tap Factory**

Distance (ft): **91.5**
Structural Grade: **0**
O&M Grade: **0**
Clock Start/From: **12**
Clock To:
1st Value: **4.000**
2nd Value:
Value Percent:
Continuous Index:
Within 8" of Joint:
Remarks:

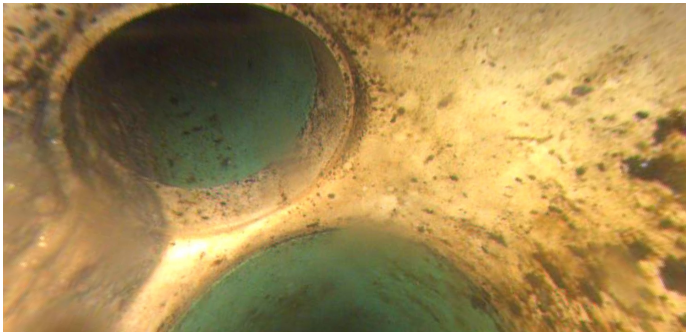
Code: **TF**
Description: **Tap Factory**

Distance (ft): **131.8**
Structural Grade: **0**
O&M Grade: **0**
Clock Start/From: **11**
Clock To:
1st Value: **4.000**
2nd Value:
Value Percent:
Continuous Index:
Within 8" of Joint:
Remarks:

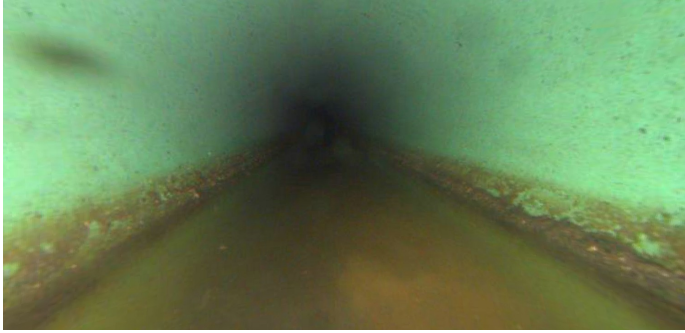
Code: **MWL**
Description: **Water Level**

Distance (ft): **168.9**
Structural Grade: **0**
O&M Grade: **0**
Clock Start/From:
Clock To:
1st Value:
2nd Value:
Value Percent: **30.000**
Continuous Index:
Within 8" of Joint: **NO**
Remarks:

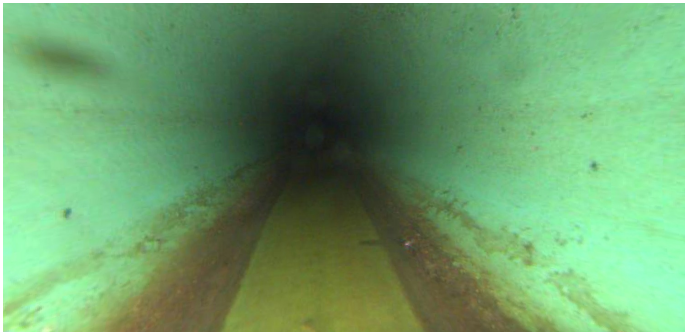
Code: **MWL**
Description: **Water Level**

Distance (ft): **193.4**
Structural Grade: **0**
O&M Grade: **0**
Clock Start/From:
Clock To:
1st Value:
2nd Value:
Value Percent: **5.000**
Continuous Index:
Within 8" of Joint: **NO**
Remarks:

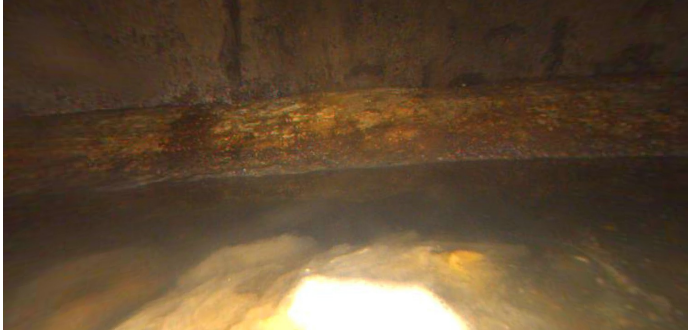
Code:	AMH
Description:	Manhole
Distance (ft):	378.1
Structural Grade:	0
O&M Grade:	0
Clock Start/From:	
Clock To:	
1st Value:	
2nd Value:	
Value Percent:	
Continuous Index:	
Within 8" of Joint:	NO
Remarks:	M-707-009
