Profile/Photo Observation Report

Street:	Capitol	Flow Control:	Not Controlled
City:	Hobart, IN	Year Renewed:	
Location:	Light Highway	Tape/Media #:	
Purpose:	Maintenance Related	Dia/Height:	10"
Use:	Sanitary	Material:	PVC
Drain Area:	NA	Lining:	Cured in Place
Category:	NA		
Comment:	flow incorrect.

Location Details:		Direction of Survey:	Upstream
US MH:	M-707-009	DS MH:	M-707-010
		Total Length Surveyed (ft):	378.1

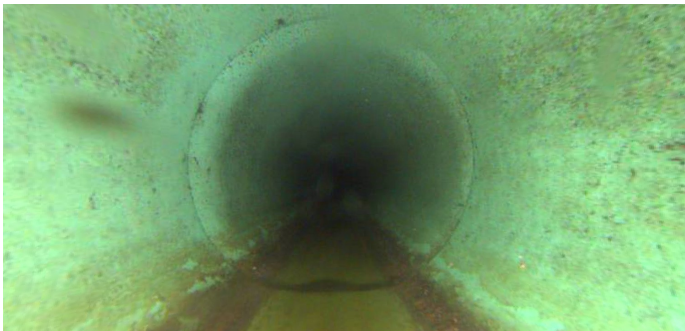
Code: **AMH**
Description: **Manhole**

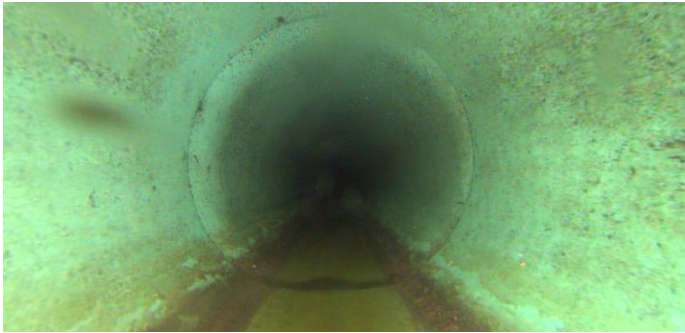
Code:	MWL
Description:	Water Level

Distance (ft):	.0
Structural Grade:	0
O&M Grade:	0
Clock Start/From:	
Clock To:	
1st Value:	
2nd Value:	
Value Percent:	5.000
Continuous Index:	
Within 8" of Joint:	NO
Remarks:

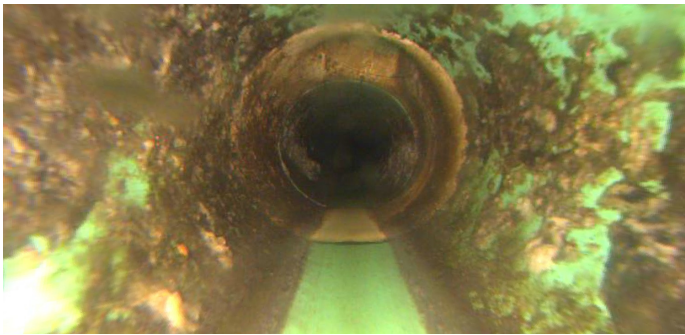
Code:	DAGS
Description:	Deposits Attached Grease

Distance (ft):	90.2
Structural Grade:	0
O&M Grade:	2
Clock Start/From:	8
Clock To:	4
1st Value:	
2nd Value:	
Value Percent:	5.000
Continuous Index:	
Within 8" of Joint:	NO
Remarks:

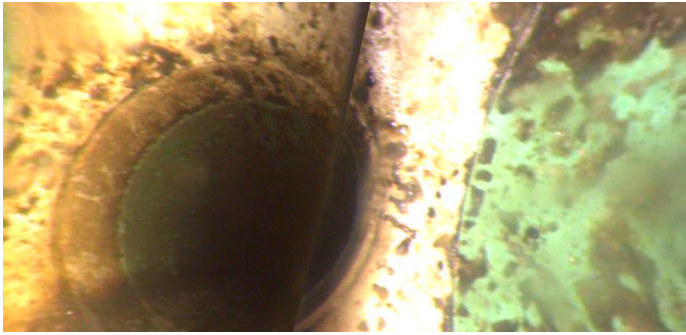
Code: **TF**
Description: **Tap Factory**

Distance (ft): **91.5**
Structural Grade: **0**
O&M Grade: **0**
Clock Start/From: **12**
Clock To:
1st Value: **4.000**
2nd Value:
Value Percent:
Continuous Index:
Within 8" of Joint:
Remarks:

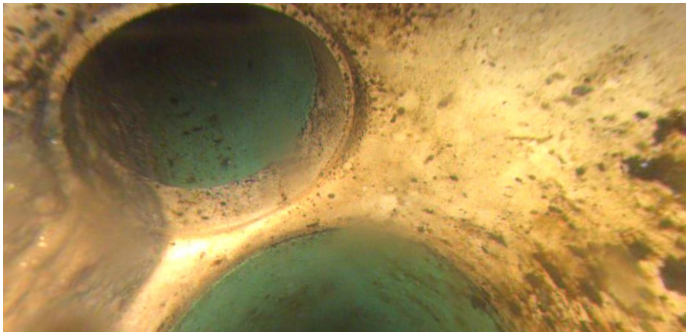
Code: **TF**
Description: **Tap Factory**

Distance (ft): **131.8**
Structural Grade: **0**
O&M Grade: **0**
Clock Start/From: **11**
Clock To:
1st Value: **4.000**
2nd Value:
Value Percent:
Continuous Index:
Within 8" of Joint:
Remarks:

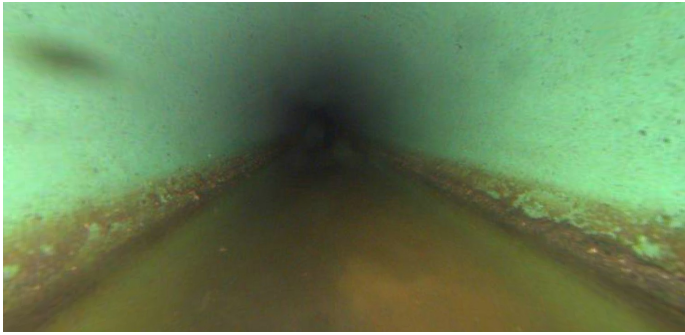
Code: **MWL**
Description: **Water Level**

Distance (ft): **168.9**
Structural Grade: **0**
O&M Grade: **0**
Clock Start/From:
Clock To:
1st Value:
2nd Value:
Value Percent: **30.000**
Continuous Index:
Within 8" of Joint: **NO**
Remarks:

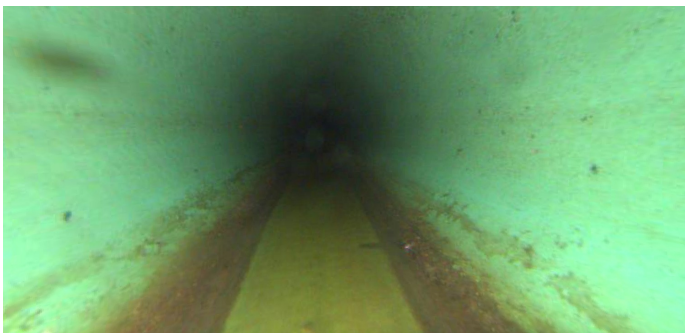
Code: **MWL**
Description: **Water Level**

Distance (ft): **193.4**
Structural Grade: **0**
O&M Grade: **0**
Clock Start/From:
Clock To:
1st Value:
2nd Value:
Value Percent: **5.000**
Continuous Index:
Within 8" of Joint: **NO**
Remarks:

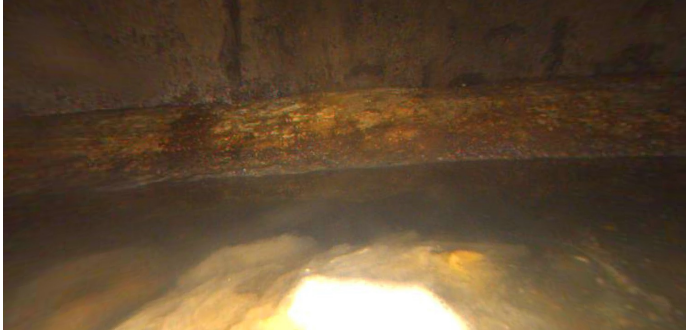
Code:	AMH
Description:	Manhole
Distance (ft):	378.1
Structural Grade:	0
O&M Grade:	0
Clock Start/From:	
Clock To:	
1st Value:	
2nd Value:	
Value Percent:	
Continuous Index:	
Within 8" of Joint:	NO
Remarks:	M-707-009
