## Profile/Photo Observation Report

Street:	<b>E 12TH ST</b>	Flow Control:	<b>Not Controlled</b>
City:	<b>Hobart, IN</b>	Year Renewed:	
Location:	<b>Light Highway</b>	Tape/Media #:	
Purpose:	<b>Maintenance Related</b>	Dia/Height:	<b>10"</b>
Use:	<b>Sanitary</b>	Material:	<b>PVC</b>
Drain Area:	<b>NA</b>	Lining:	<b>Cured in Place</b>
Category:	<b>NA</b>		
Comment:	<b>flow incorrect.</b>

Location Details:		Direction of Survey:	<b>Downstream</b>
US MH:	<b>M-707-010</b>	DS MH:	<b>M-807-004</b>
		Total Length Surveyed (ft):	<b>387.9</b>

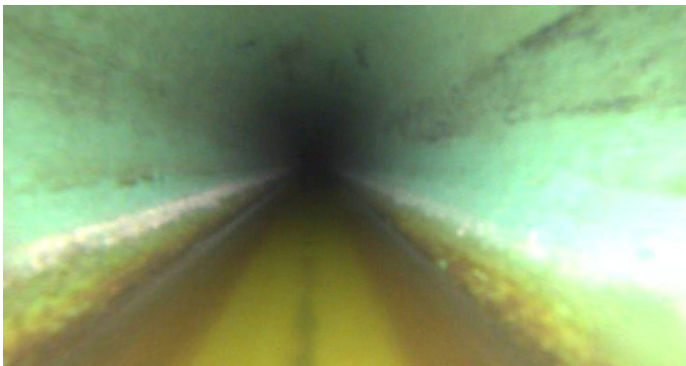
Code: **AMH**  
Description: **Manhole**

Distance (ft):	.0
Structural Grade:	0
O&M Grade:	0
Clock Start/From:	
Clock To:	
1st Value:	
2nd Value:	
Value Percent:	
Continuous Index:	
Within 8" of Joint:	NO
Remarks:	M-707-010

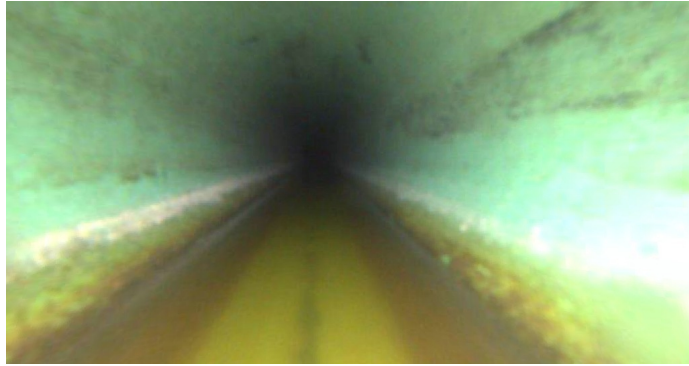
Code: **MWL**  
Description: **Water Level**

Distance (ft): **.0**  
Structural Grade: **0**  
O&M Grade: **0**  
Clock Start/From:  
Clock To:  
1st Value:  
2nd Value:  
Value Percent: **10.000**  
Continuous Index:  
Within 8" of Joint: **NO**  
Remarks:

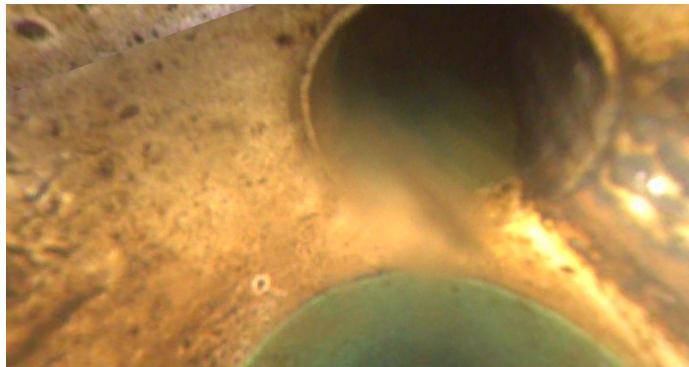
Code: **TF**  
Description: **Tap Factory**

Distance (ft): **13.0**  
Structural Grade: **0**  
O&M Grade: **0**  
Clock Start/From: **1**  
Clock To:  
1st Value: **4.000**  
2nd Value:  
Value Percent:  
Continuous Index:  
Within 8" of Joint:  
Remarks:

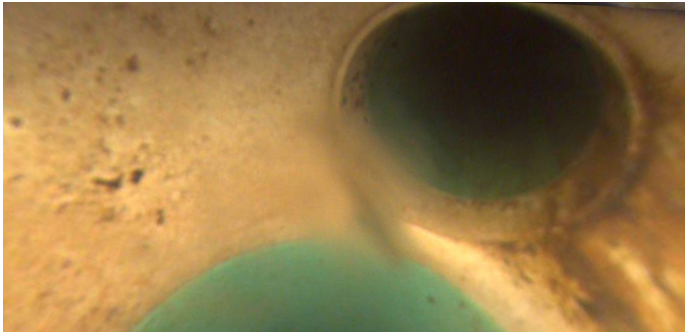
Code: **TF**  
Description: **Tap Factory**

Distance (ft): **102.9**  
Structural Grade: **0**  
O&M Grade: **0**  
Clock Start/From: **1**  
Clock To:  
1st Value: **4.000**  
2nd Value:  
Value Percent:  
Continuous Index:  
Within 8" of Joint:  
Remarks:

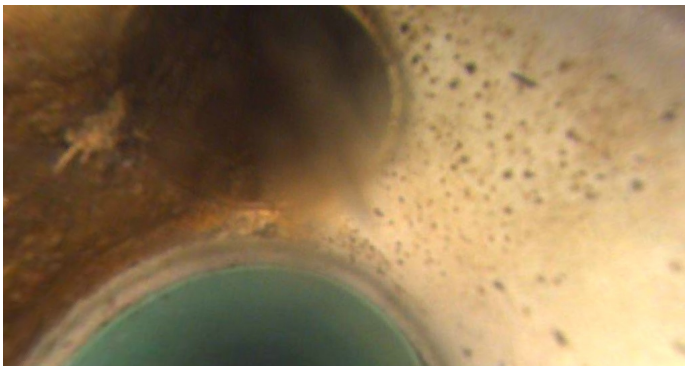
Code: **TF**  
Description: **Tap Factory**

Distance (ft): **132.9**  
Structural Grade: **0**  
O&M Grade: **0**  
Clock Start/From: **12**  
Clock To:  
1st Value: **4.000**  
2nd Value:  
Value Percent:  
Continuous Index:  
Within 8" of Joint:  
Remarks:

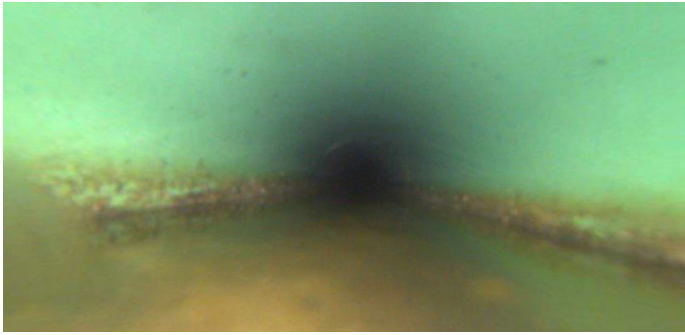
Code: **MWL**  
Description: **Water Level**

Distance (ft): **190.4**  
Structural Grade: **0**  
O&M Grade: **0**  
Clock Start/From:  
Clock To:  
1st Value:  
2nd Value:  
Value Percent: **40.000**  
Continuous Index:  
Within 8" of Joint: **NO**  
Remarks:

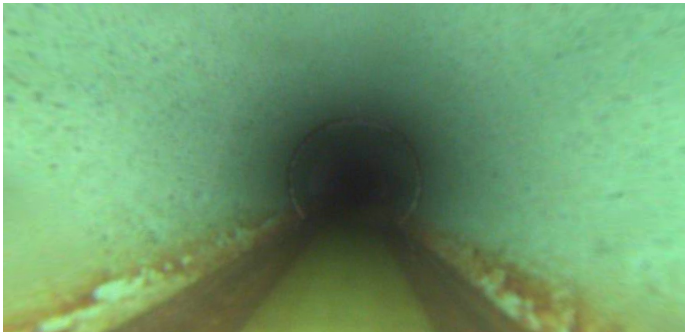
Code: **MWL**  
Description: **Water Level**

Distance (ft): **205.8**  
Structural Grade: **0**  
O&M Grade: **0**  
Clock Start/From:  
Clock To:  
1st Value:  
2nd Value:  
Value Percent: **10.000**  
Continuous Index:  
Within 8" of Joint: **NO**  
Remarks:

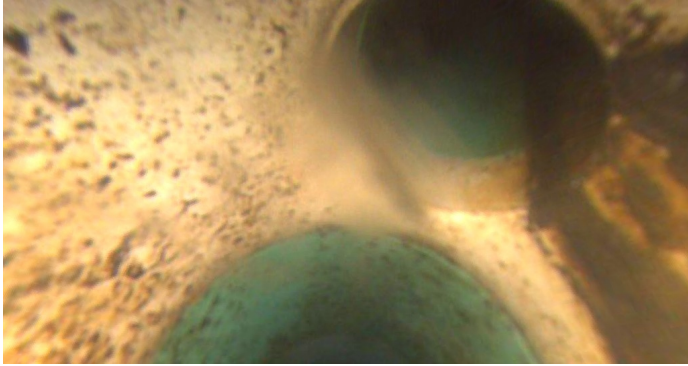
Code: **TF**  
Description: **Tap Factory**

Distance (ft): **225.0**  
Structural Grade: **0**  
O&M Grade: **0**  
Clock Start/From: **2**  
Clock To:  
1st Value: **4.000**  
2nd Value:  
Value Percent:  
Continuous Index:  
Within 8" of Joint:  
Remarks:

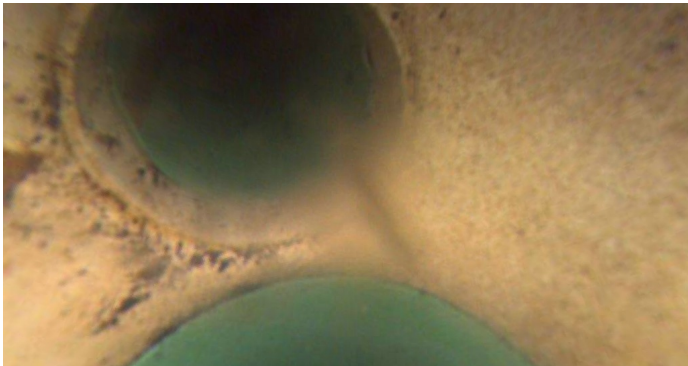
Code: **TF**  
Description: **Tap Factory**

Distance (ft): **245.5**  
Structural Grade: **0**  
O&M Grade: **0**  
Clock Start/From: **10**  
Clock To:  
1st Value: **4.000**  
2nd Value:  
Value Percent:  
Continuous Index:  
Within 8" of Joint:  
Remarks:

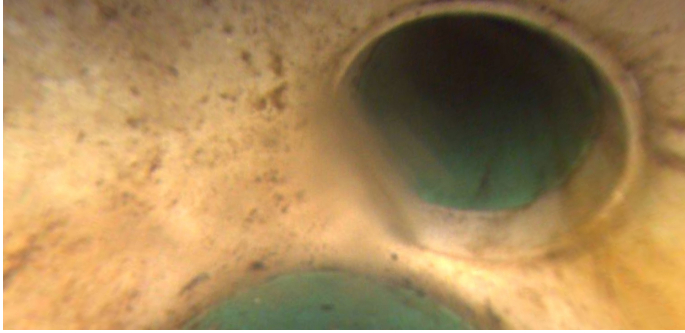
Code: **TF**  
Description: **Tap Factory**

Distance (ft): **332.6**  
Structural Grade: **0**  
O&M Grade: **0**  
Clock Start/From: **1**  
Clock To:  
1st Value: **4.000**  
2nd Value:  
Value Percent:  
Continuous Index:  
Within 8" of Joint:  
Remarks:

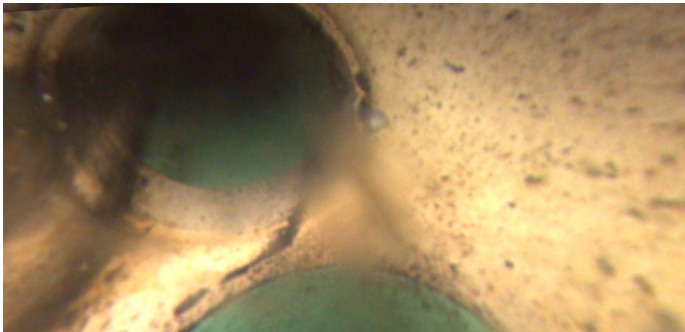
Code: **TFA**  
Description: **Tap Factory Active**

Distance (ft): **343.3**  
Structural Grade: **0**  
O&M Grade: **0**  
Clock Start/From: **11**  
Clock To:  
1st Value: **4.000**  
2nd Value:  
Value Percent:  
Continuous Index:  
Within 8" of Joint:  
Remarks:

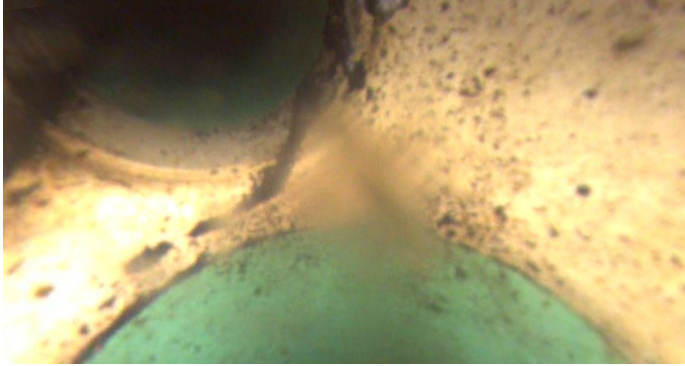
Code: **TF**  
Description: **Tap Factory**

Distance (ft): **343.4**  
Structural Grade: **0**  
O&M Grade: **0**  
Clock Start/From: **10**  
Clock To:  
1st Value: **4.000**  
2nd Value:  
Value Percent:  
Continuous Index:  
Within 8" of Joint:  
Remarks:

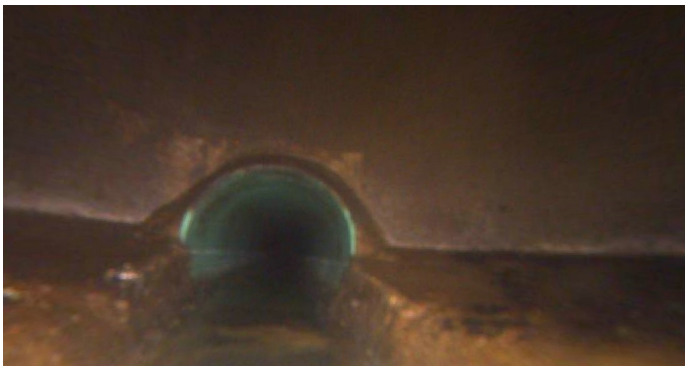
Code: **AMH**  
Description: **Manhole**

Distance (ft): **387.9**  
Structural Grade: **0**  
O&M Grade: **0**  
Clock Start/From:  
Clock To:  
1st Value:  
2nd Value:  
Value Percent:  
Continuous Index:  
Within 8" of Joint: **NO**  
Remarks: **M-807-004**
