Profile/Photo Observation Report

Date:	04/09/2018	Weather:		Coding:	PACP 6.0
Pipe Length (ft):	393.3	Owner:	NA	Pre Clean:	Not Known
P.O.#:		Surveyor:	Mark Ruby	PSR:	P-807-004-010
Customer:		Clean Date:	01/01/1900	Shape:	C

Location Details:		Direction of Survey:	Downstream
US MH:	M-707-010	DS MH:	M-807-004
		Total Length Surveyed (ft):	387.9

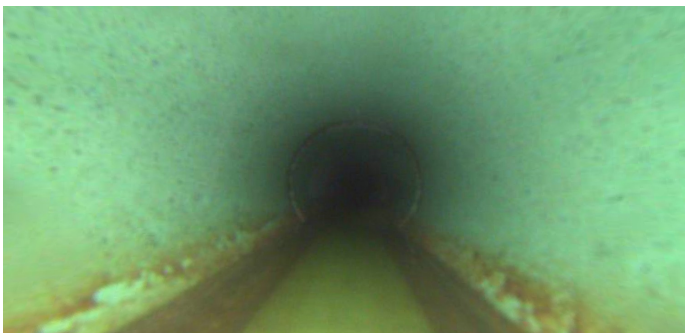
Code: **MWL**
Description: **Water Level**

Distance (ft): **205.8**
Structural Grade: **0**
O&M Grade: **0**
Clock Start/From:
Clock To:
1st Value:
2nd Value:
Value Percent: **10.000**
Continuous Index:
Within 8" of Joint: **NO**
Remarks:
