Profile/Photo Observation Report

Street:	GARFIELD ST & E 12TH ST	Flow Control:	Not Controlled
City:	Hobart, IN	Year Renewed:	
Location:	Light Highway	Tape/Media #:	
Purpose:	Maintenance Related	Dia/Height:	12"
Use:	Sanitary	Material:	PVC
Drain Area:	NA	Lining:	Cured in Place
Category:	NA		
Comment:	battery at 200'.-flow incorrect.		
Location Details:		Direction of Survey:	Downstream
US MH:	M-707-011	DS MH:	M-707-009
		Total Length Surveyed (ft):	201.6

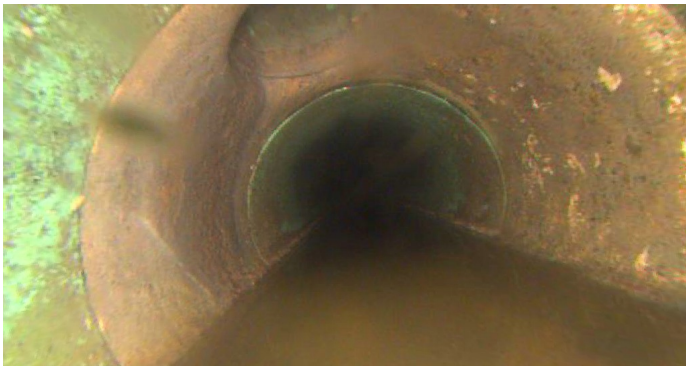
Position	Code	Observation	Video (sec)	Grade
.0	AMH	Manhole	10	NA
.0	MWL	Water Level	21	NA
1.9	TF	Tap Factory	36	NA
90.4	TF	Tap Factory	226	NA
93.6	TFA	Tap Factory Active	244	NA
147.5	TF	Tap Factory	364	NA
187.8	TF	Tap Factory	457	NA
201.6	MSA	Abandoned Survey	497	NA

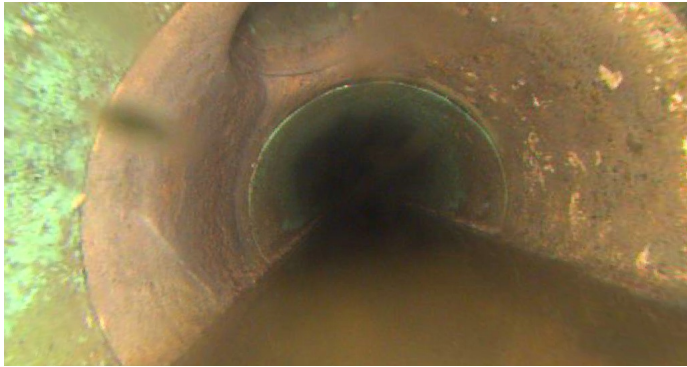
Code: **MWL**
Description: **Water Level**

Distance (ft): **.0**
Structural Grade: **0**
O&M Grade: **0**
Clock Start/From:
Clock To:
1st Value:
2nd Value:
Value Percent: **10.000**
Continuous Index:
Within 8" of Joint: **NO**
Remarks:

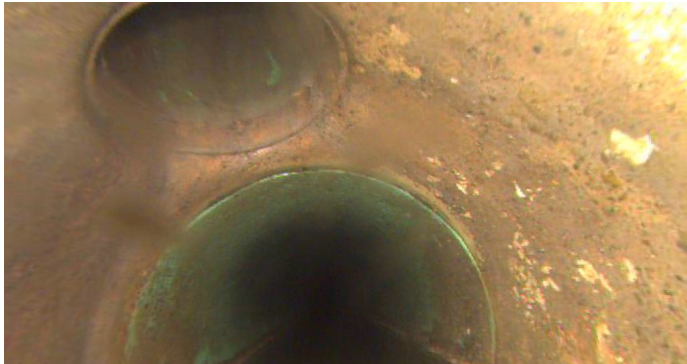
Code: **TF**
Description: **Tap Factory**

Distance (ft): **1.9**
Structural Grade: **0**
O&M Grade: **0**
Clock Start/From: **11**
Clock To:
1st Value: **4.000**
2nd Value:
Value Percent:
Continuous Index:
Within 8" of Joint:
Remarks:

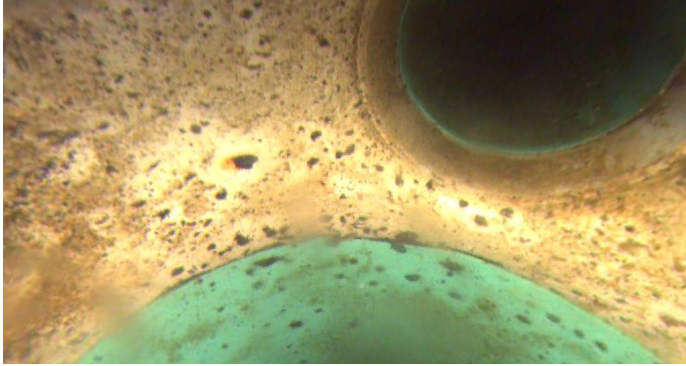
Code: **TF**
Description: **Tap Factory**

Distance (ft): **90.4**
Structural Grade: **0**
O&M Grade: **0**
Clock Start/From: **2**
Clock To:
1st Value: **4.000**
2nd Value:
Value Percent:
Continuous Index:
Within 8" of Joint:
Remarks:

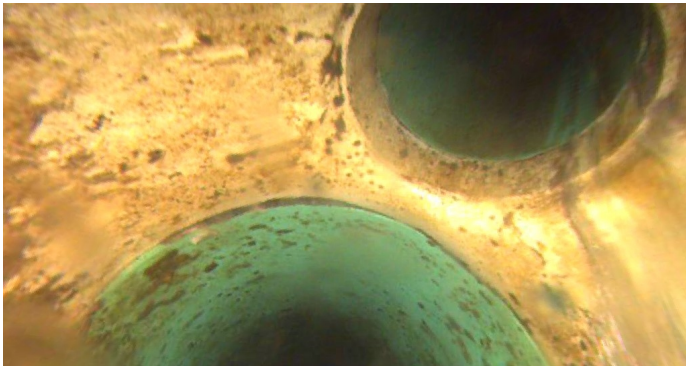
Code: **TFA**
Description: **Tap Factory Active**

Distance (ft): **93.6**
Structural Grade: **0**
O&M Grade: **0**
Clock Start/From: **2**
Clock To:
1st Value: **4.000**
2nd Value:
Value Percent:
Continuous Index:
Within 8" of Joint:
Remarks:

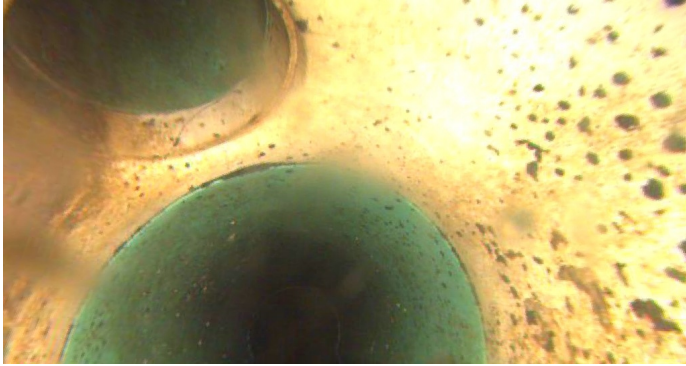
Code: **TF**
Description: **Tap Factory**

Distance (ft): **147.5**
Structural Grade: **0**
O&M Grade: **0**
Clock Start/From: **10**
Clock To:
1st Value: **4.000**
2nd Value:
Value Percent:
Continuous Index:
Within 8" of Joint:
Remarks:

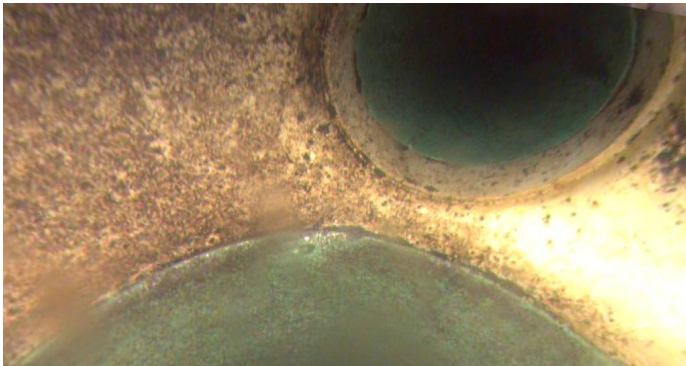
Code: **TF**
Description: **Tap Factory**

Distance (ft): **187.8**
Structural Grade: **0**
O&M Grade: **0**
Clock Start/From: **2**
Clock To:
1st Value: **4.000**
2nd Value:
Value Percent:
Continuous Index:
Within 8" of Joint:
Remarks:

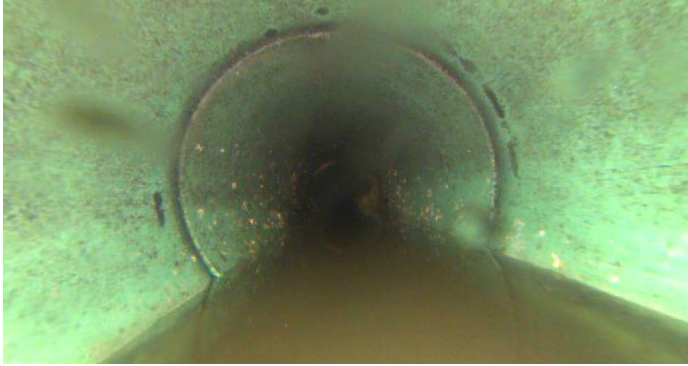
Code:	MSA
Description:	Abandoned Survey
Distance (ft):	201.6
Structural Grade:	0
O&M Grade:	0
Clock Start/From:	
Clock To:	
1st Value:	
2nd Value:	
Value Percent:	
Continuous Index:	
Within 8" of Joint:	NO
Remarks:	No blockage
