Profile/Photo Observation Report

Date:	02/12/2022	Weather:		Coding:	PACP 7.0
Pipe Length (ft):	348.1	Owner:	City of Hobart	Pre Clean:	Heavy Cleaning
P.O.#:	YES502259	Surveyor:	S. Bucklin	PSR:	P-707-011-012
Customer:	City of Hobart	Clean Date:	02/11/2022	Shape:	C

Street:	South Garfield Street	Flow Control:	Not Controlled
City:	Hobart, IN	Year Renewed:	
Location:	Local rural streets with light traffic, t	Tape/Media #:	
Purpose:	Routine Assessment	Dia/Height:	12"
Use:	Sanitary Sewage Pipe	Material:	PVC
Drain Area:		Lining:	None
Category:	NA		
Comment:			
Location Details:		Direction of Survey:	Downstream
US MH:	M-707-012	DS MH:	M-707-011
		Total Length Surveyed (ft):	348.1

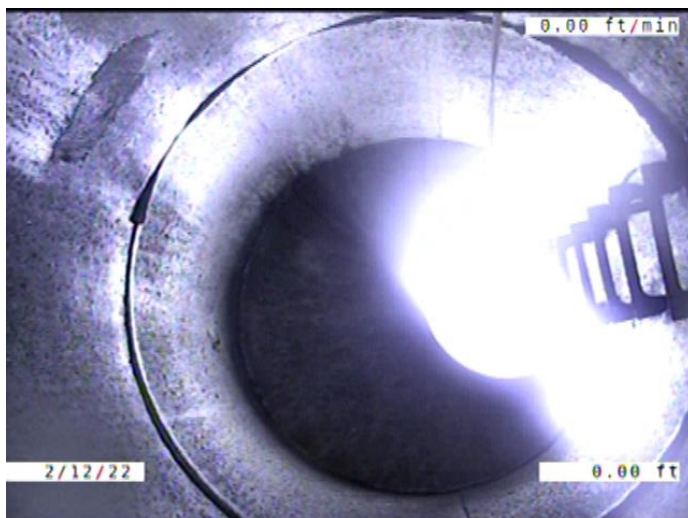
Code: **AMH**
Description: **Manhole**

Distance (ft): **.0**
Structural Grade: **0**
O&M Grade: **0**
Clock Start/From:
Clock To:
1st Value:
2nd Value:
Value Percent:
Continuous Index:
Within 8" of Joint: **NO**
Remarks: **M-707-012**

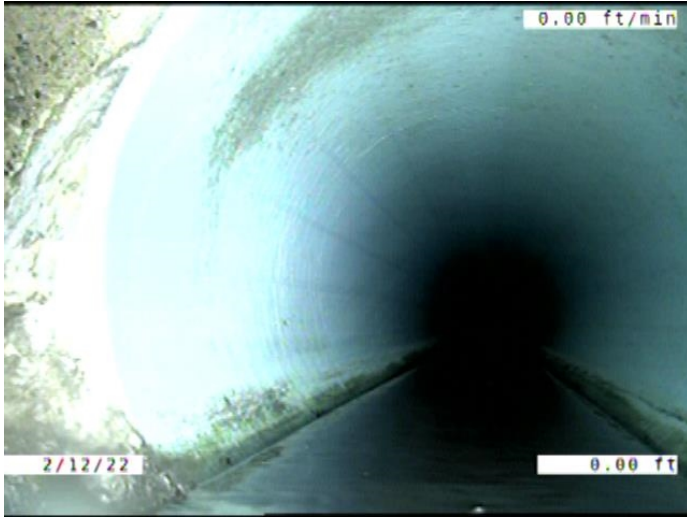
Code: **MWL**
Description: **Miscellaneous Water Level**

Distance (ft): **.0**
Structural Grade: **0**
O&M Grade: **0**
Clock Start/From:
Clock To:
1st Value:
2nd Value:
Value Percent: **10.000**
Continuous Index:
Within 8" of Joint: **NO**
Remarks:

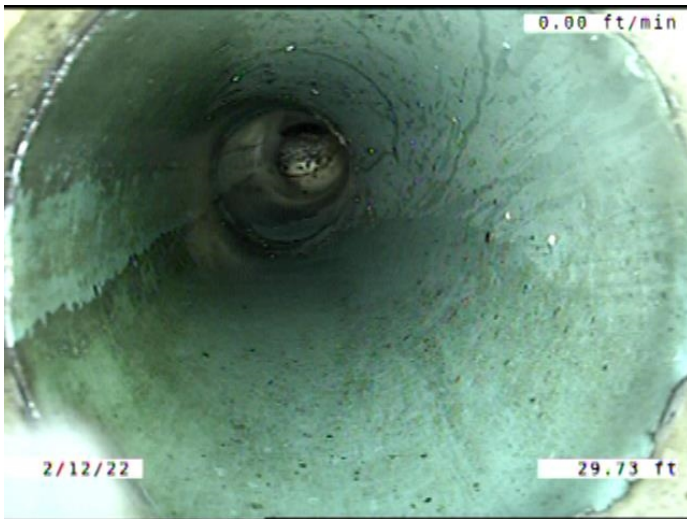
Code: **TF**
Description: **Tap Factory**

Distance (ft): **29.7**
Structural Grade: **0**
O&M Grade: **0**
Clock Start/From: **10**
Clock To:
1st Value: **6.000**
2nd Value:
Value Percent:
Continuous Index:
Within 8" of Joint: **YES**
Remarks: **CONSTANTLY RUNNING WATER.**

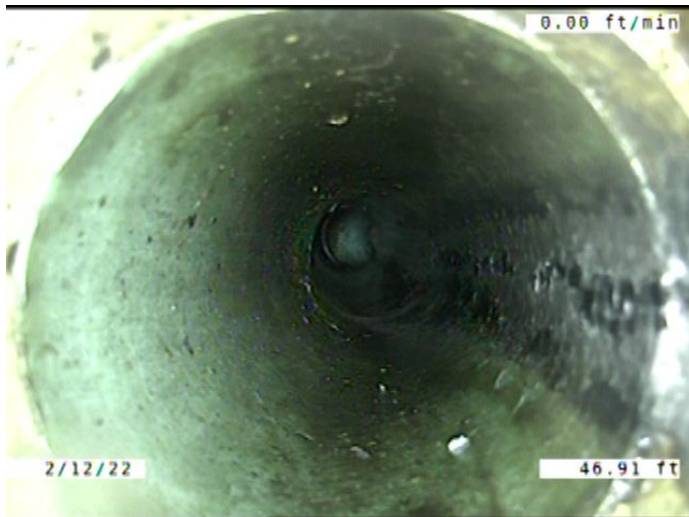
Code: **TFA**
Description: **Tap Factory Activity**

Distance (ft): **46.9**
Structural Grade: **0**
O&M Grade: **0**
Clock Start/From: **2**
Clock To:
1st Value: **6.000**
2nd Value:
Value Percent:
Continuous Index:
Within 8" of Joint: **YES**
Remarks:

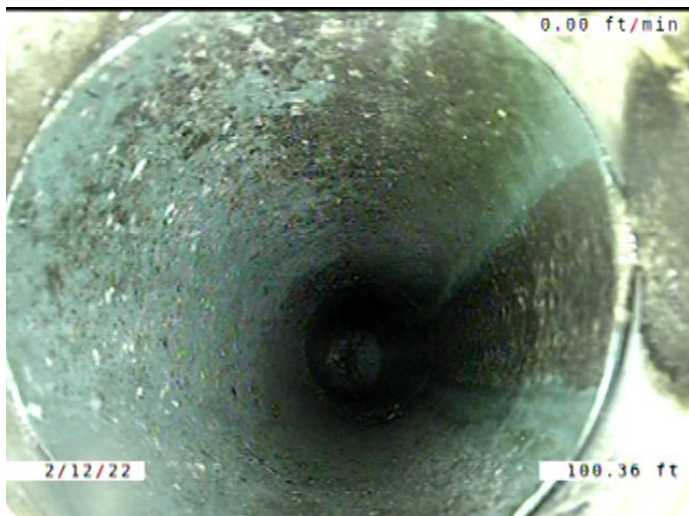
Code: **TF**
Description: **Tap Factory**

Distance (ft): **100.4**
Structural Grade: **0**
O&M Grade: **0**
Clock Start/From: **1**
Clock To:
1st Value: **6.000**
2nd Value:
Value Percent:
Continuous Index:
Within 8" of Joint: **YES**
Remarks:

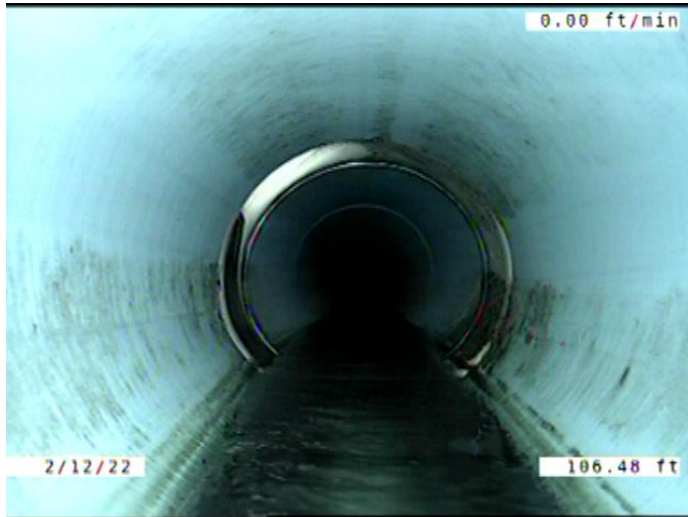
Code: **MWLS**
Description: **Miscellaneous Water Level Sag**

Distance (ft): **106.5**
Structural Grade: **2**
O&M Grade: **0**
Clock Start/From:
Clock To:
1st Value:
2nd Value:
Value Percent: **10.000**
Continuous Index: **S01**
Within 8" of Joint: **NO**
Remarks:

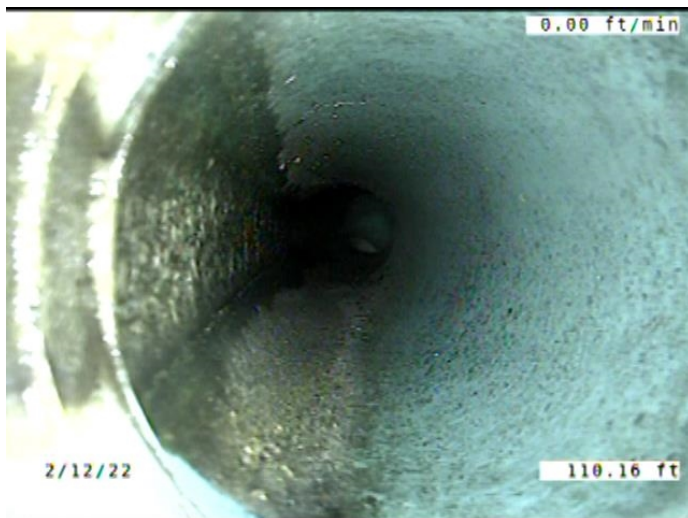
Code: **TF**
Description: **Tap Factory**

Distance (ft): **110.2**
Structural Grade: **0**
O&M Grade: **0**
Clock Start/From: **10**
Clock To:
1st Value: **6.000**
2nd Value:
Value Percent:
Continuous Index:
Within 8" of Joint: **YES**
Remarks:

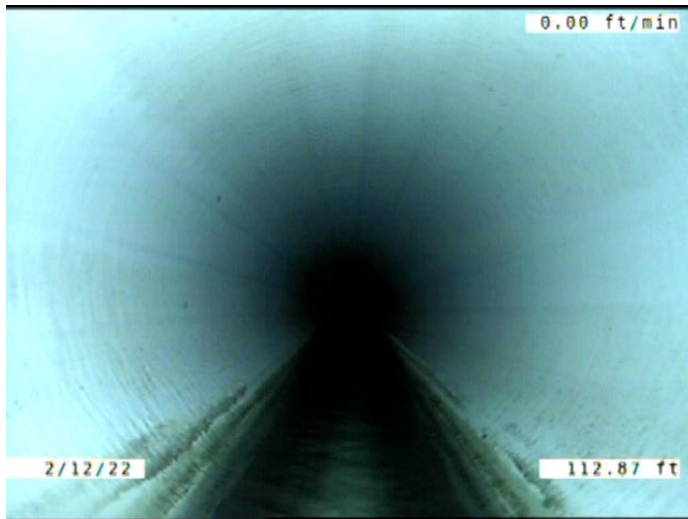
Code: **MWLS**
 Description: **Miscellaneous Water Level Sag**

Distance (ft): **112.9**
 Structural Grade: **2**
 O&M Grade: **0**
 Clock Start/From:
 Clock To:
 1st Value:
 2nd Value:
 Value Percent: **10.000**
 Continuous Index: **F01**
 Within 8" of Joint: **NO**
 Remarks:

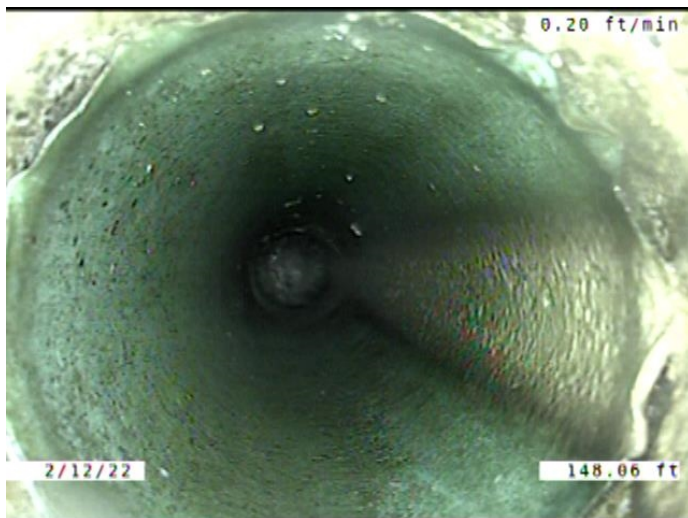
Code: **TF**
 Description: **Tap Factory**

Distance (ft): **148.1**
 Structural Grade: **0**
 O&M Grade: **0**
 Clock Start/From: **1**
 Clock To:
 1st Value: **6.000**
 2nd Value:
 Value Percent:
 Continuous Index:
 Within 8" of Joint: **YES**
 Remarks:

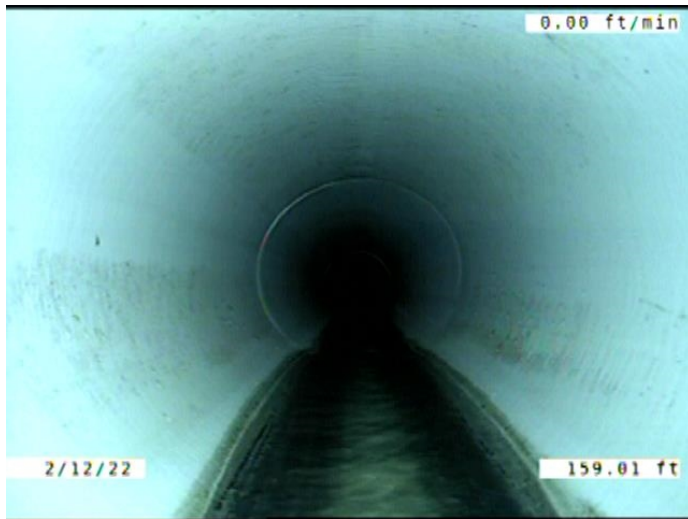
Code: **MWLS**
 Description: **Miscellaneous Water Level Sag**

Distance (ft): **159.0**
 Structural Grade: **2**
 O&M Grade: **0**
 Clock Start/From:
 Clock To:
 1st Value:
 2nd Value:
 Value Percent: **5.000**
 Continuous Index:
 Within 8" of Joint: **NO**
 Remarks:

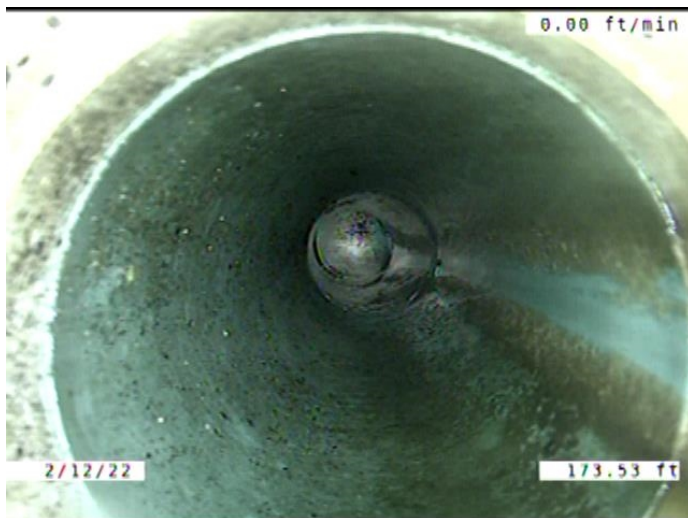
Code: **TF**
 Description: **Tap Factory**

Distance (ft): **173.5**
 Structural Grade: **0**
 O&M Grade: **0**
 Clock Start/From: **1**
 Clock To:
 1st Value: **6.000**
 2nd Value:
 Value Percent:
 Continuous Index:
 Within 8" of Joint: **YES**
 Remarks:

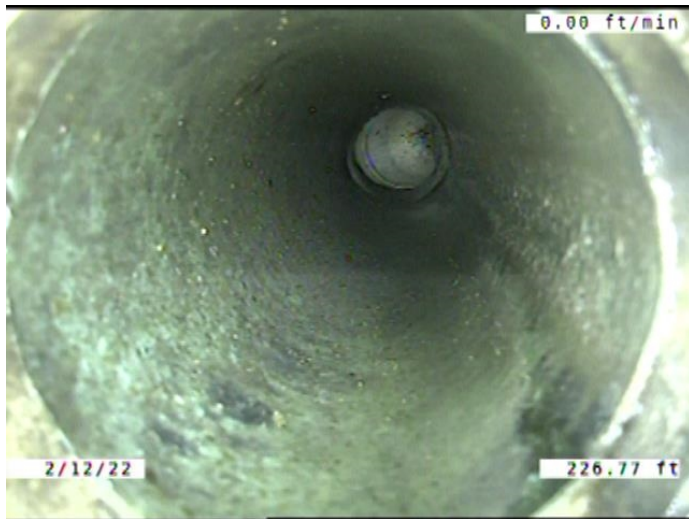
Code: **TF**
Description: **Tap Factory**

Distance (ft): **226.8**
Structural Grade: **0**
O&M Grade: **0**
Clock Start/From: **1**
Clock To:
1st Value: **6.000**
2nd Value:
Value Percent:
Continuous Index:
Within 8" of Joint: **YES**
Remarks:

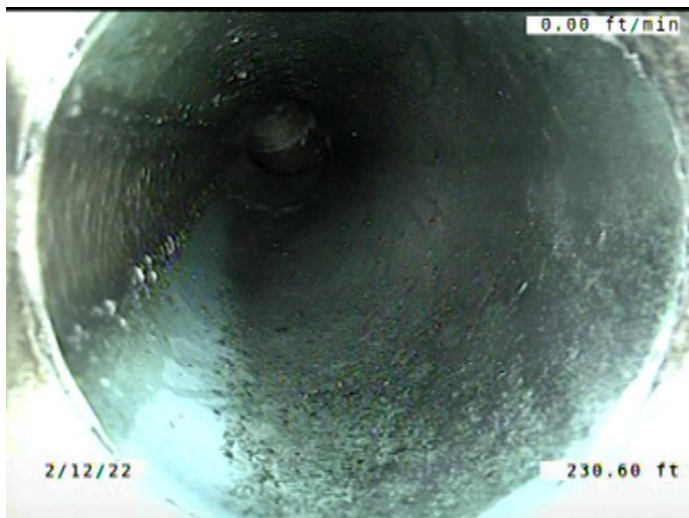
Code: **TF**
Description: **Tap Factory**

Distance (ft): **230.6**
Structural Grade: **0**
O&M Grade: **0**
Clock Start/From: **11**
Clock To:
1st Value: **6.000**
2nd Value:
Value Percent:
Continuous Index:
Within 8" of Joint: **YES**
Remarks:

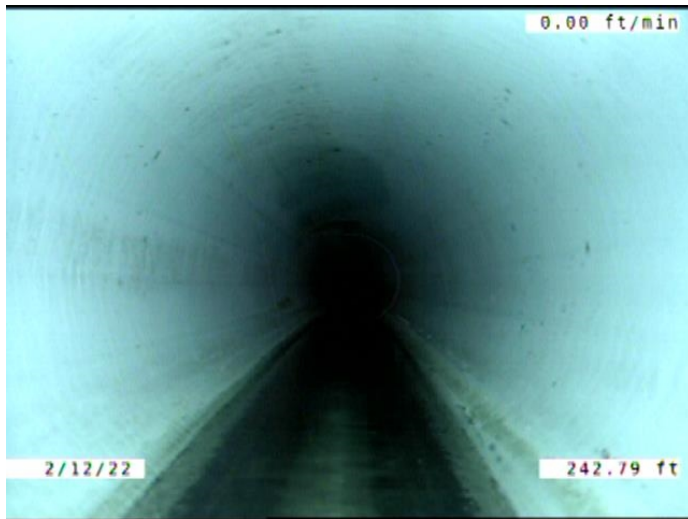
Code: **MWLS**
Description: **Miscellaneous Water Level Sag**

Distance (ft): **242.8**
Structural Grade: **2**
O&M Grade: **0**
Clock Start/From:
Clock To:
1st Value:
2nd Value:
Value Percent: **10.000**
Continuous Index: **S02**
Within 8" of Joint: **NO**
Remarks:

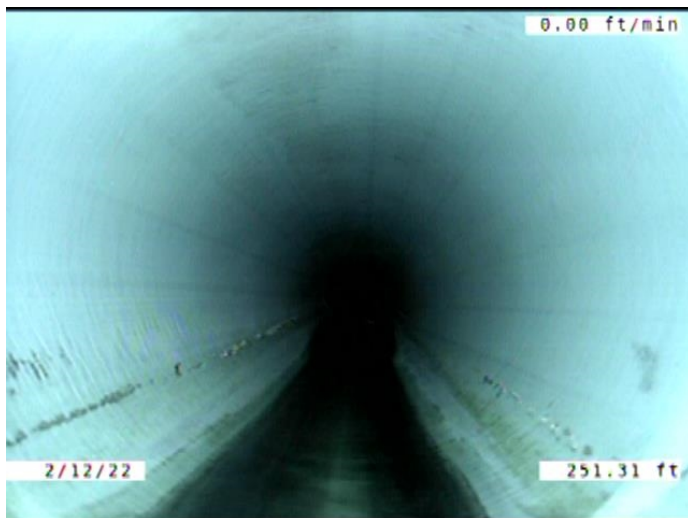
Code: **MWLS**
Description: **Miscellaneous Water Level Sag**

Distance (ft): **251.3**
Structural Grade: **2**
O&M Grade: **0**
Clock Start/From:
Clock To:
1st Value:
2nd Value:
Value Percent: **10.000**
Continuous Index: **F02**
Within 8" of Joint: **NO**
Remarks:

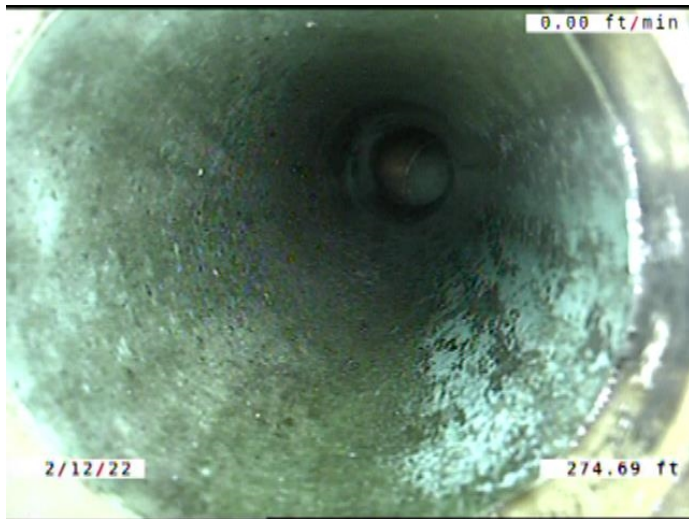
Code: **TF**
Description: **Tap Factory**

Distance (ft): **274.7**
Structural Grade: **0**
O&M Grade: **0**
Clock Start/From: **2**
Clock To:
1st Value: **6.000**
2nd Value:
Value Percent:
Continuous Index:
Within 8" of Joint: **YES**
Remarks:

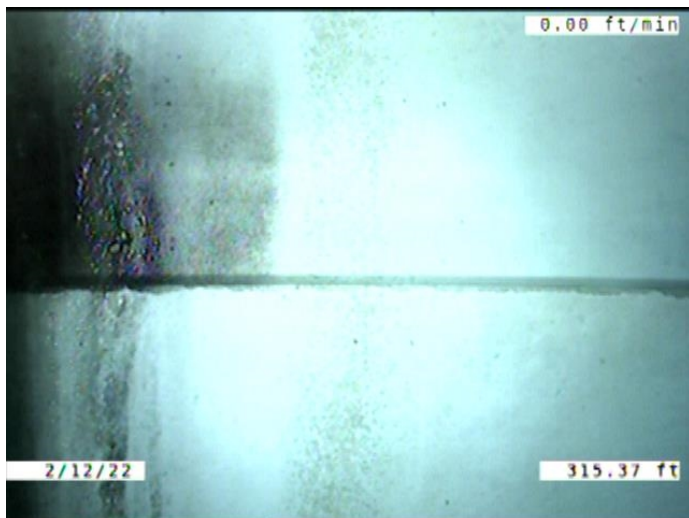
Code: **MGO**
Description: **Miscellaneous General Observation**

Distance (ft): **315.4**
Structural Grade: **0**
O&M Grade: **0**
Clock Start/From:
Clock To:
1st Value:
2nd Value:
Value Percent:
Continuous Index:
Within 8" of Joint: **NO**
Remarks: **JOINT/ PIPES NOT PUSHED ALL THE WAY TOGETHER WHEN INSTALLED**

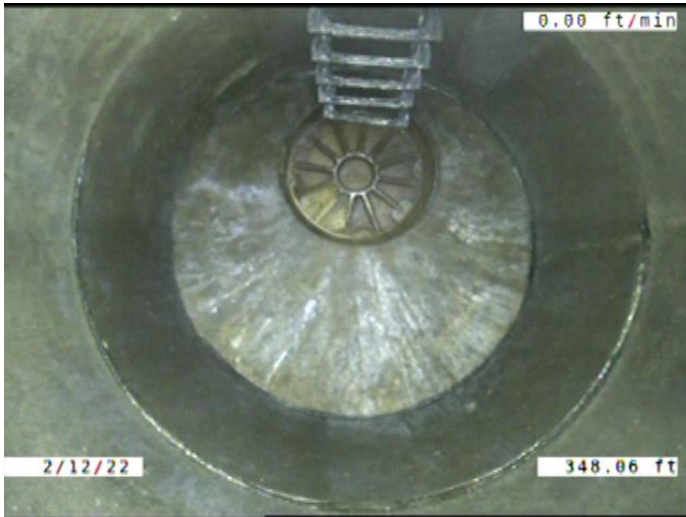
Code:	AMH
Description:	Manhole
Distance (ft):	348.1
Structural Grade:	0
O&M Grade:	0
Clock Start/From:	
Clock To:	
1st Value:	
2nd Value:	
Value Percent:	
Continuous Index:	
Within 8" of Joint:	NO
Remarks:	M-707-011
