## Profile/Photo Observation Report

Street:	<b>GARFIELD ST &amp; E 11TH ST</b>	Flow Control:	<b>Not Controlled</b>
City:	<b>Hobart, IN</b>	Year Renewed:	
Location:	<b>Light Highway</b>	Tape/Media #:	
Purpose:	<b>Maintenance Related</b>	Dia/Height:	<b>12"</b>
Use:	<b>Sanitary</b>	Material:	<b>PVC</b>
Drain Area:	<b>NA</b>	Lining:	<b>Cured in Place</b>
Category:	<b>NA</b>		
Comment:	<b>mh.</b>

Location Details:		Direction of Survey:	<b>Downstream</b>
US MH:	<b>M-707-012</b>	DS MH:	<b>M-707-013</b>
		Total Length Surveyed (ft):	<b>21.2</b>

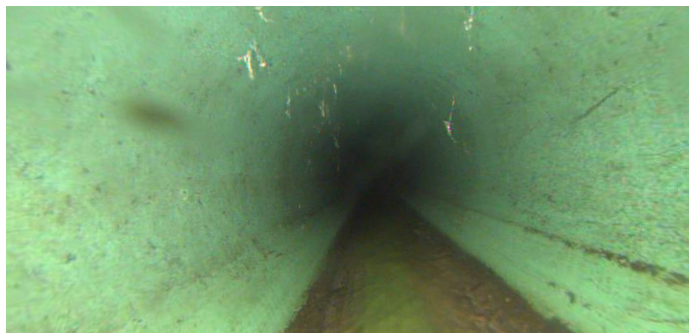
Code: **AMH**  
Description: **Manhole**

Distance (ft): **.0**  
Structural Grade: **0**  
O&M Grade: **0**  
Clock Start/From:  
Clock To:  
1st Value:  
2nd Value:  
Value Percent:  
Continuous Index:  
Within 8" of Joint: **NO**  
Remarks: **M-707-012**

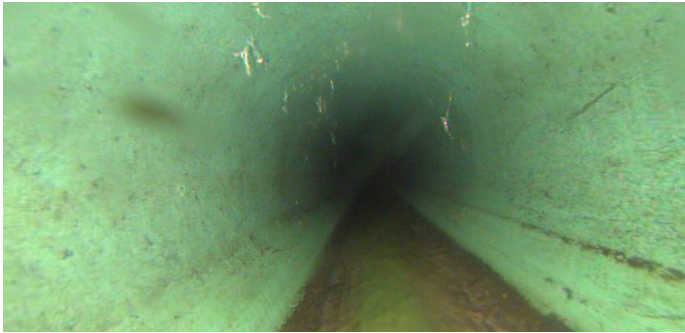
Code:	<b>MWL</b>
Description:	<b>Water Level</b>

Distance (ft):	<b>.0</b>
Structural Grade:	<b>0</b>
O&M Grade:	<b>0</b>
Clock Start/From:	
Clock To:	
1st Value:	
2nd Value:	
Value Percent:	<b>5.000</b>
Continuous Index:	
Within 8" of Joint:	<b>NO</b>
Remarks:

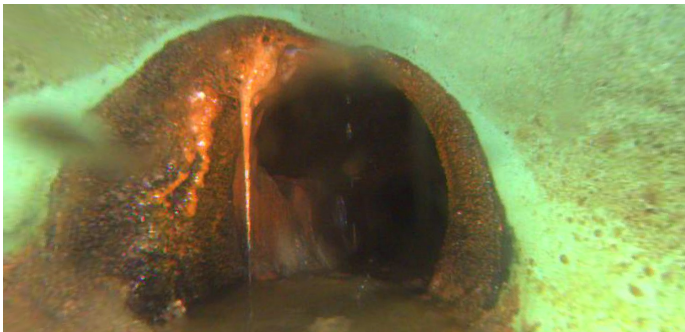
Code:	<b>DAE</b>
Description:	<b>Deposits Attached Encrustation</b>

Distance (ft):	<b>17.3</b>
Structural Grade:	<b>0</b>
O&M Grade:	<b>2</b>
Clock Start/From:	<b>8</b>
Clock To:	<b>4</b>
1st Value:	
2nd Value:	
Value Percent:	<b>10.000</b>
Continuous Index:	
Within 8" of Joint:	<b>NO</b>
Remarks:

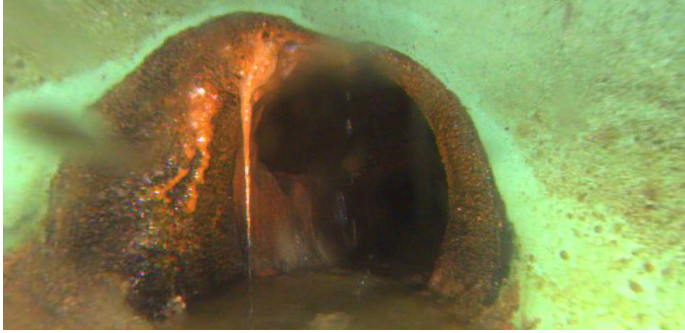
Code: **IR**  
Description: **Infil Runner**

Distance (ft): **17.3**  
Structural Grade: **0**  
O&M Grade: **4**  
Clock Start/From: **12**  
Clock To:  
1st Value:  
2nd Value:  
Value Percent:  
Continuous Index:  
Within 8" of Joint:  
Remarks:

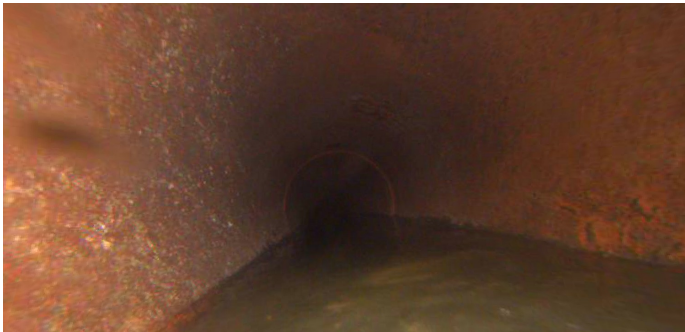
Code: **AMH**  
Description: **Manhole**

Distance (ft): **21.2**  
Structural Grade: **0**  
O&M Grade: **0**  
Clock Start/From:  
Clock To:  
1st Value:  
2nd Value:  
Value Percent:  
Continuous Index:  
Within 8" of Joint: **NO**  
Remarks: **M-707-013**
