Profile/Photo Observation Report

Date:	04/10/2018	Weather:		Coding:	PACP 6.0
Pipe Length (ft):	23.7	Owner:	NA	Pre Clean:	Not Known
P.O.#:		Surveyor:	Jen Costello	PSR:	P-707-012-013
Customer:		Clean Date:	01/01/1900	Shape:	C

Location Details:		Direction of Survey:	Downstream
US MH:	M-707-012	DS MH:	M-707-013
		Total Length Surveyed (ft):	21.2

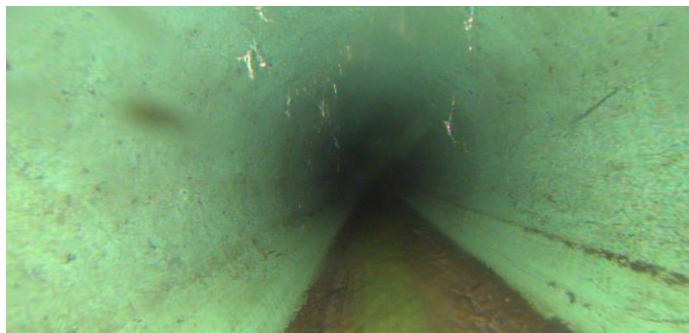
Code: **AMH**
Description: **Manhole**

Distance (ft): **.0**
Structural Grade: **0**
O&M Grade: **0**
Clock Start/From:
Clock To:
1st Value:
2nd Value:
Value Percent:
Continuous Index:
Within 8" of Joint: **NO**
Remarks: **M-707-012**

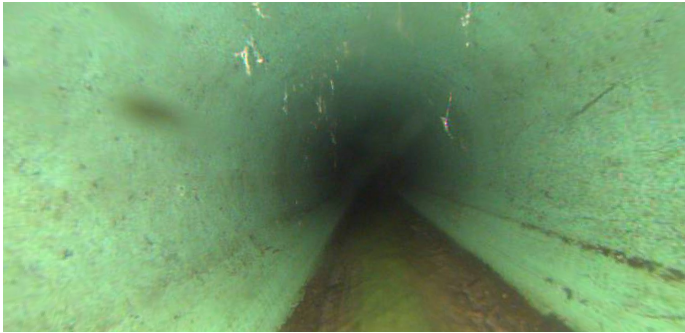
Code:	MWL
Description:	Water Level

Distance (ft):	.0
Structural Grade:	0
O&M Grade:	0
Clock Start/From:	
Clock To:	
1st Value:	
2nd Value:	
Value Percent:	5.000
Continuous Index:	
Within 8" of Joint:	NO
Remarks:

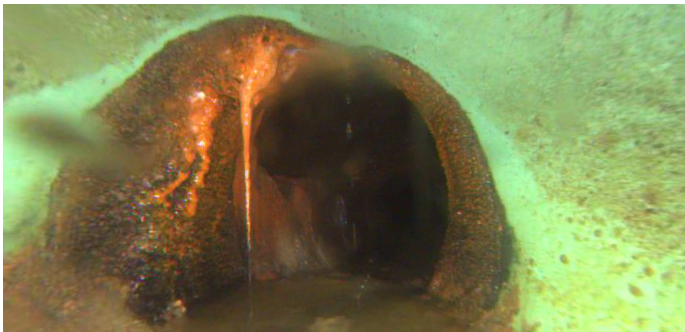
Code:	DAE
Description:	Deposits Attached Encrustation

Distance (ft):	17.3
Structural Grade:	0
O&M Grade:	2
Clock Start/From:	8
Clock To:	4
1st Value:	
2nd Value:	
Value Percent:	10.000
Continuous Index:	
Within 8" of Joint:	NO
Remarks:

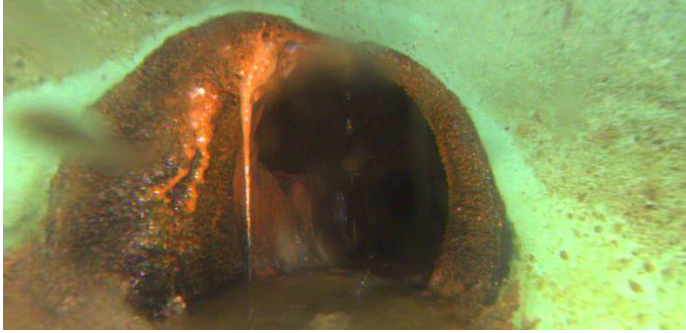
Code: **IR**
Description: **Infil Runner**

Distance (ft): **17.3**
Structural Grade: **0**
O&M Grade: **4**
Clock Start/From: **12**
Clock To:
1st Value:
2nd Value:
Value Percent:
Continuous Index:
Within 8" of Joint:
Remarks:

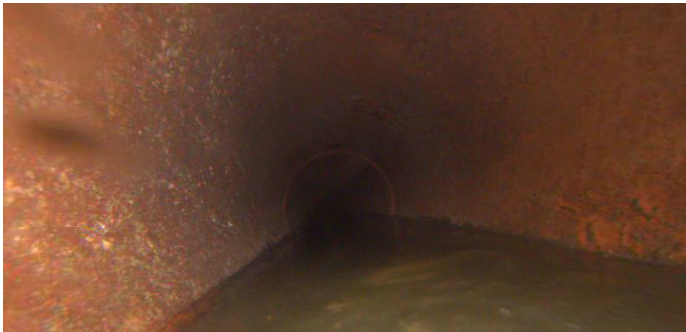
Code: **AMH**
Description: **Manhole**

Distance (ft): **21.2**
Structural Grade: **0**
O&M Grade: **0**
Clock Start/From:
Clock To:
1st Value:
2nd Value:
Value Percent:
Continuous Index:
Within 8" of Joint: **NO**
Remarks: **M-707-013**
