Profile/Photo Observation Report

Street:	LINCOLN ST	Flow Control:	Not Controlled
City:	Hobart, IN	Year Renewed:	
Location:	Light Highway	Tape/Media #:	
Purpose:	Maintenance Related	Dia/Height:	8"
Use:	Sanitary	Material:	VCP
Drain Area:	NA	Lining:	Cured in Place
Category:	NA		
Comment:	sediment at 195'.-flow incorrect.		
Location Details:		Direction of Survey:	Downstream
US MH:	M-707-020	DS MH:	M-707-019
		Total Length Surveyed (ft):	196.4

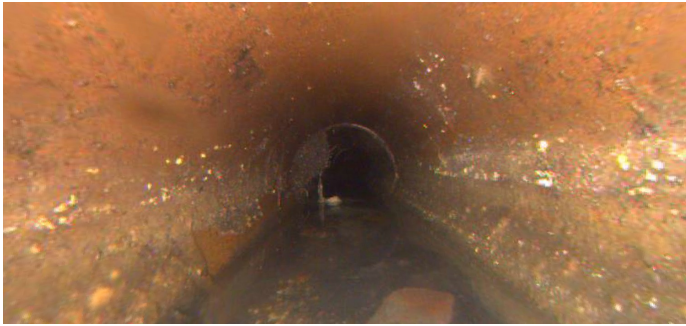
Code: **AMH**
Description: **Manhole**

Distance (ft): **.0**
Structural Grade: **0**
O&M Grade: **0**
Clock Start/From:
Clock To:
1st Value:
2nd Value:
Value Percent:
Continuous Index:
Within 8" of Joint: **NO**
Remarks: **M-707-020**

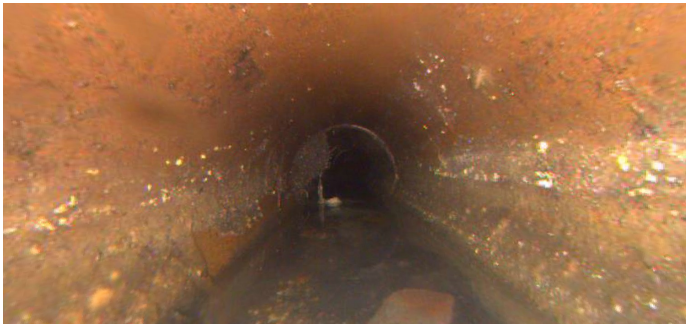
Code: **MWL**
Description: **Water Level**

Distance (ft): **.0**
Structural Grade: **0**
O&M Grade: **0**
Clock Start/From:
Clock To:
1st Value:
2nd Value:
Value Percent: **10.000**
Continuous Index:
Within 8" of Joint: **NO**
Remarks:

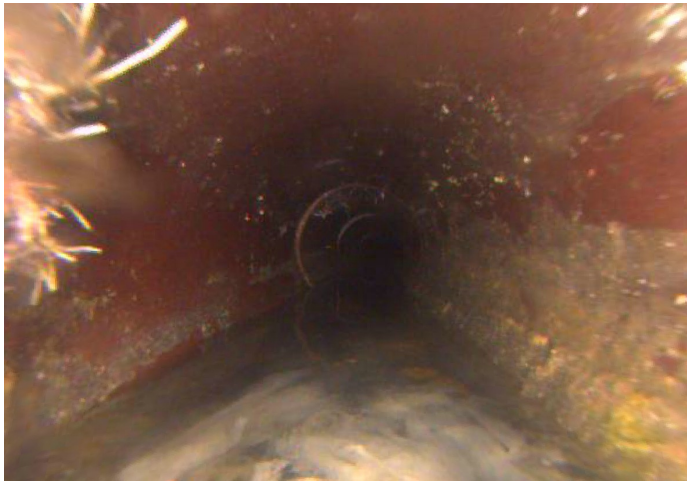
Code:	RFJ
Description:	Roots Fine Joint
Distance (ft):	3.0
Structural Grade:	0
O&M Grade:	1
Clock Start/From:	7
Clock To:	12
1st Value:	
2nd Value:	
Value Percent:	
Continuous Index:	
Within 8" of Joint:	YES
Remarks:

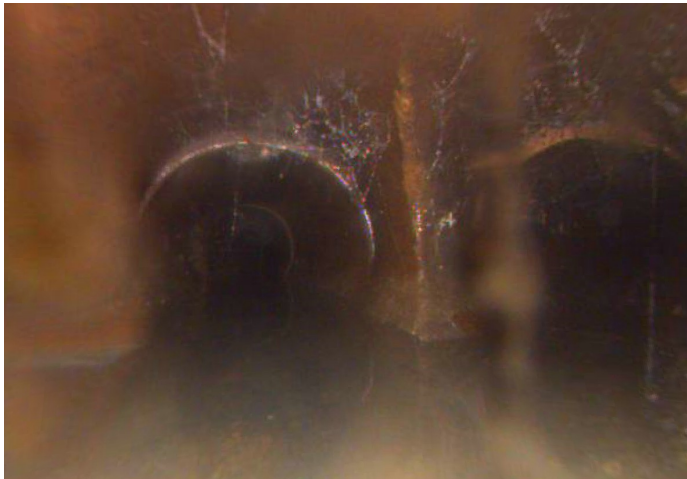
Code:	TF
Description:	Tap Factory
Distance (ft):	22.5
Structural Grade:	0
O&M Grade:	0
Clock Start/From:	4
Clock To:	
1st Value:	4.000
2nd Value:	
Value Percent:	
Continuous Index:	
Within 8" of Joint:	
Remarks:

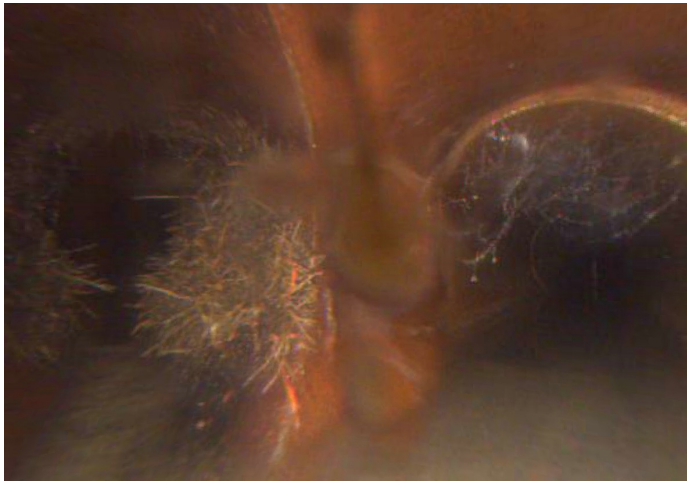
Code: **TF**
Description: **Tap Factory**

Distance (ft): **24.8**
Structural Grade: **0**
O&M Grade: **0**
Clock Start/From: **7**
Clock To:
1st Value: **4.000**
2nd Value:
Value Percent:
Continuous Index:
Within 8" of Joint:
Remarks:

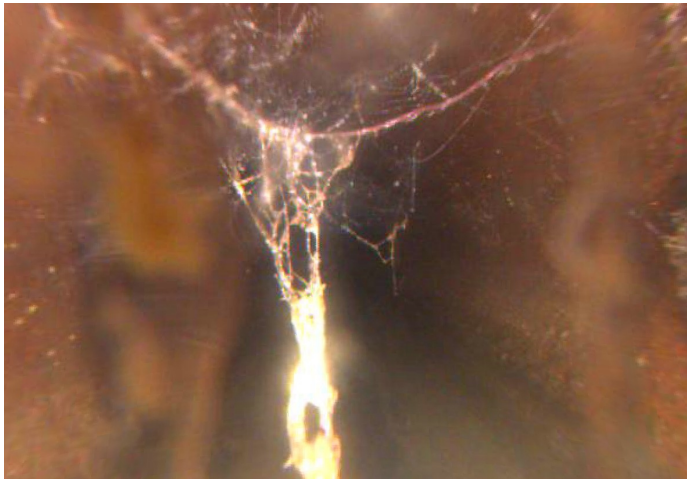
Code: **RFJ**
Description: **Roots Fine Joint**

Distance (ft): **29.6**
Structural Grade: **0**
O&M Grade: **1**
Clock Start/From: **7**
Clock To: **5**
1st Value:
2nd Value:
Value Percent:
Continuous Index:
Within 8" of Joint: **YES**
Remarks:

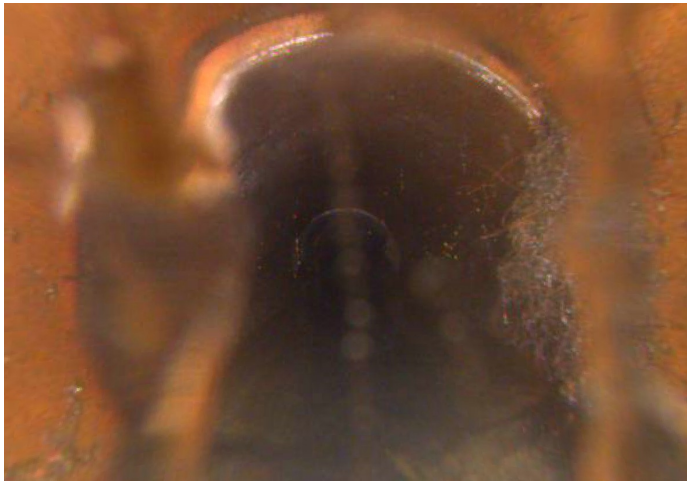
Code: **RFJ**
Description: **Roots Fine Joint**

Distance (ft): **39.6**
Structural Grade: **0**
O&M Grade: **1**
Clock Start/From: **7**
Clock To: **5**
1st Value:
2nd Value:
Value Percent:
Continuous Index: **S01**
Within 8" of Joint: **YES**
Remarks:

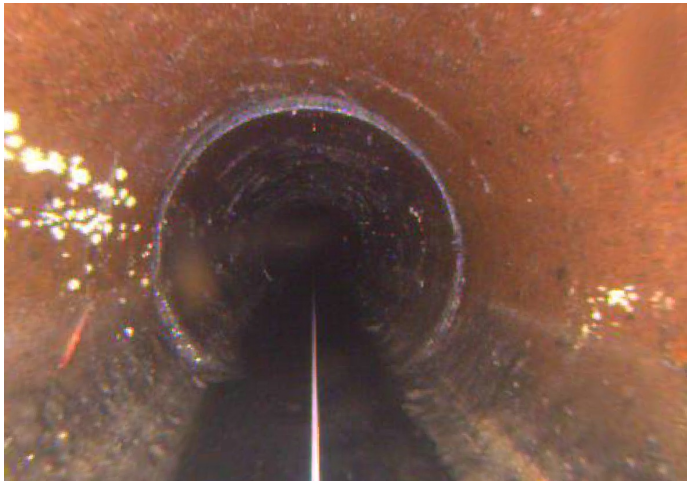
Code: **RFJ**
Description: **Roots Fine Joint**

Distance (ft): **63.8**
Structural Grade: **0**
O&M Grade: **1**
Clock Start/From: **7**
Clock To: **5**
1st Value:
2nd Value:
Value Percent:
Continuous Index: **F01**
Within 8" of Joint: **YES**
Remarks:

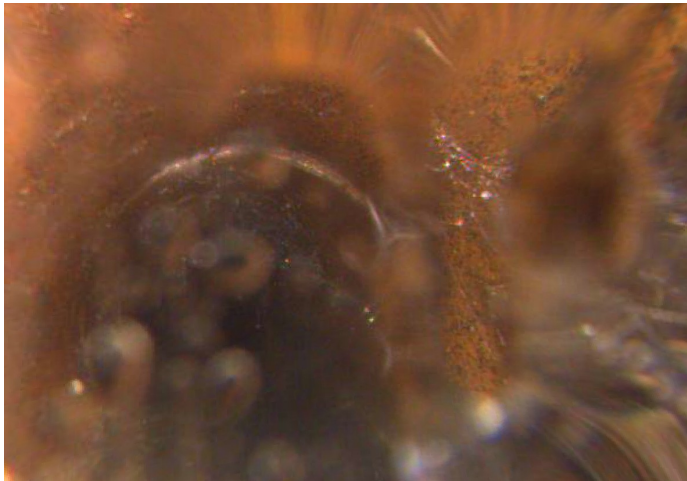
Code:	TFD
Description:	Tap Factory Defective
Distance (ft):	72.3
Structural Grade:	0
O&M Grade:	2
Clock Start/From:	4
Clock To:	
1st Value:	4.000
2nd Value:	
Value Percent:	
Continuous Index:	
Within 8" of Joint:	
Remarks:	RFL

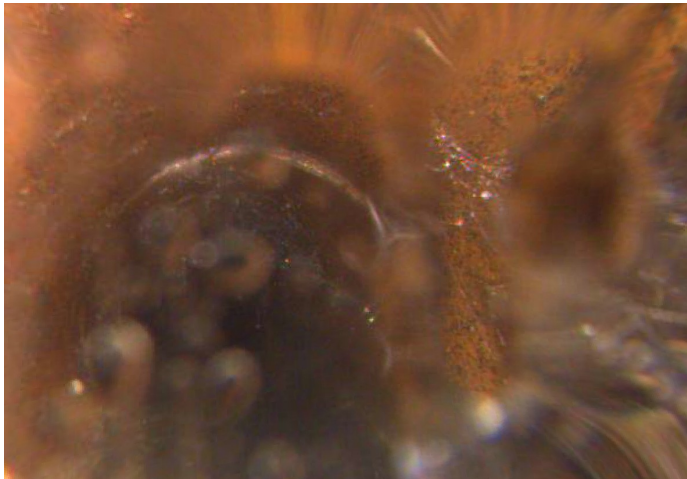
Code:	RFL
Description:	Roots Fine Lateral
Distance (ft):	72.3
Structural Grade:	0
O&M Grade:	1
Clock Start/From:	4
Clock To:	
1st Value:	
2nd Value:	
Value Percent:	
Continuous Index:	
Within 8" of Joint:	NO
Remarks:

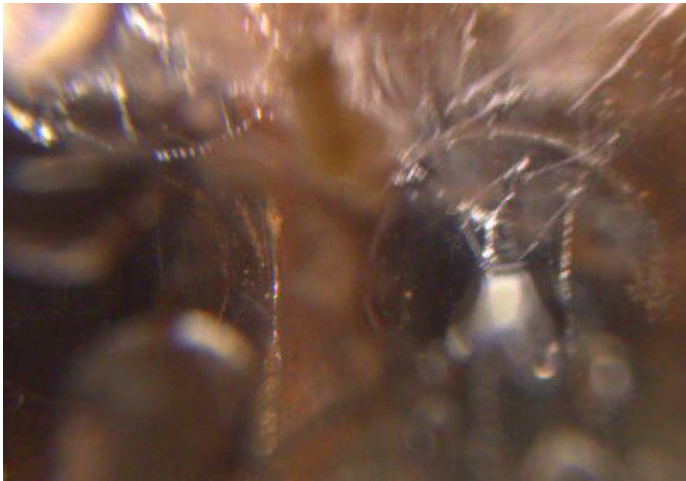
Code: **TF**
Description: **Tap Factory**

Distance (ft): **74.1**
Structural Grade: **0**
O&M Grade: **0**
Clock Start/From: **8**
Clock To:
1st Value: **4.000**
2nd Value:
Value Percent:
Continuous Index:
Within 8" of Joint:
Remarks:

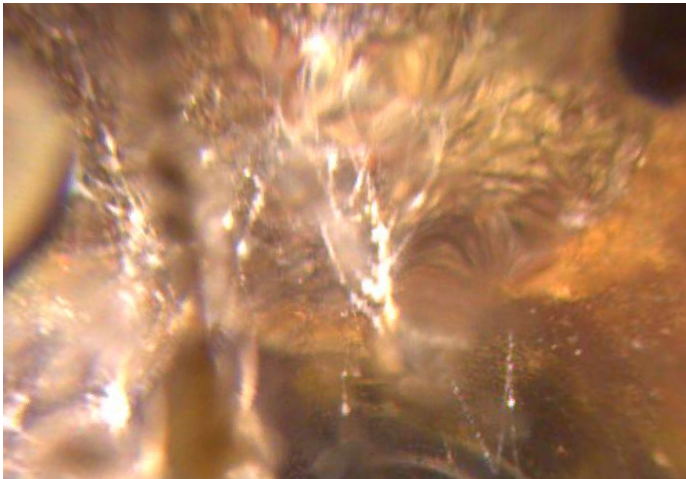
Code: **TFC**
Description: **Tap Factory Capped**

Distance (ft): **75.8**
Structural Grade: **0**
O&M Grade: **0**
Clock Start/From: **12**
Clock To:
1st Value: **4.000**
2nd Value:
Value Percent:
Continuous Index:
Within 8" of Joint:
Remarks:

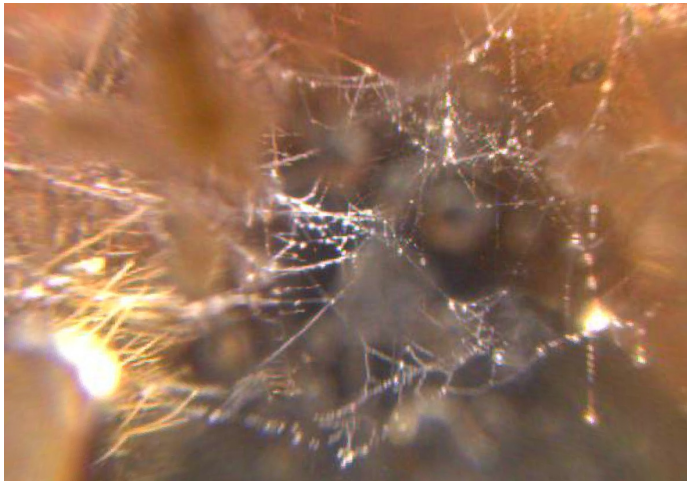
Code: **RFJ**
Description: **Roots Fine Joint**

Distance (ft): **78.8**
Structural Grade: **0**
O&M Grade: **1**
Clock Start/From: **7**
Clock To: **5**
1st Value:
2nd Value:
Value Percent:
Continuous Index:
Within 8" of Joint: **YES**
Remarks:

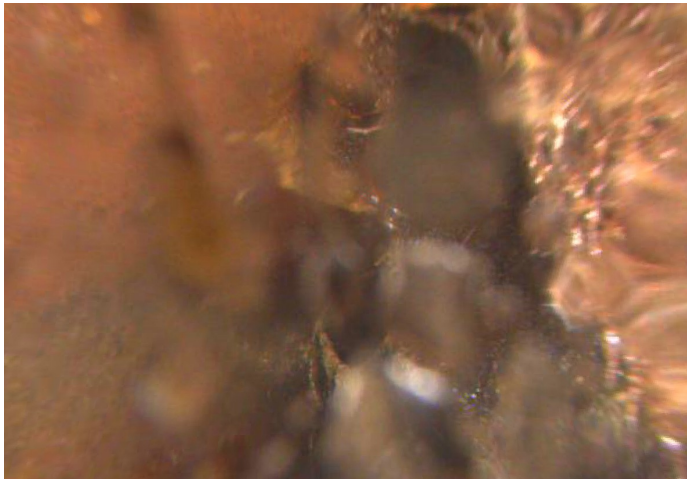
Code: **TBD**
Description: **Tap Break-in Defective**

Distance (ft): **88.0**
Structural Grade: **0**
O&M Grade: **3**
Clock Start/From: **2**
Clock To:
1st Value: **4.000**
2nd Value:
Value Percent:
Continuous Index:
Within 8" of Joint:
Remarks: **Rfl**

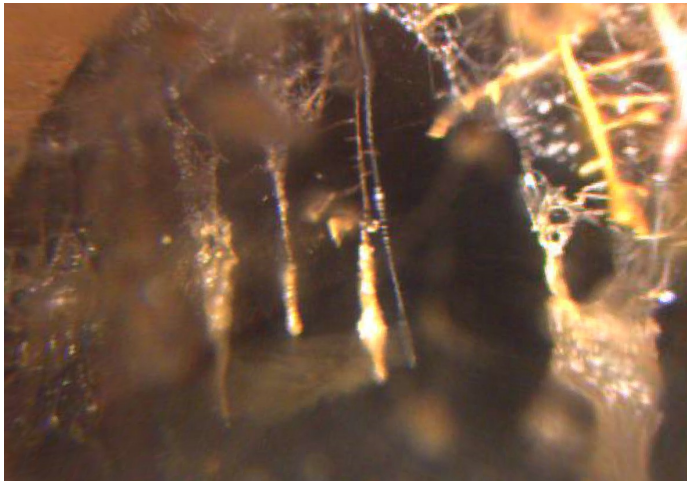
Code:	RFJ
Description:	Roots Fine Joint
Distance (ft):	95.3
Structural Grade:	0
O&M Grade:	1
Clock Start/From:	8
Clock To:	4
1st Value:	
2nd Value:	
Value Percent:	
Continuous Index:	
Within 8" of Joint:	YES
Remarks:

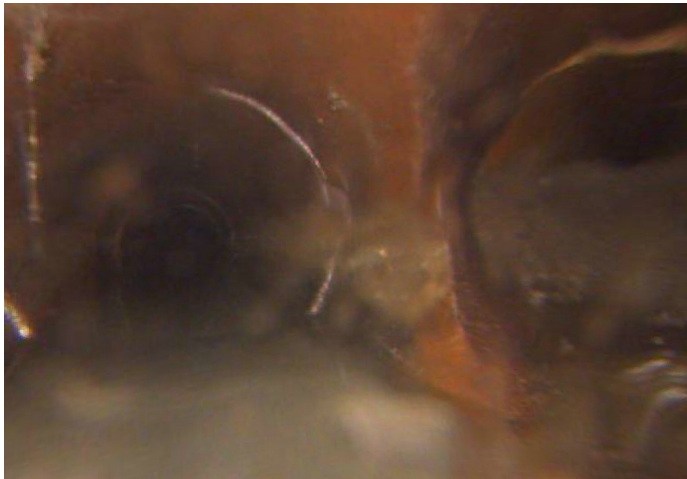
Code:	TF
Description:	Tap Factory
Distance (ft):	121.5
Structural Grade:	0
O&M Grade:	0
Clock Start/From:	4
Clock To:	
1st Value:	4.000
2nd Value:	
Value Percent:	
Continuous Index:	
Within 8" of Joint:	
Remarks:

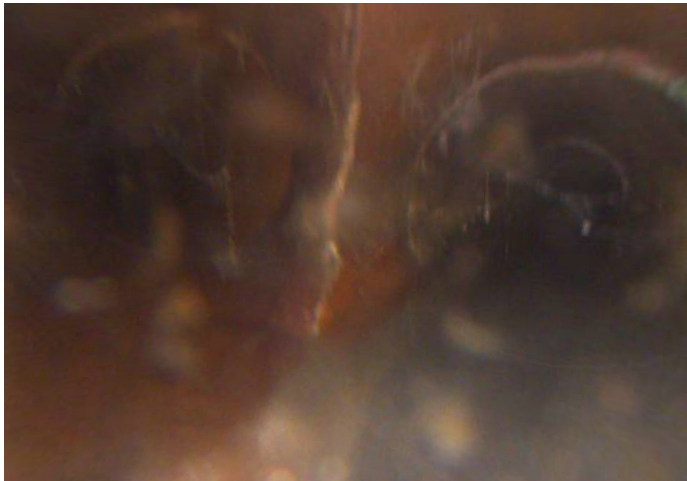
Code: **TF**
Description: **Tap Factory**

Distance (ft): **123.4**
Structural Grade: **0**
O&M Grade: **0**
Clock Start/From: **8**
Clock To:
1st Value: **4.000**
2nd Value:
Value Percent:
Continuous Index:
Within 8" of Joint:
Remarks:

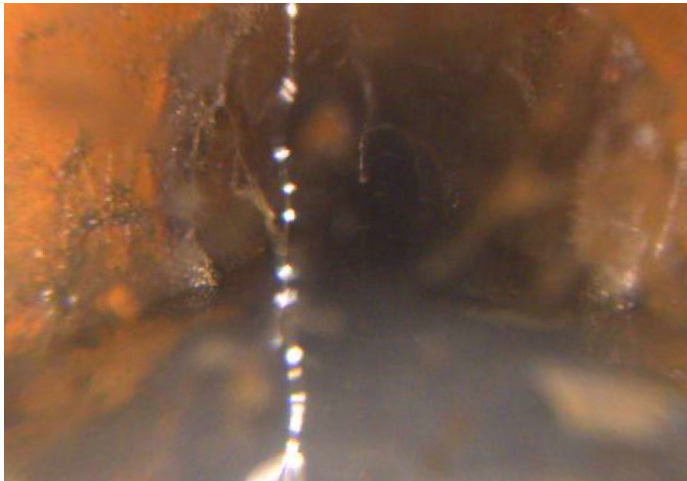
Code: **RFJ**
Description: **Roots Fine Joint**

Distance (ft): **140.5**
Structural Grade: **0**
O&M Grade: **1**
Clock Start/From: **7**
Clock To: **5**
1st Value:
2nd Value:
Value Percent:
Continuous Index: **S02**
Within 8" of Joint: **YES**
Remarks:

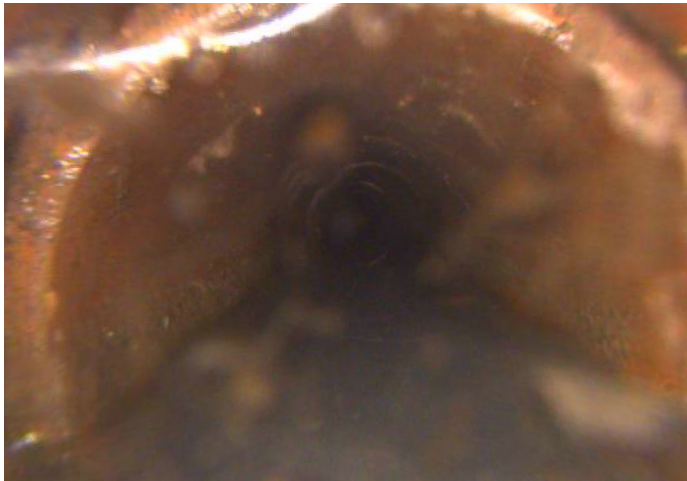
Code: **RFJ**
Description: **Roots Fine Joint**

Distance (ft): **149.0**
Structural Grade: **0**
O&M Grade: **1**
Clock Start/From: **7**
Clock To: **5**
1st Value:
2nd Value:
Value Percent:
Continuous Index: **F02**
Within 8" of Joint: **YES**
Remarks:

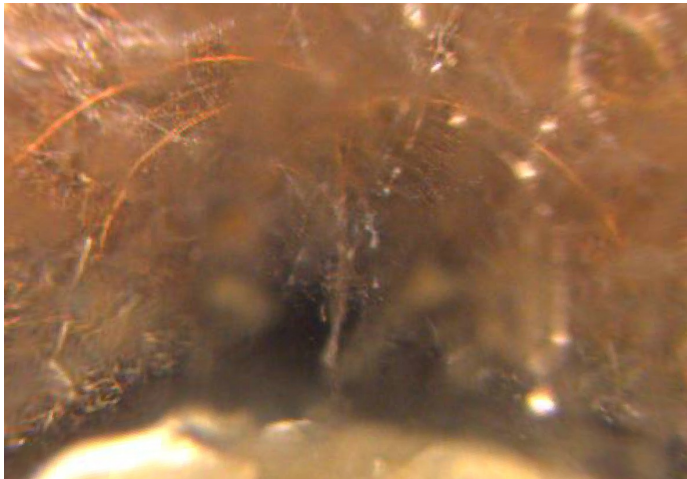
Code: **RFB**
Description: **Roots Fine Barrel**

Distance (ft): **172.2**
Structural Grade: **0**
O&M Grade: **2**
Clock Start/From: **8**
Clock To: **4**
1st Value:
2nd Value:
Value Percent:
Continuous Index:
Within 8" of Joint: **NO**
Remarks:

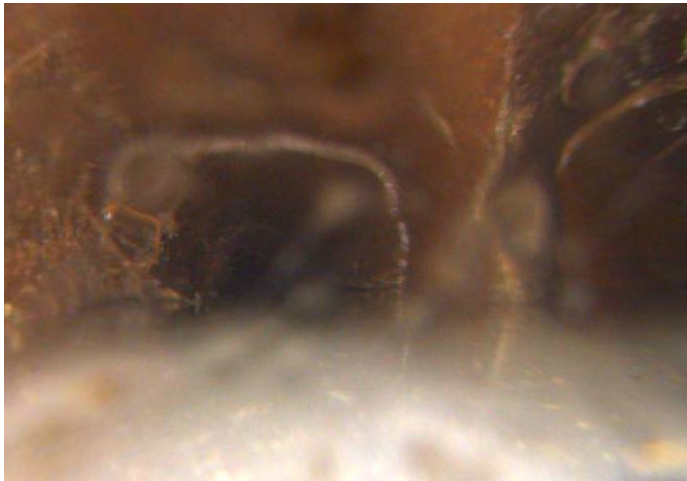
Code: **TF**
Description: **Tap Factory**

Distance (ft): **175.5**
Structural Grade: **0**
O&M Grade: **0**
Clock Start/From: **4**
Clock To:
1st Value: **4.000**
2nd Value:
Value Percent:
Continuous Index:
Within 8" of Joint:
Remarks:

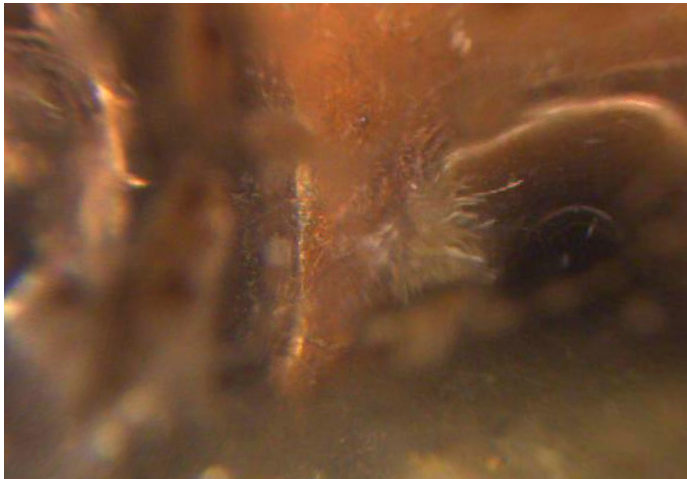
Code: **TFD**
Description: **Tap Factory Defective**

Distance (ft): **177.6**
Structural Grade: **0**
O&M Grade: **2**
Clock Start/From: **7**
Clock To:
1st Value: **4.000**
2nd Value:
Value Percent:
Continuous Index:
Within 8" of Joint:
Remarks: **RFL**

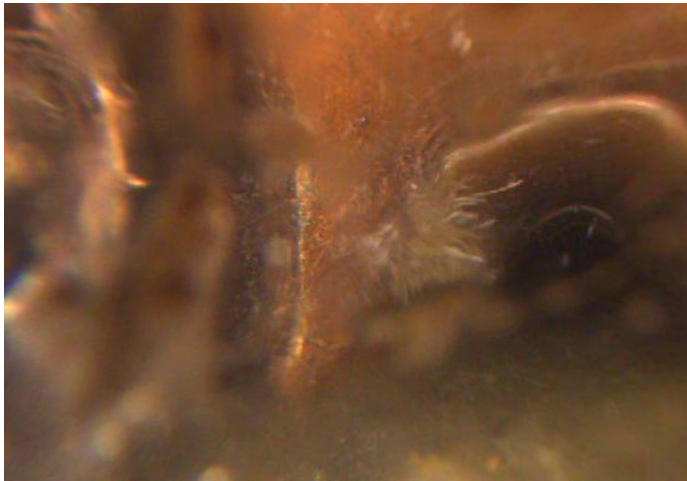
Code: **RFL**
Description: **Roots Fine Lateral**

Distance (ft): **177.6**
Structural Grade: **0**
O&M Grade: **1**
Clock Start/From: **7**
Clock To:
1st Value:
2nd Value:
Value Percent:
Continuous Index:
Within 8" of Joint: **NO**
Remarks:

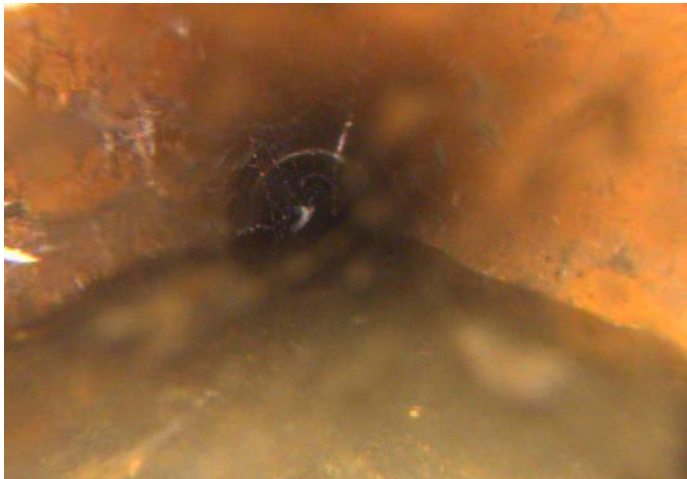
Code: **RFJ**
Description: **Roots Fine Joint**

Distance (ft): **178.2**
Structural Grade: **0**
O&M Grade: **1**
Clock Start/From: **7**
Clock To: **10**
1st Value:
2nd Value:
Value Percent:
Continuous Index:
Within 8" of Joint: **YES**
Remarks:

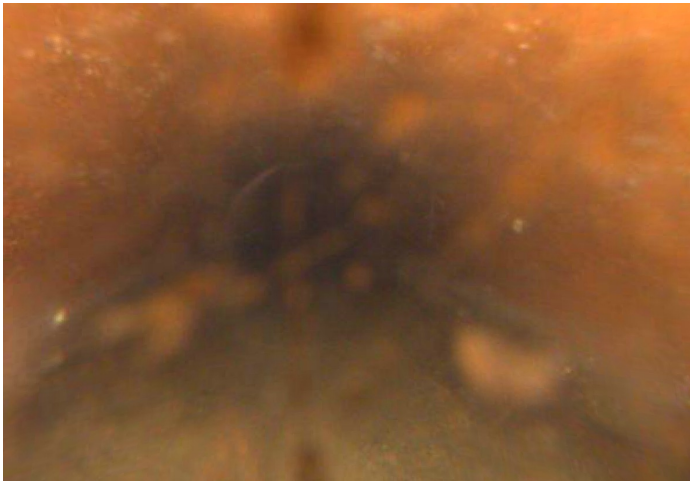
Code:	MSA
Description:	Abandoned Survey
Distance (ft):	196.4
Structural Grade:	0
O&M Grade:	0
Clock Start/From:	
Clock To:	
1st Value:	
2nd Value:	
Value Percent:	
Continuous Index:	
Within 8" of Joint:	NO
Remarks:	Debris under water
