## Profile/Photo Observation Report

Date:	<b>04/09/2018</b>	Weather:		Coding:	<b>PACP 6.0</b>
Pipe Length (ft):	<b>226.0</b>	Owner:	<b>NA</b>	Pre Clean:	<b>Not Known</b>
P.O.#:		Surveyor:	<b>Jen Costello</b>	PSR:	<b>P-707-019-020</b>
Customer:		Clean Date:	<b>01/01/1900</b>	Shape:	<b>C</b>

Street:	<b>Capitol</b>	Flow Control:	<b>Not Controlled</b>
City:	<b>Hobart, IN</b>	Year Renewed:	
Location:	<b>Light Highway</b>	Tape/Media #:	
Purpose:	<b>Maintenance Related</b>	Dia/Height:	<b>8"</b>
Use:	<b>Sanitary</b>	Material:	<b>VCP</b>
Drain Area:	<b>NA</b>	Lining:	<b>Cured in Place</b>
Category:	<b>NA</b>		
Comment:	<b>sediment at 195'.-flow incorrect.</b>		
Location Details:		Direction of Survey:	<b>Downstream</b>
US MH:	<b>M-707-020</b>	DS MH:	<b>M-707-019</b>
		Total Length Surveyed (ft):	<b>196.4</b>

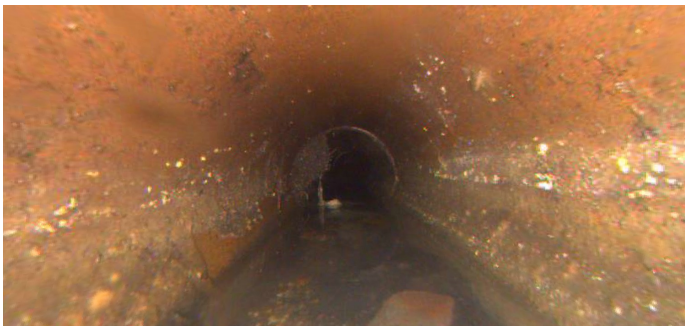
Code: **MWL**  
Description: **Water Level**

Distance (ft): **.0**  
Structural Grade: **0**  
O&M Grade: **0**  
Clock Start/From:  
Clock To:  
1st Value:  
2nd Value:  
Value Percent: **10.000**  
Continuous Index:  
Within 8" of Joint: **NO**  
Remarks:

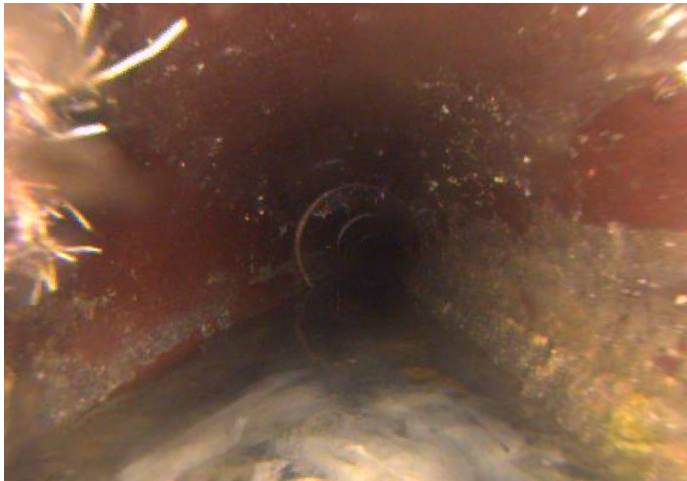
Code:	<b>RFJ</b>
Description:	<b>Roots Fine Joint</b>
Distance (ft):	<b>3.0</b>
Structural Grade:	<b>0</b>
O&M Grade:	<b>1</b>
Clock Start/From:	<b>7</b>
Clock To:	<b>12</b>
1st Value:	
2nd Value:	
Value Percent:	
Continuous Index:	
Within 8" of Joint:	<b>YES</b>
Remarks:

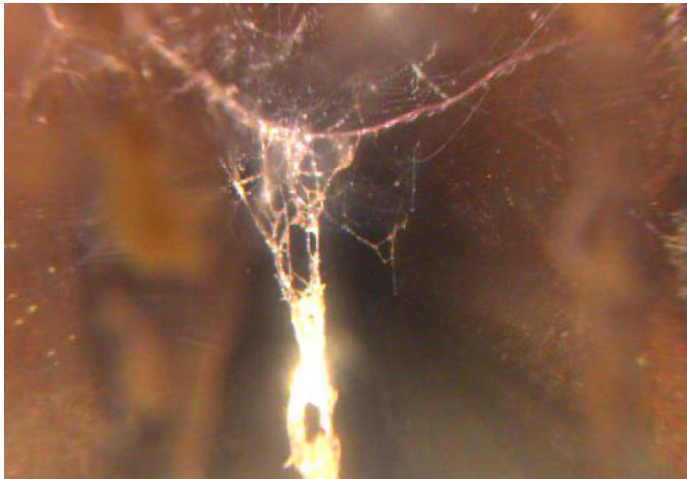
Code: **RFJ**  
Description: **Roots Fine Joint**

Distance (ft): **29.6**  
Structural Grade: **0**  
O&M Grade: **1**  
Clock Start/From: **7**  
Clock To: **5**  
1st Value:  
2nd Value:  
Value Percent:  
Continuous Index:  
Within 8" of Joint: **YES**  
Remarks:

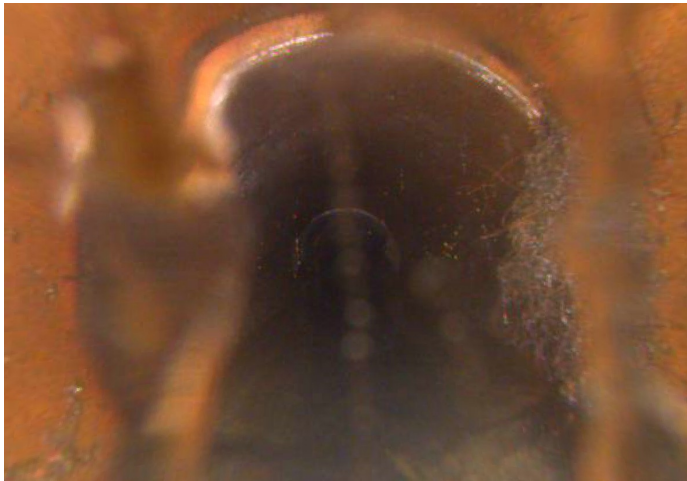
Code: **RFJ**  
Description: **Roots Fine Joint**

Distance (ft): **39.6**  
Structural Grade: **0**  
O&M Grade: **1**  
Clock Start/From: **7**  
Clock To: **5**  
1st Value:  
2nd Value:  
Value Percent:  
Continuous Index: **S01**  
Within 8" of Joint: **YES**  
Remarks:

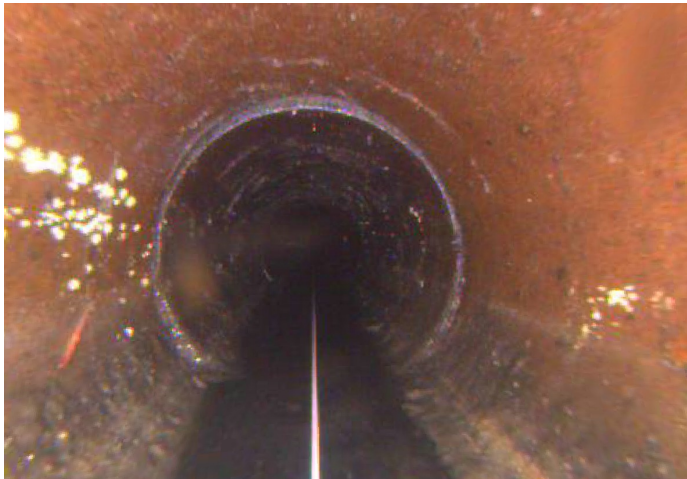
Code: **RFJ**  
Description: **Roots Fine Joint**

Distance (ft): **63.8**  
Structural Grade: **0**  
O&M Grade: **1**  
Clock Start/From: **7**  
Clock To: **5**  
1st Value:  
2nd Value:  
Value Percent:  
Continuous Index: **F01**  
Within 8" of Joint: **YES**  
Remarks:

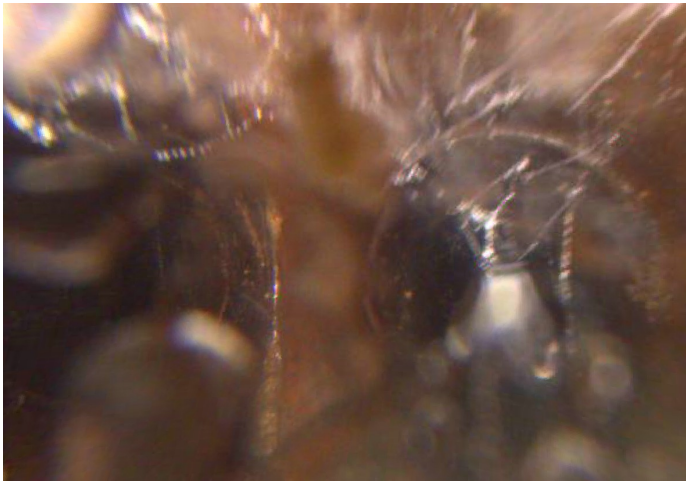
Code: **TF**  
Description: **Tap Factory**

Distance (ft): **74.1**  
Structural Grade: **0**  
O&M Grade: **0**  
Clock Start/From: **8**  
Clock To:  
1st Value: **4.000**  
2nd Value:  
Value Percent:  
Continuous Index:  
Within 8" of Joint:  
Remarks:

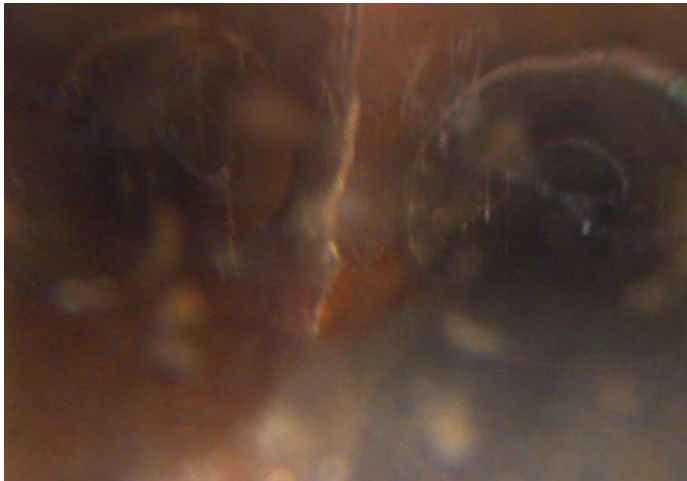
Code: **TF**  
Description: **Tap Factory**

Distance (ft): **123.4**  
Structural Grade: **0**  
O&M Grade: **0**  
Clock Start/From: **8**  
Clock To:  
1st Value: **4.000**  
2nd Value:  
Value Percent:  
Continuous Index:  
Within 8" of Joint:  
Remarks:

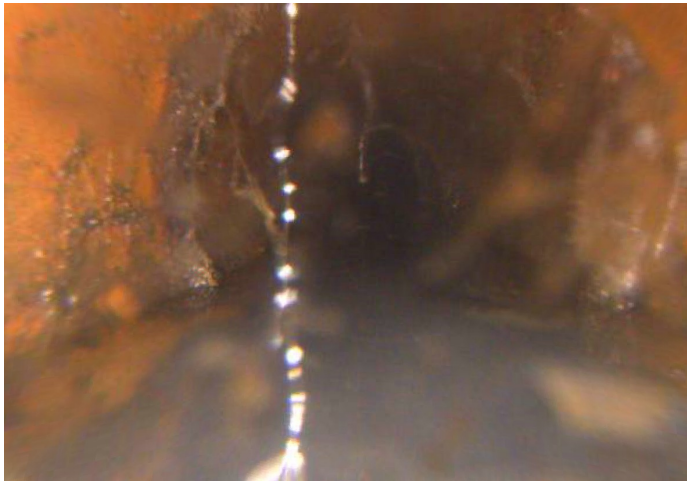
Code: **RFJ**  
Description: **Roots Fine Joint**

Distance (ft): **140.5**  
Structural Grade: **0**  
O&M Grade: **1**  
Clock Start/From: **7**  
Clock To: **5**  
1st Value:  
2nd Value:  
Value Percent:  
Continuous Index: **S02**  
Within 8" of Joint: **YES**  
Remarks:

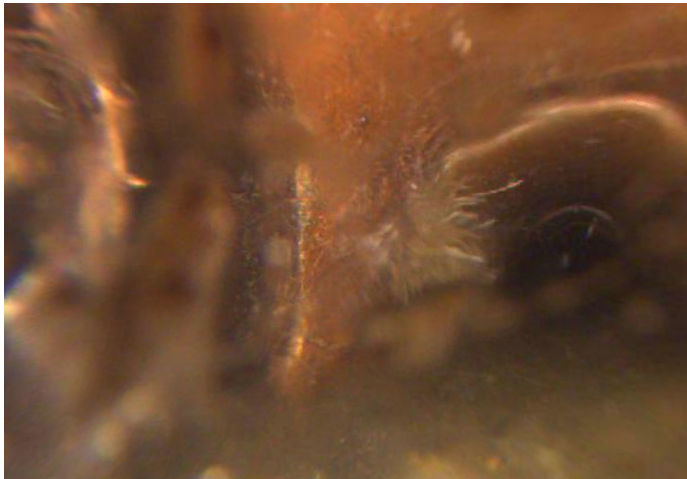
Code: **TFD**  
Description: **Tap Factory Defective**

Distance (ft): **177.6**  
Structural Grade: **0**  
O&M Grade: **2**  
Clock Start/From: **7**  
Clock To:  
1st Value: **4.000**  
2nd Value:  
Value Percent:  
Continuous Index:  
Within 8" of Joint:  
Remarks: **RFL**

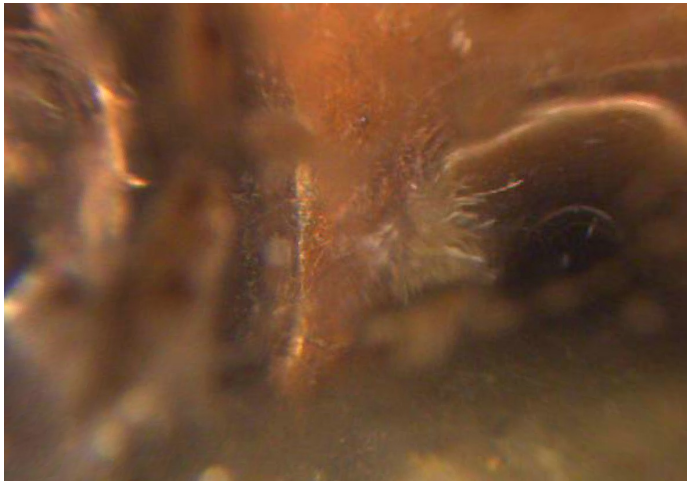
Code: **RFL**  
Description: **Roots Fine Lateral**

Distance (ft): **177.6**  
Structural Grade: **0**  
O&M Grade: **1**  
Clock Start/From: **7**  
Clock To:  
1st Value:  
2nd Value:  
Value Percent:  
Continuous Index:  
Within 8" of Joint: **NO**  
Remarks:
